# AKOURI CONSULTING ENGINEERS

RE Summary of repairs and recommendations obtained from the Milestone Phase 1 and 2  
for the building located at:

Las Vistas in Inverrary Condominium Association Inc.  
3521 Inverrary Dr Bldg J, Lauderdale, FL 33319

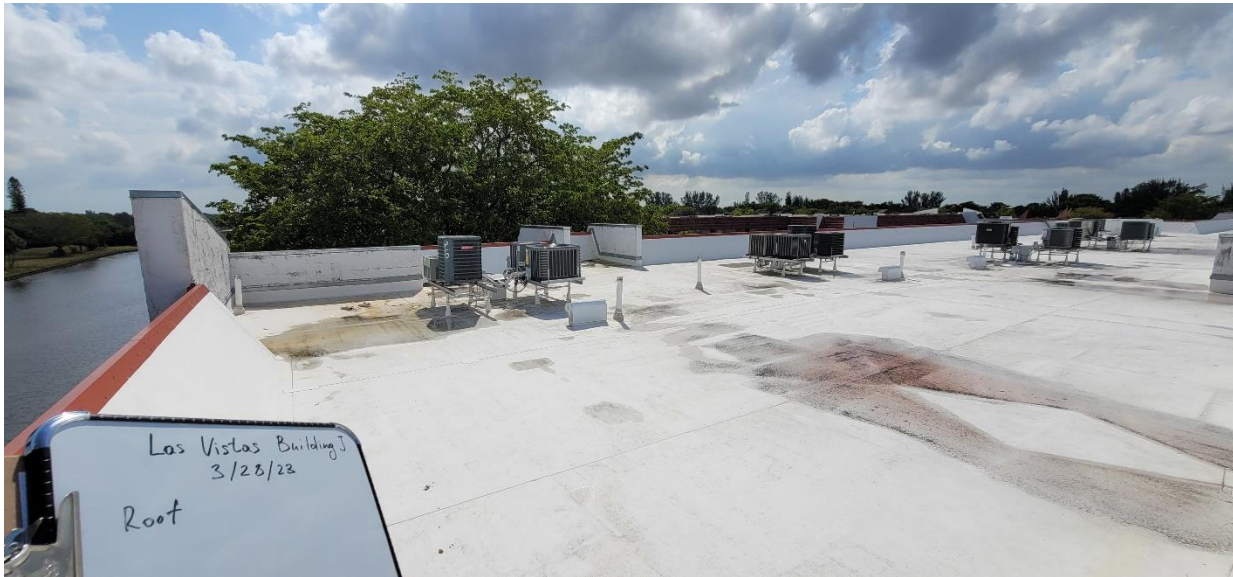
Roof (Single-ply roofing system. Good condition)

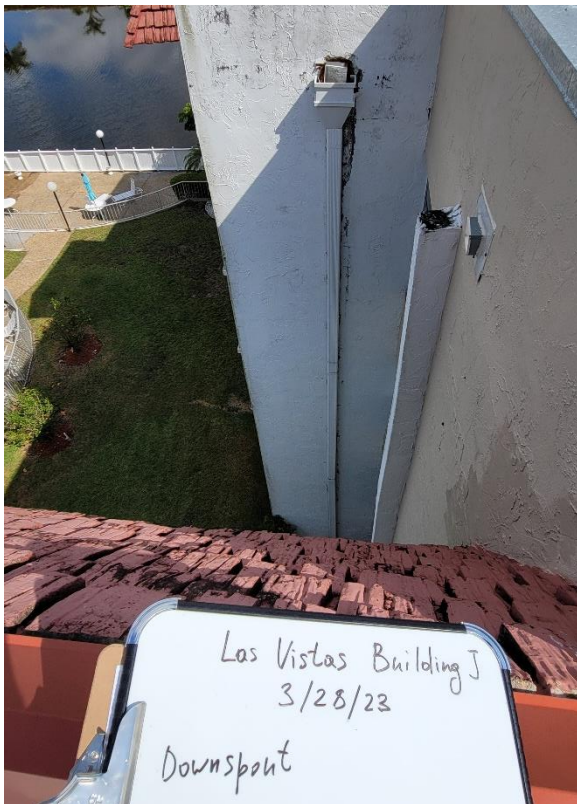
Roof: Downspout broken
