# AKOURI CONSULTING ENGINEERS

RE Summary of repairs and recommendations obtained from the Milestone Phase 1 and 2 for  
the building located at:

Las Vistas in Inverrary Condominium Association Inc.  
3551 Inverrary Dr Bldg F, Lauderdale, FL 33319

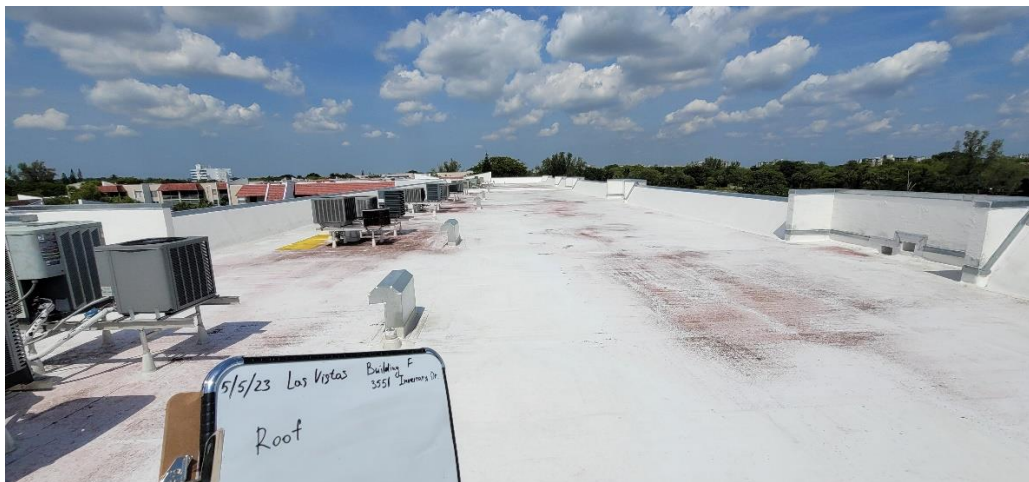
Roof (Single-ply roofing system. Good condition)
