# AKOURI CONSULTING ENGINEERS

RE Summary of repairs and recommendations obtained from the Milestone Phase 1 and 2 for the building located at:

Las Vistas in Inverrary Condominium Association Inc.  
3571 Inverrary Dr Bldg D, Lauderdale, FL 33319

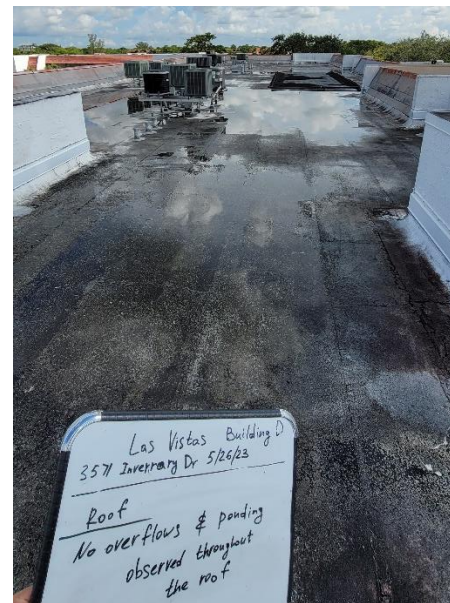
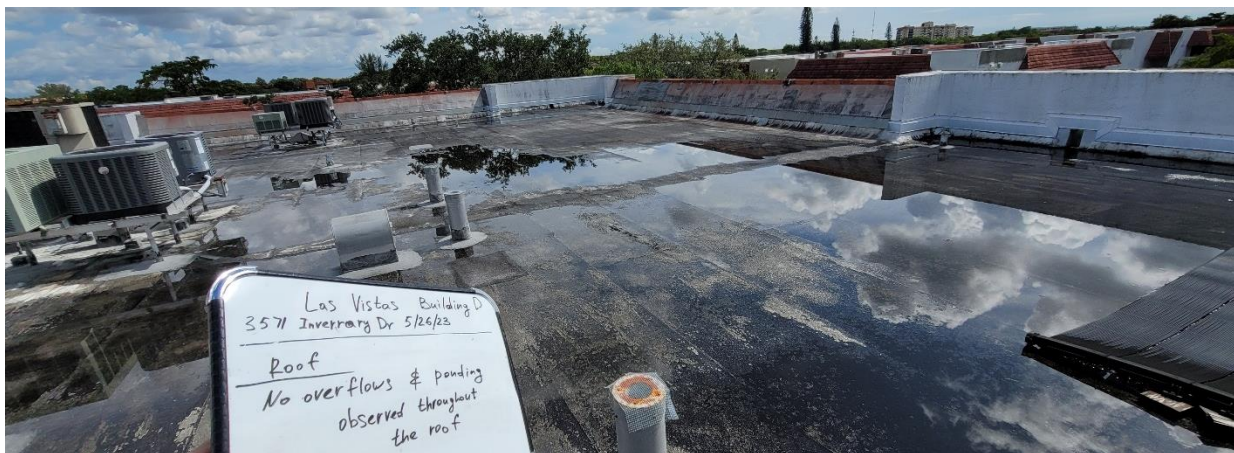
Roof (must be replaced)
