# STRUCTURAL SAFETY INSPECTION REPORT FORM

a. Name on Title: LAS VISTAS IN INVERRARY CONDOMINIUM ASSOCIATION, INC.b. Street Address: 3591 Inverrary Dr Lauderhill, FL, 33319. Building B.c. Legal Description: LAS VISTAS B IN INVERRARY CONDO PER CDO BK/PG: 5956/99d. Owner's Name: LAS VISTAS IN INVER CONDO ASSNe. Owner's Mailing Address: 3533 Inverrary Dr, Lauderhill, FL 33319-5921.f. Email Address: Contact Number: Dwayne Griffin, Office Manager (954-731-8484), accounting@lasvistascondo.comg. Folio Number of Property on which building is located: 4941 23 CB 0010 (reference) (Reference)h. Building Code Occupancy Classification: R-2 FBC 2023, Type III residentiali. Present Use: Condominium Buildingj. General Description: Type of Construction: This is a (4) story concrete building Type of Construction: IIIk. Square Footage: Approximately: 11,000 S.F. Number of Stories: (4)

## Photo Report

Property Address: 3591 Inverrary Dr., Lauderhill, FL 33319. **Building B.**

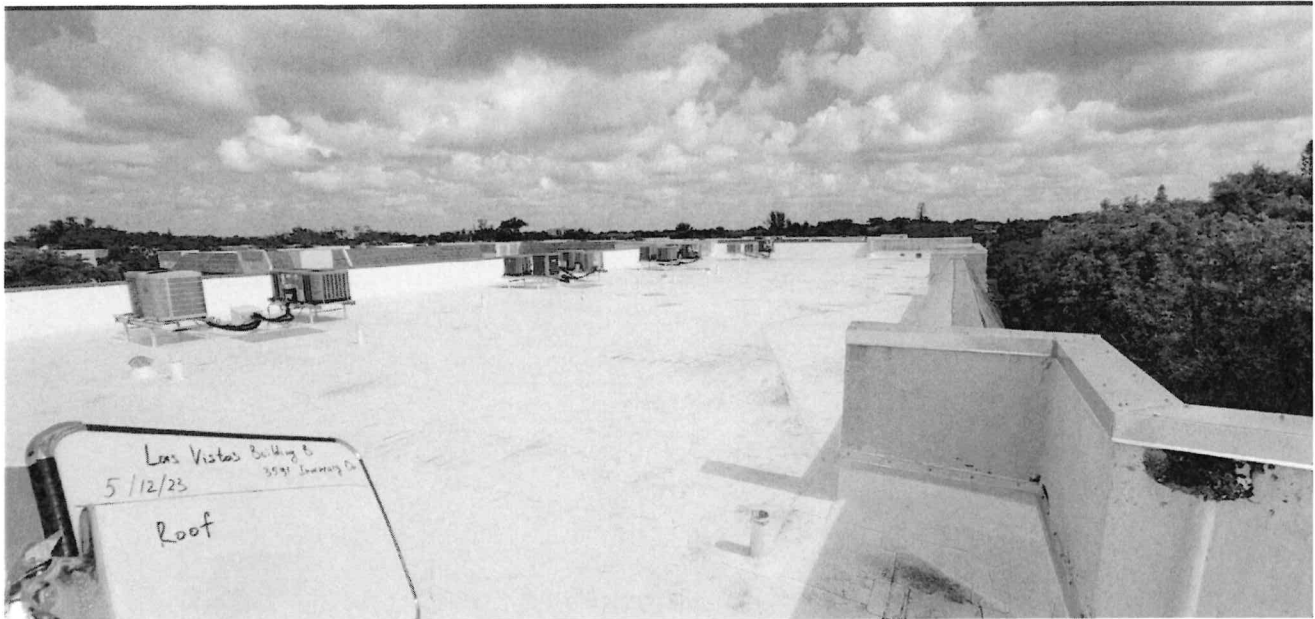
Photo 5: Roof View.

Flat single ply roof system over the concrete deck was observed to be in fair condition.

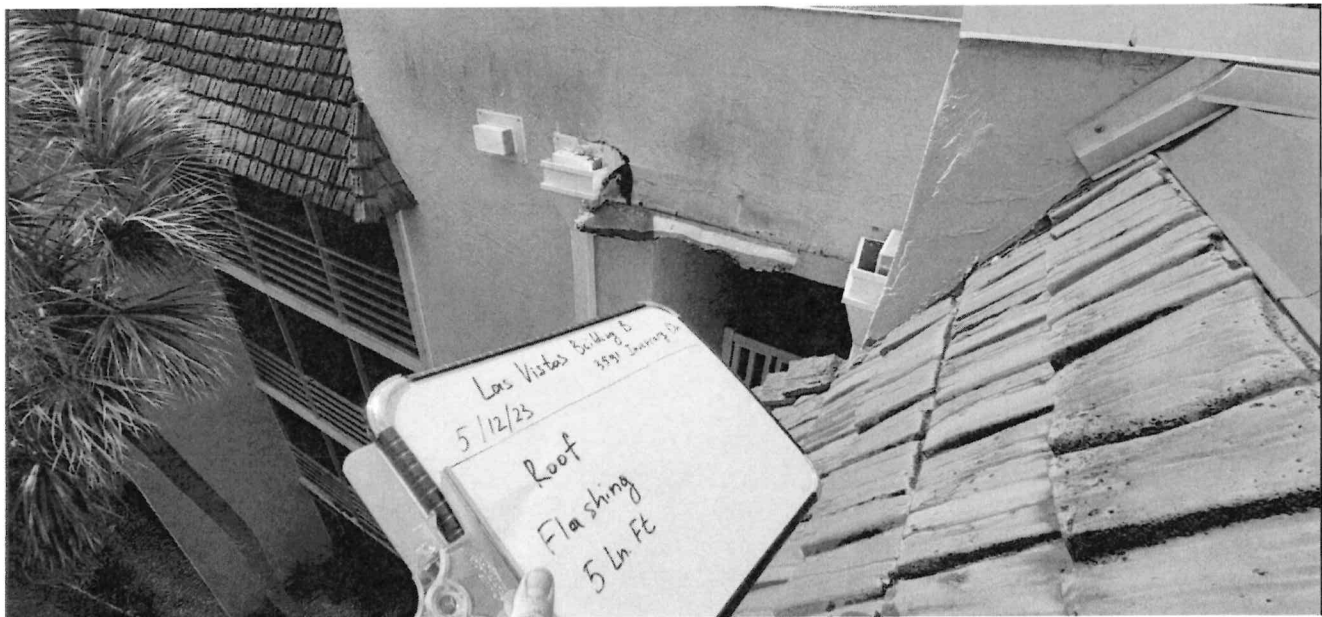
Photo 6: Roof View. Flashing repair required 5 Feet.

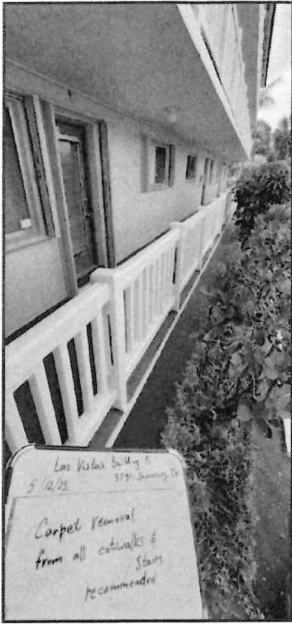
Spalling of the catwalk and balcony slabs was observed in multiple locations.

Photo 7: Concrete catwalk edge spalling observed. Carpet removal from all Catwalks and stairs recommended.

The building is structurally safe for its intended use and occupancy, but requires repairs as described in the report. All repairs must be performed in accordance with plans prepared by an engineer and approved by the local building department. The carpet along the catwalks must be removed and concrete spalling repaired.

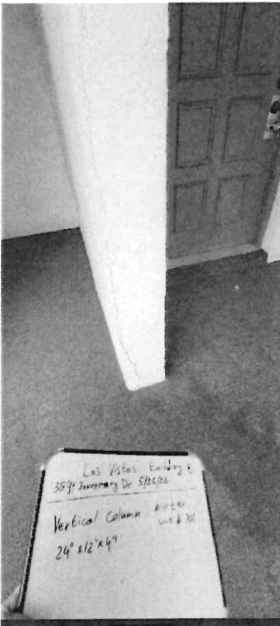
Photo 8: Vertical crack at column near unit #101.

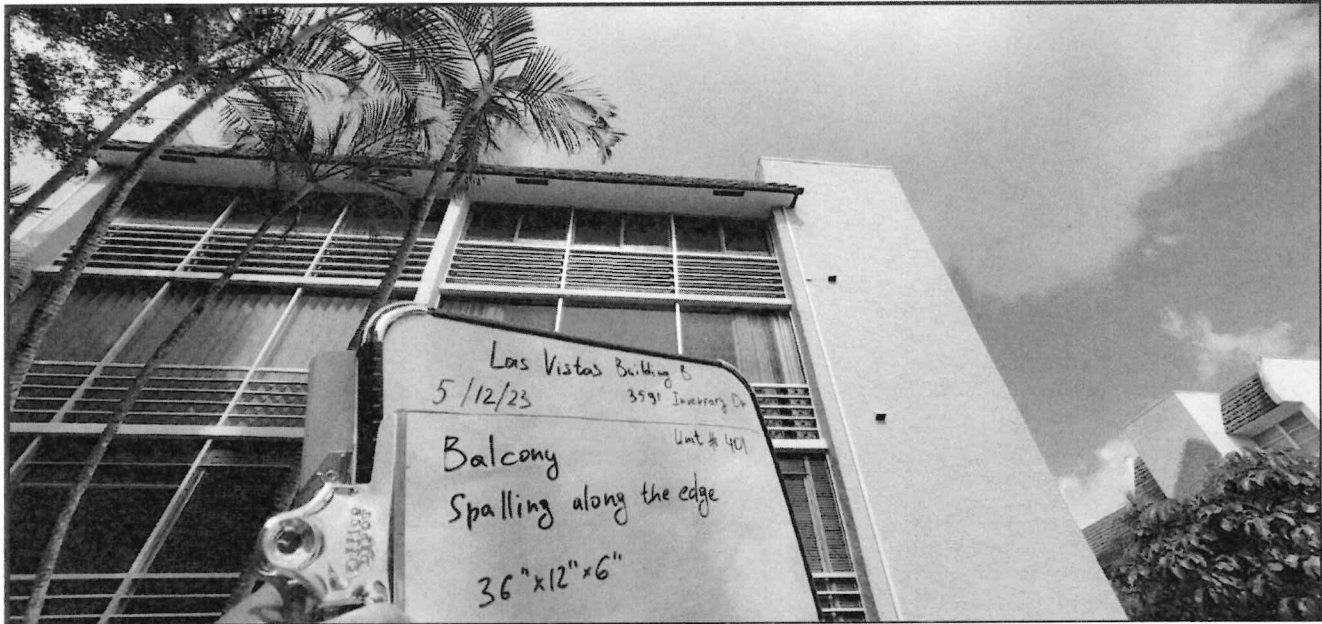
The concrete balconies are located at the rear of the building are composed of a structural reinforced concrete slab system (6-7) inches in thickness. Concrete spalling of the balcony slabs was observed in multiple locations.

Photo 9: Concrete balcony edge spalling next to unit #401.

Spalling of the catwalk and balcony slabs was observed in multiple locations. All repairs must be performed in accordance with plans prepared by an engineer and approved by the local building department.

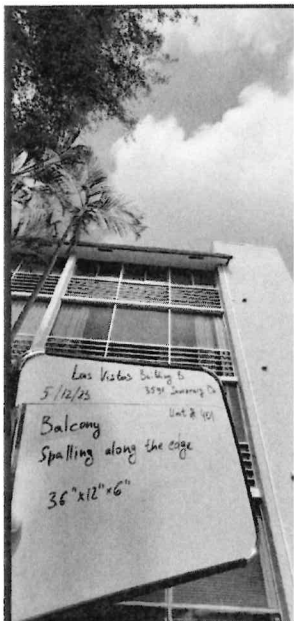
Photo 10: Concrete edge of balcony spalling next to unit #401.
