# STRUCTURAL SAFETY INSPECTION REPORT FORM

a. Name on Title: LAS VISTAS IN INVERRARY CONDOMINIUM ASSOCIATION, INC.b. Street Address: 3772 Inverrary Boulevard Bldg M, Lauderhill, FL 33319. Building Mc. Legal Description: LAS VISTAS M IN INVERRARY CONDO PER CDO BK/PG: 5956/393d. Owner's Name: LAS VISTAS IN INVER CONDO ASSNe. Owner's Mailing Address: 3533 Inverrary Dr, Lauderhill, FL 33319-5921.f. Email Address: Contact Number: Dwayne Griffin, Office Manager (954-731-8484), accounting@lasvistascondo.comg. Folio Number of Property on which building is located: 4941 23 DB 0000 (Reference)h. Building Code Occupancy Classification: R-2 FBC 2023, Type III residentiali. Present Use: Condominium Buildingj. General Description: Type of Construction: This is a (2) story concrete building Type of Construction: IIIk. Square Footage: Approximately 12,200 S.F. Number of Stories: (2)

## Photo Report

Property Address: 3772 Inverrary Boulevard, Lauderhill, FL 33319 Building M

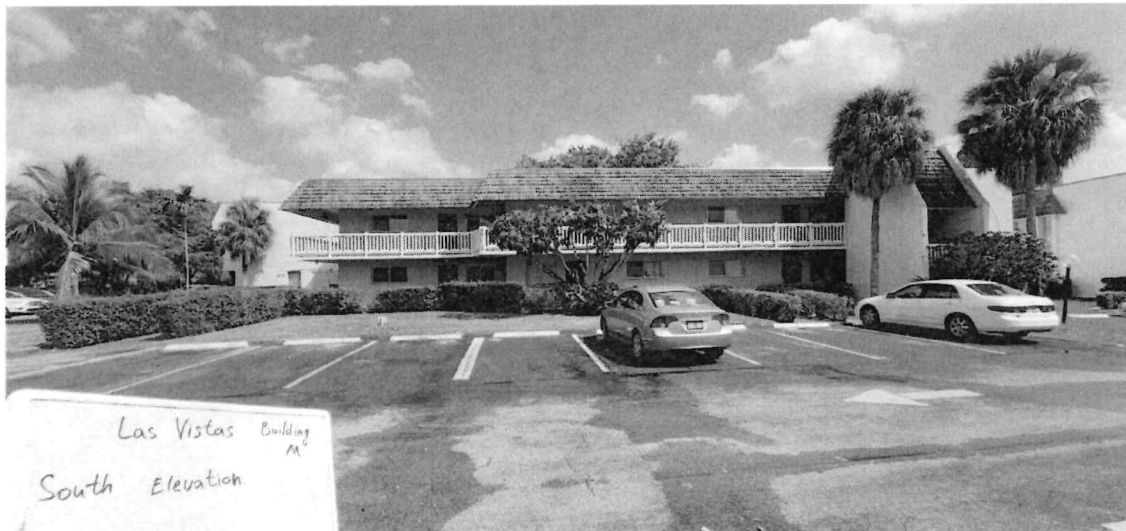
Photo 1: South Side View.

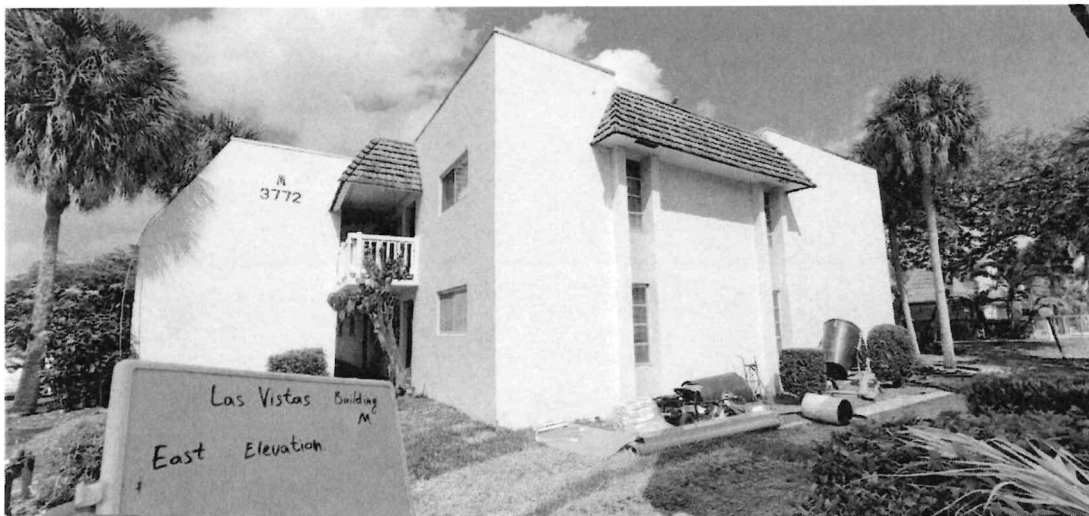
Photo 2: East Side View.

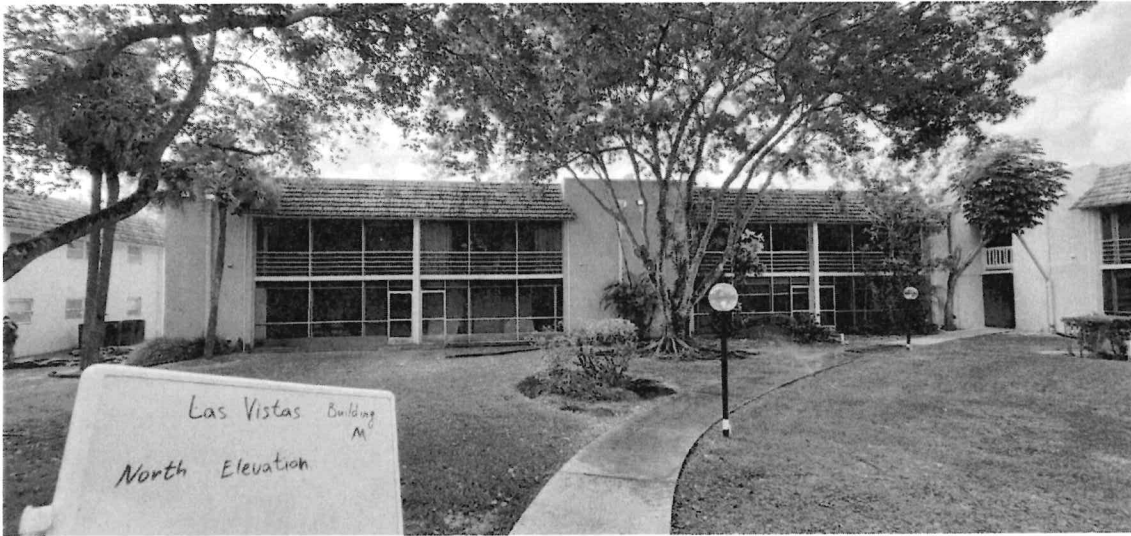
Photo 3: North Side View.

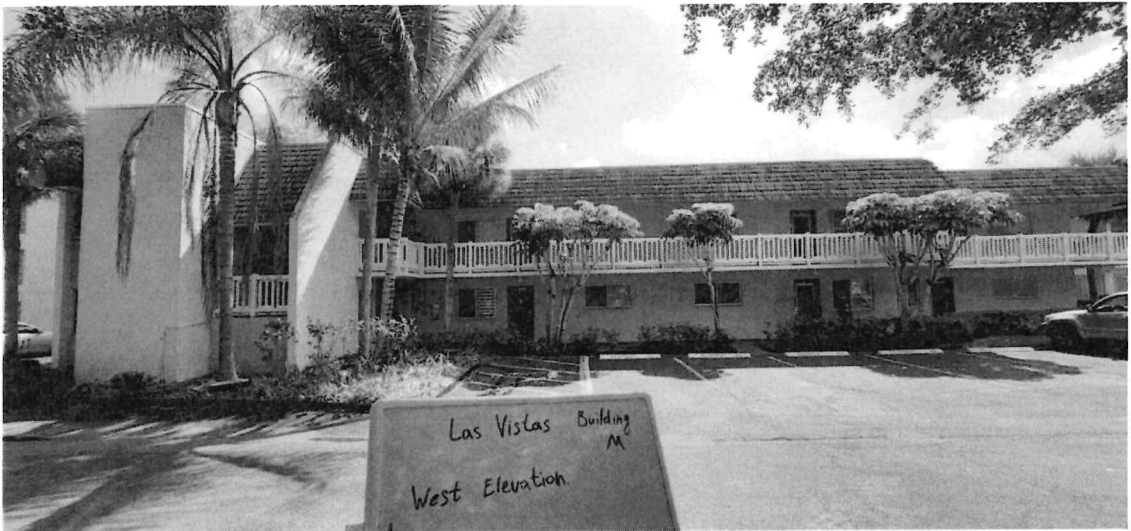
Photo 4: West Side View.

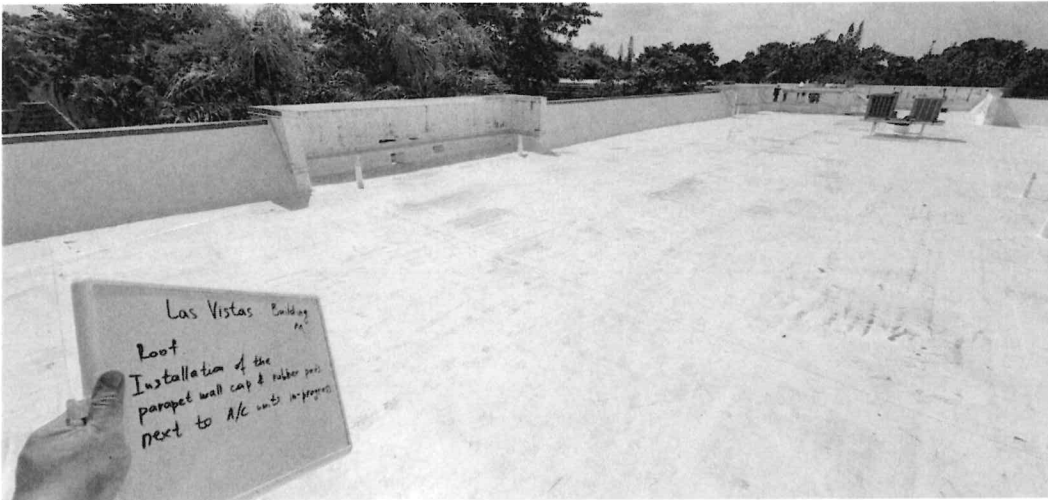
Photo 5: Roof View.

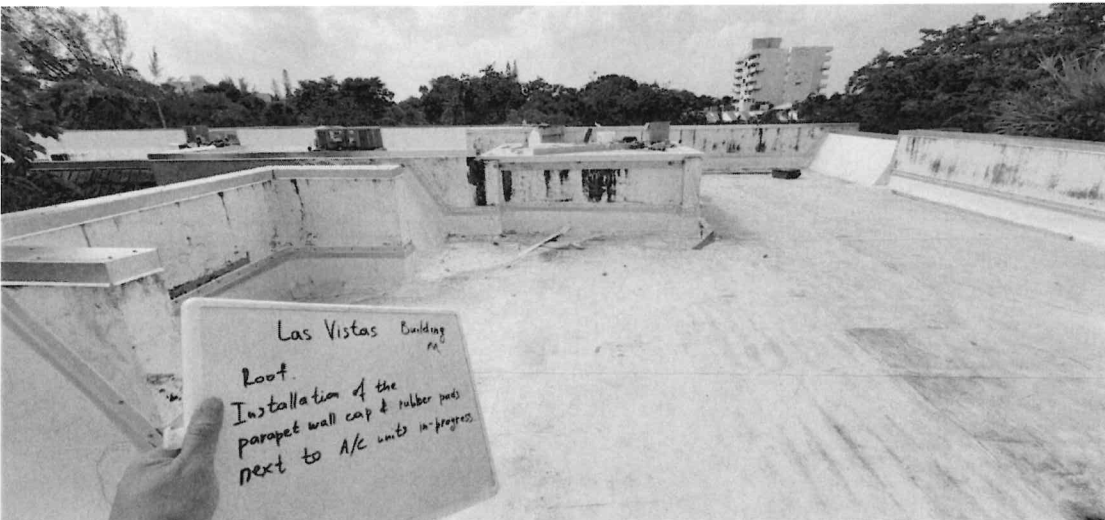
Photo 6: Roof View. installation of parapet wall cap & rubber pads, next to AC units.

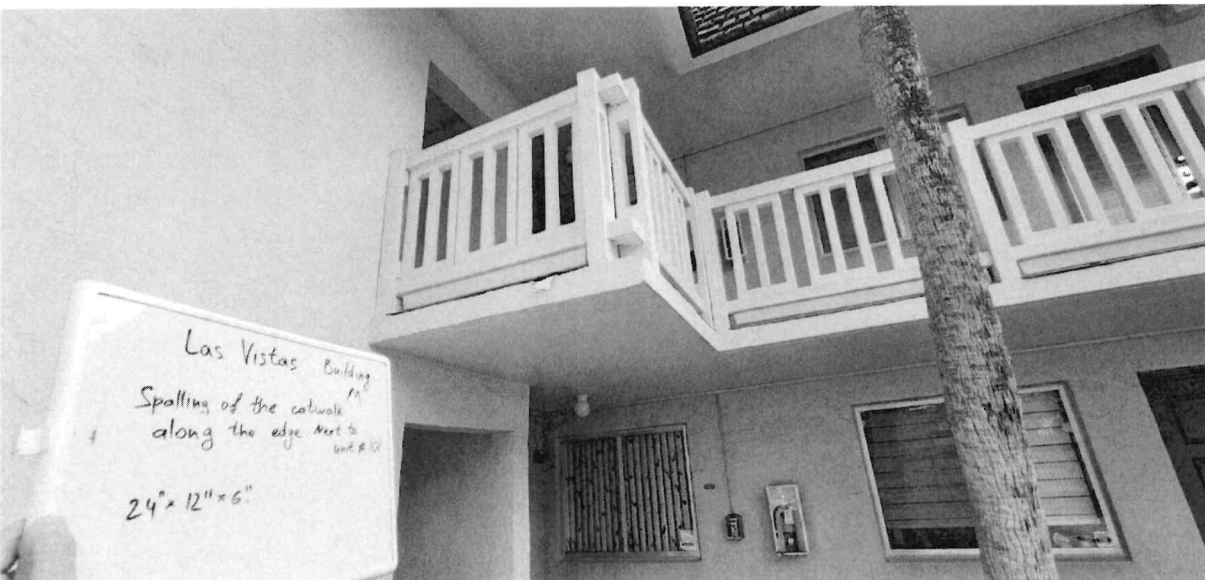
Photo 7: Spalling of the concrete catwalk along the edge next to unit #101; 24"x12"x6"

Spalling of the catwalk and balcony slabs was observed in multiple locations. All repairs must be performed in accordance with plans prepared by an engineer and approved by the local building department.

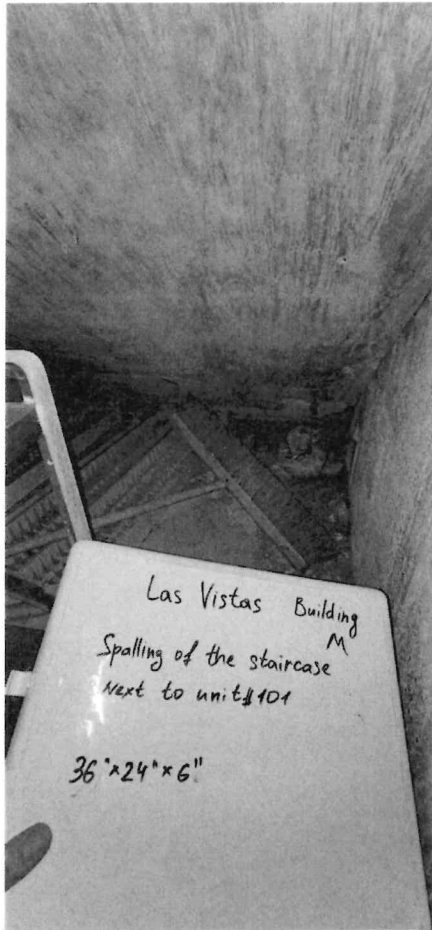
The exterior concrete stairs were observed in fair condition. However, spalled sections were found at multiple locations.

Photo 8: Spalling of the staircase next to unit #101; 36"x24"x6"

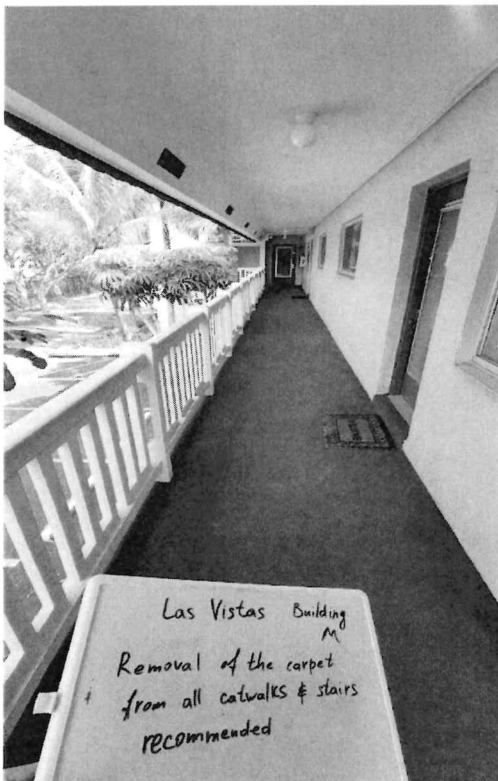
Photo 9: Removal of the carpet from all catwalks & stairs recommended

The building is structurally safe for its intended use and occupancy, but requires repairs as described in the report. All repairs must be performed in accordance with plans prepared by an engineer and approved by the local building department. The carpet along the catwalks must be removed and concrete spalling repaired.

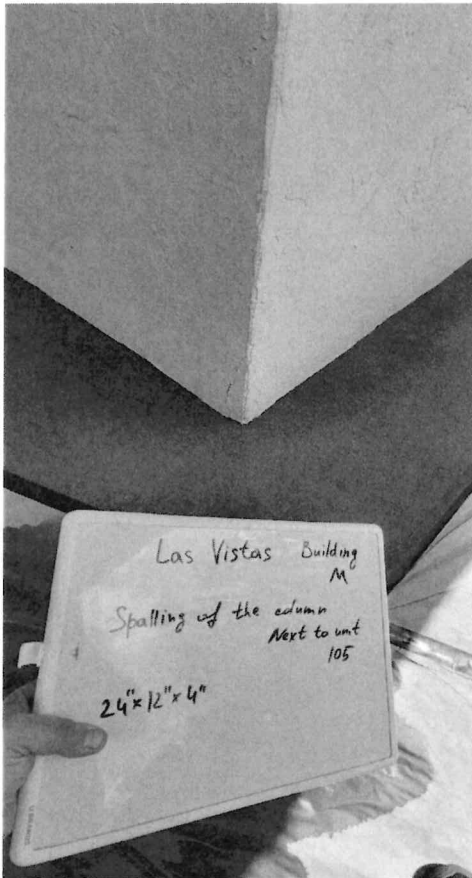
Photo 10: Spalling of the column next to unit 105; 24"x12"x4"

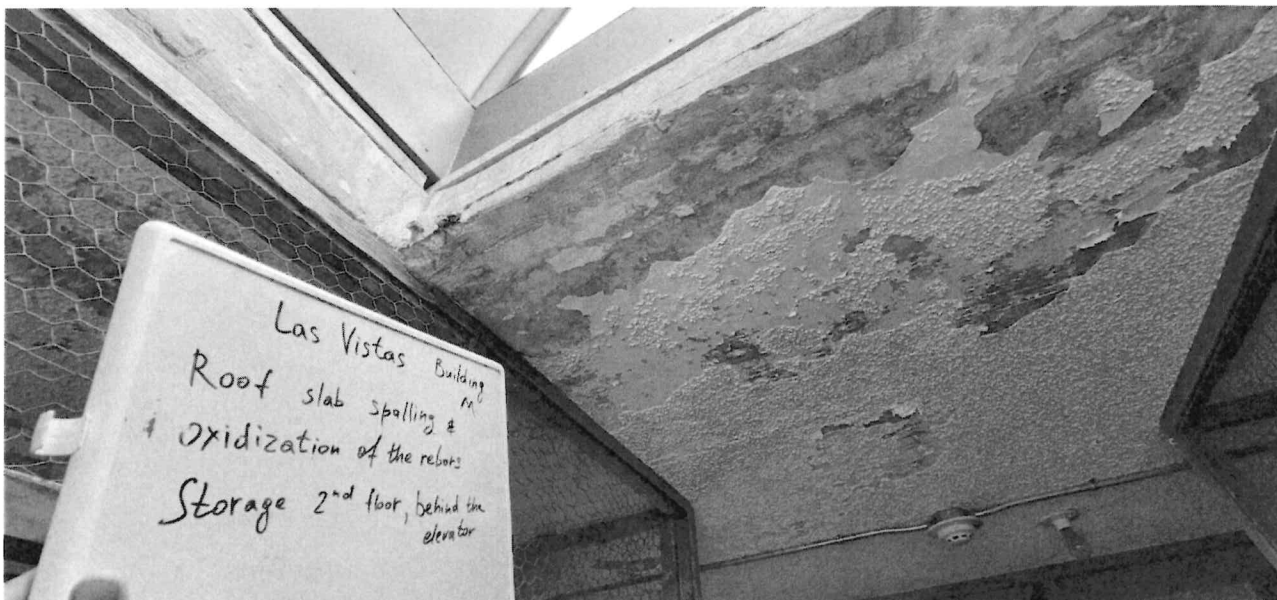
1. ☐ None Visible
2. ☒ Location and Description of Members Affected and Type Cracking: Behind elevator slab, 2nd floor  
Signs of rebar oxidation, reference photo-11.
3. ☐ Significant – Patching Will Suffice
4. ☐ Significant – Structural Repairs Required (Describe):

Photo 11: Roof concrete slab spalling & signs of rebar oxidation @ 2nd floor, behind the elevator.

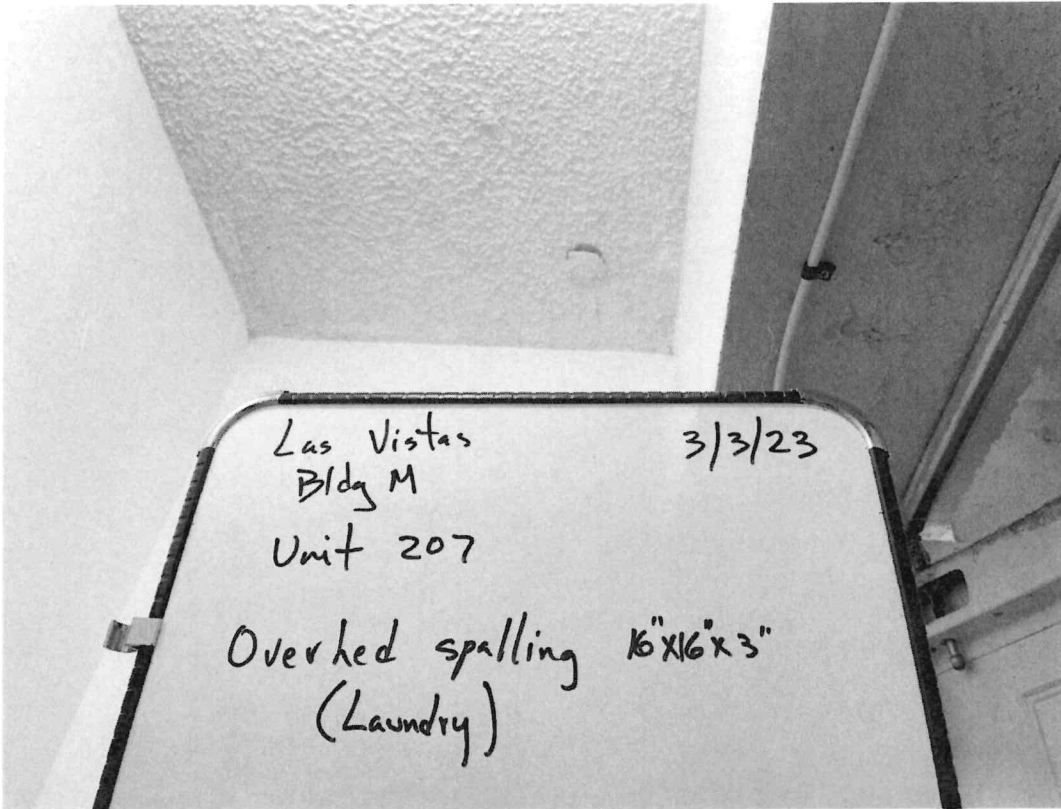
Photo 12: Overhead spalling at ceiling, near unit 207; 16"x16"x3" (Laundry)
