**ELECTRICAL SAFETY INSPECTION REPORT FORM**

| b. Street Address: | <u>3774 Inverrary Blvd., Lauderdale, FL 33319 (Building P)</u> |

Name of title: Las Vistas in Inverrary Condominium Association Inc. (Reference)  
Address: 3774 Inverrary Blvd., Lauderhill, FL 33319 (Building P)  
Folio #: 4941 23 DD 0410 (Reference)  
Legal Description: LAS VISTAS P-R IN INVERRARY CONDO UNIT 101 BLDG P PER CDO BK/PG:  
5686/350(reference)  
Reference: Photos required for the 25/30-year recertification report.

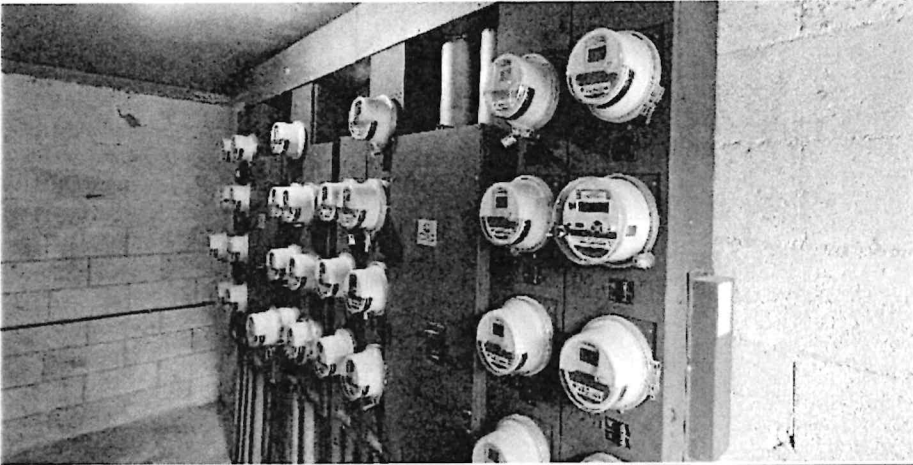
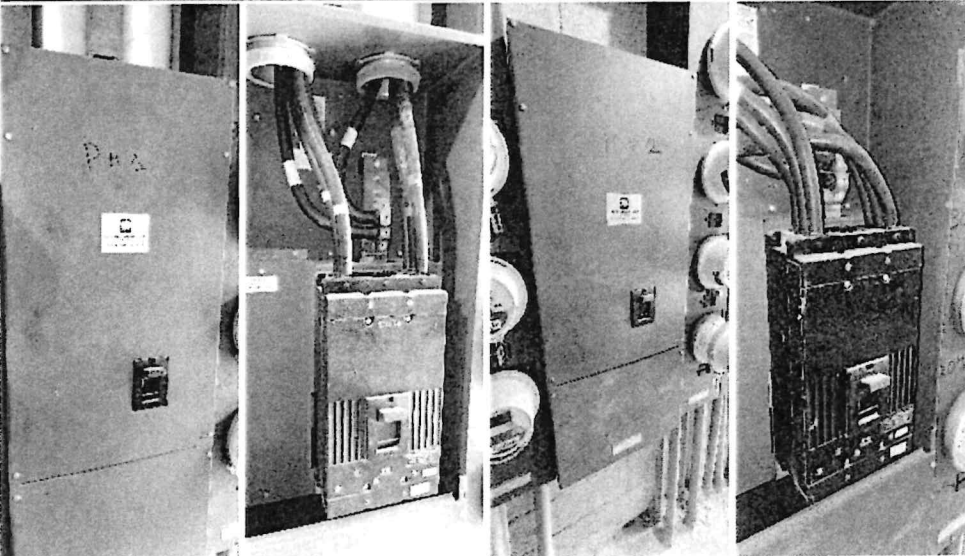
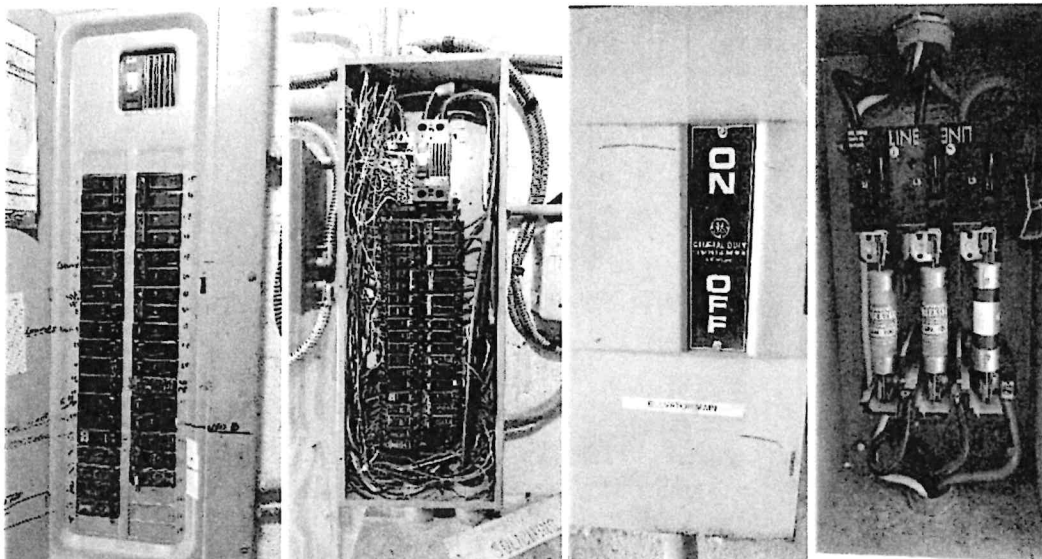
Main disconnects and metering equipment.

There are four (4) main disconnects.

#1, #2 - 800A, 120/240V, 1Ph. - breaker, each;

#3 - 200A, 120/240V, 1Ph. - breaker;

#4 - 100A, 120/240V, 1Ph. - fuse;

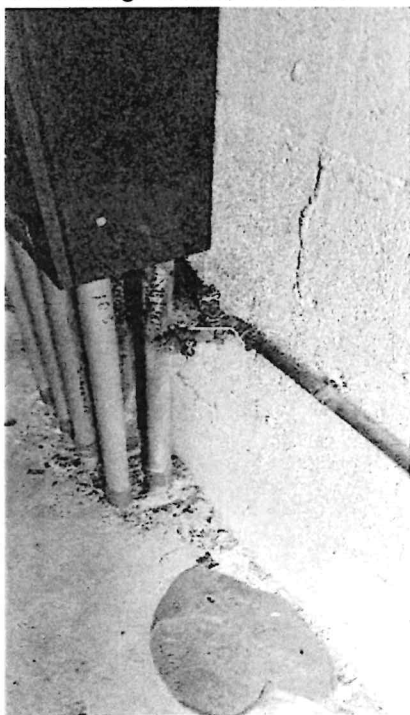
Grounding service, conduits.

- ☒ Good ☐ Repairs Required
