## STRUCTURAL SAFETY INSPECTION REPORT FORM

a. Name on Title: LAS VISTAS IN INVERRARY CONDOMINIUM ASSOCIATION, INC.b. Street Address: 3571 Inverrary Dr Lauderhill, FL, 33319c. Legal Description: LAS VISTAS D IN INVERRARY CONDO UNIT 101 PER CDO BK/PG: 5956/183d. Owner's Name: LAS VISTAS IN INVER CONDO ASSNe. Owner's Mailing Address: 3571 Inverrary Dr., Lauderhill, FL 33319. Building D.f. Email Address: Contact Number: Dwayne Griffin, Office Manager (954-731-8484), accounting@lasvistascondo.comg. Folio Number of Property on which building is located: 4941 23 CD 0010 (Reference)h. Building Code Occupancy Classification: R FBC 2023, Type III residentiali. Present Use: Condominium Buildingj. General Description: Type of Construction: This is a (4) story concrete building Type of Construction: IIIk. Square Footage: Approximately: 14,523 SF Number of Stories: (4)

## Photo Report

Property Address: 3571 Inverrary Dr., Lauderhill, FL 33319. **Building D.**

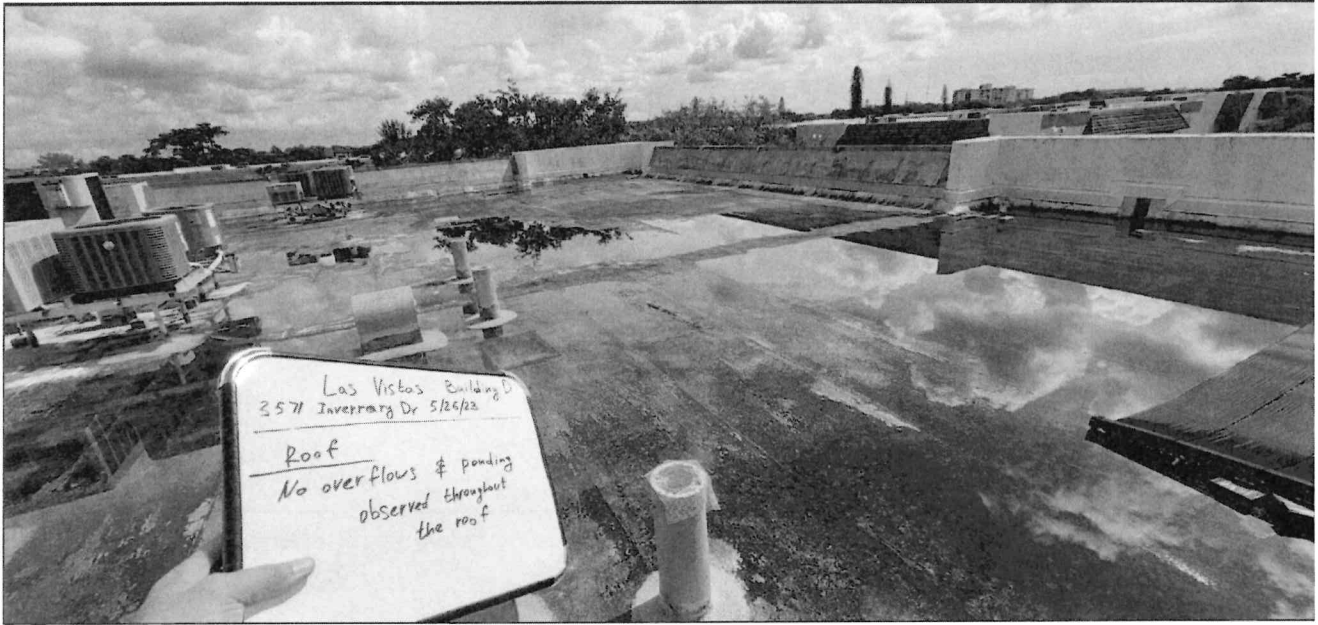
Flat single ply roof system over the concrete deck was observed to be in fair condition.

Photo 5: Roof View. No overflows was found, ponding water.

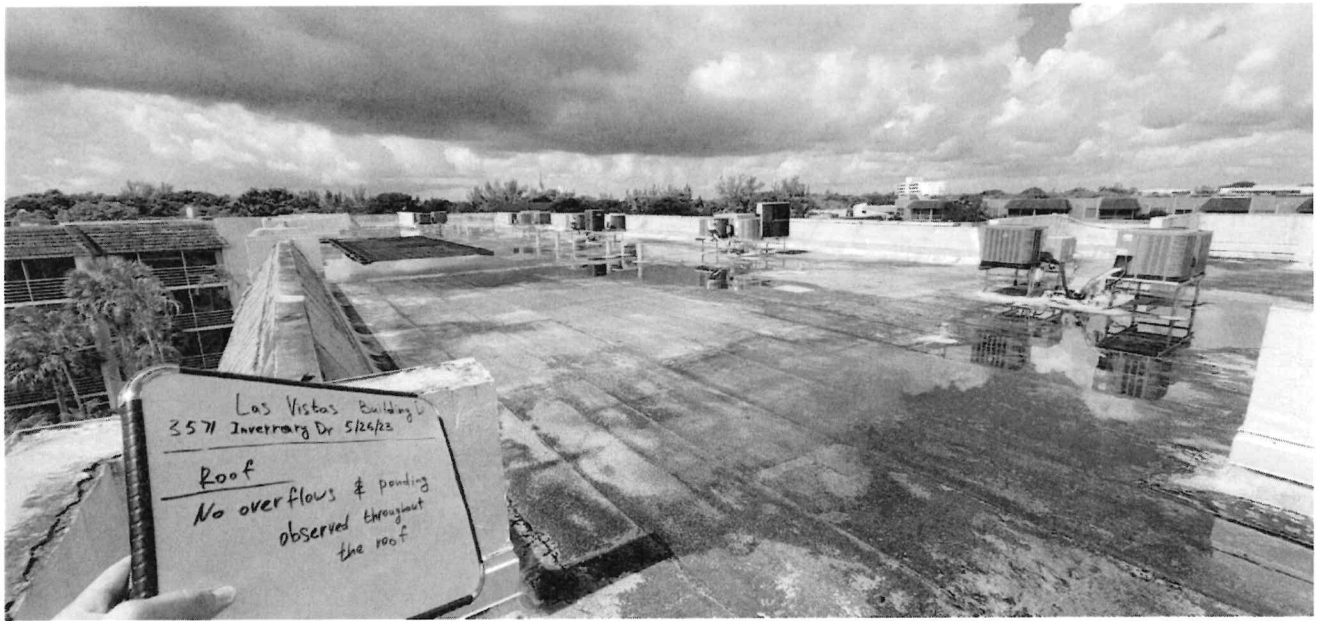
The concrete tile roof along the mansard roof was observed generally in fair condition. Although there was no access To confirm the condition of the underlying structural system, No visible deficiencies were noted during the inspection.

Photo 6: Mansard Roof and AC Units. Ponding water, no overflows.

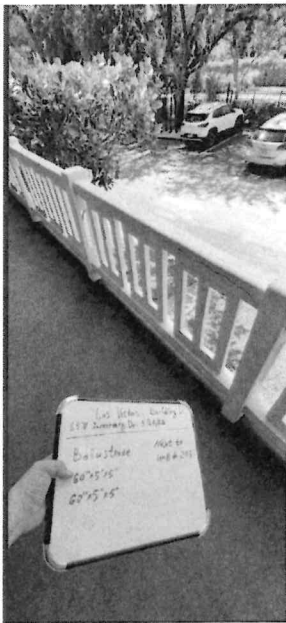
The guardrails at the catwalks are composed of concrete precast rails/balustrade and found in fair condition. The rails at the exterior stairs are metal and were found in fair condition.

Photo 7: Concrete Rail cracks ( Balustrade) next to unit #206.

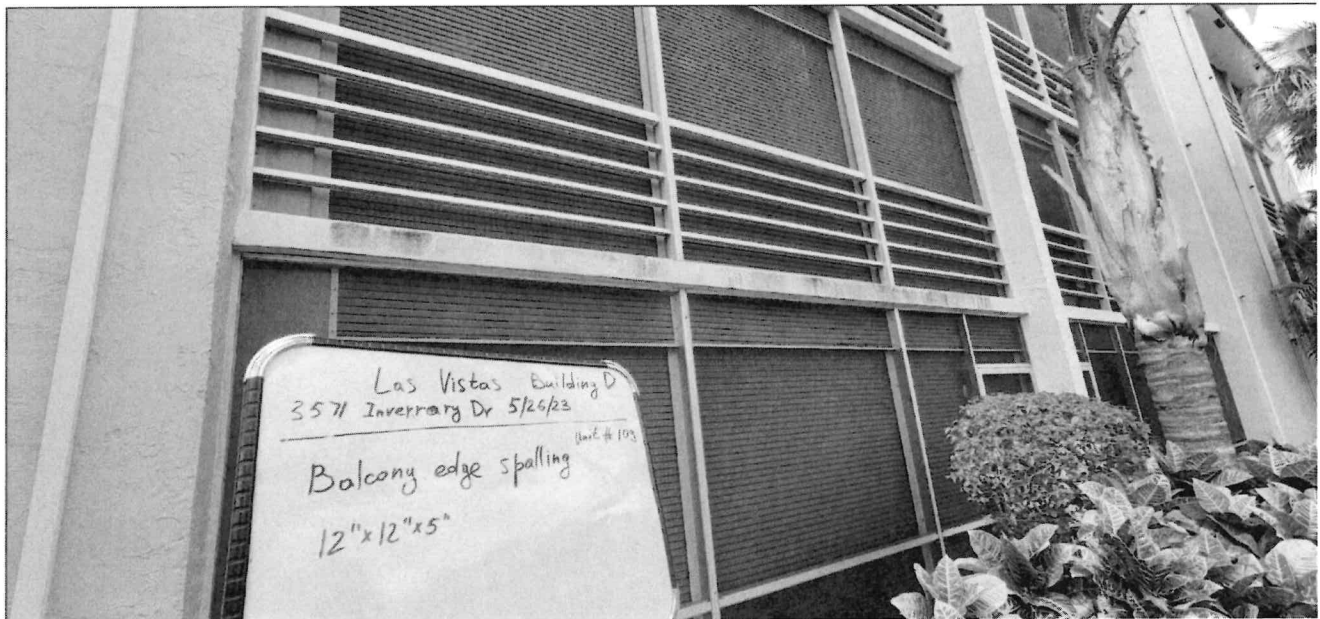
The balconies at the rear of the building are composed of a structural reinforced concrete slab system (6-7) inches in thickness. Concrete spalling of the balcony slabs was observed in multiple locations.

Photo 8: Concrete balcony edge spalling next to unit #209.

Spalling of the catwalk and balcony slabs was observed in multiple locations. All repairs must be performed in accordance with plans prepared by an engineer and approved by the local building department.

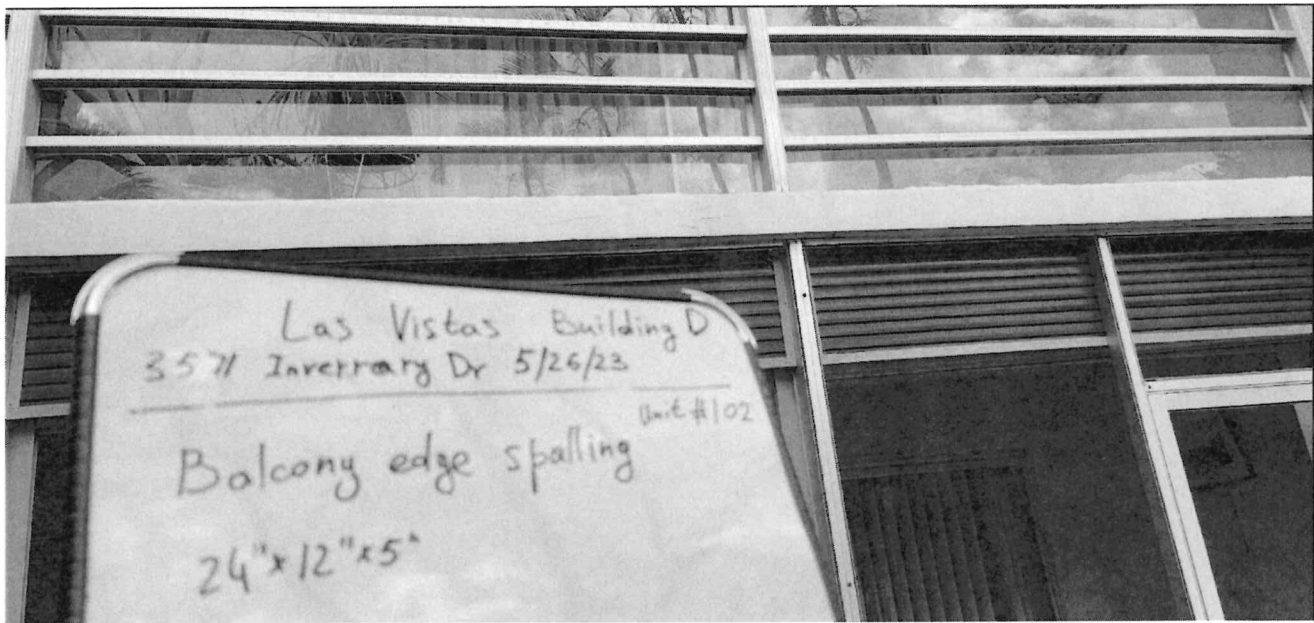
Photo 8: Concrete balcony edge spalling next to unit #102.
