## STRUCTURAL SAFETY INSPECTION REPORT FORM

**1. DESCRIPTION OF STRUCTURE**a. Name on Title: LAS VISTAS IN INVERRARY CONDOMINIUM ASSOCIATION, INC.b. Street Address: 3511 Inverrary Boulevard Bldg K, Lauderhill, FL 33319, Building K.c. Legal Description: LAS VISTAS K IN INVERRARY CONDO PER CDO BK/PG: 5917/205d. Owner's Name: LAS VISTAS IN INVER CONDO ASSNe. Owner's Mailing Address: 3533 Inverrary Dr, Lauderhill, FL 33319-5921f. Email Address: Contact Number: Dwayne Griffin, Office Manager (954-731-8484), accounting@lasvistascondo.comg. Folio Number of Property on which building is located: 4941 23 CM 0000 (Reference)h. Building Code Occupancy Classification: R -2 FBC 2023, Type III residentiali. Present Use: Condominium Buildingj. General Description: Type of Construction: This is a (3) story concrete building Type of Construction: IIIk. Square Footage: Approximately: 15,700 S.F. Number of Stories: (3)

## Photo Report

Name: Las Vistas in Inverrary Condominium Association Inc.

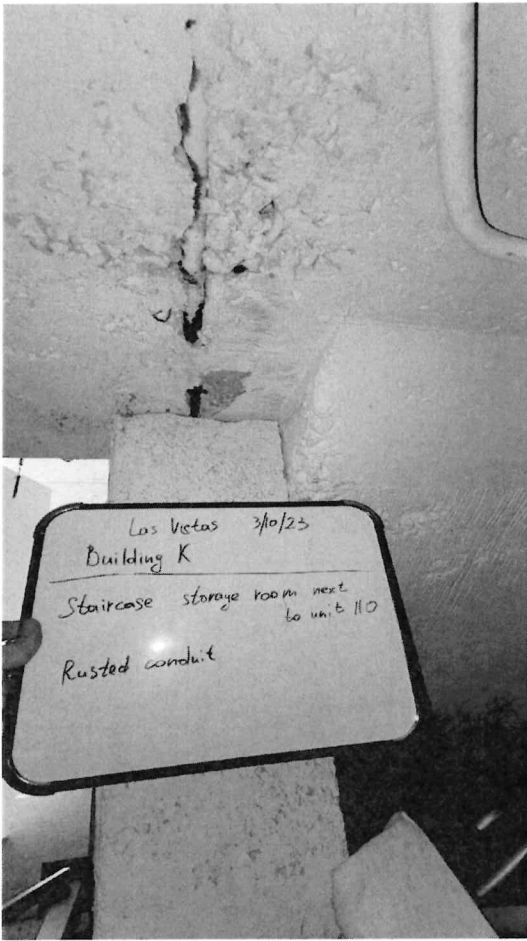
Photo 5: Staircase Storage room next to unit 110 - Rusted conduit.

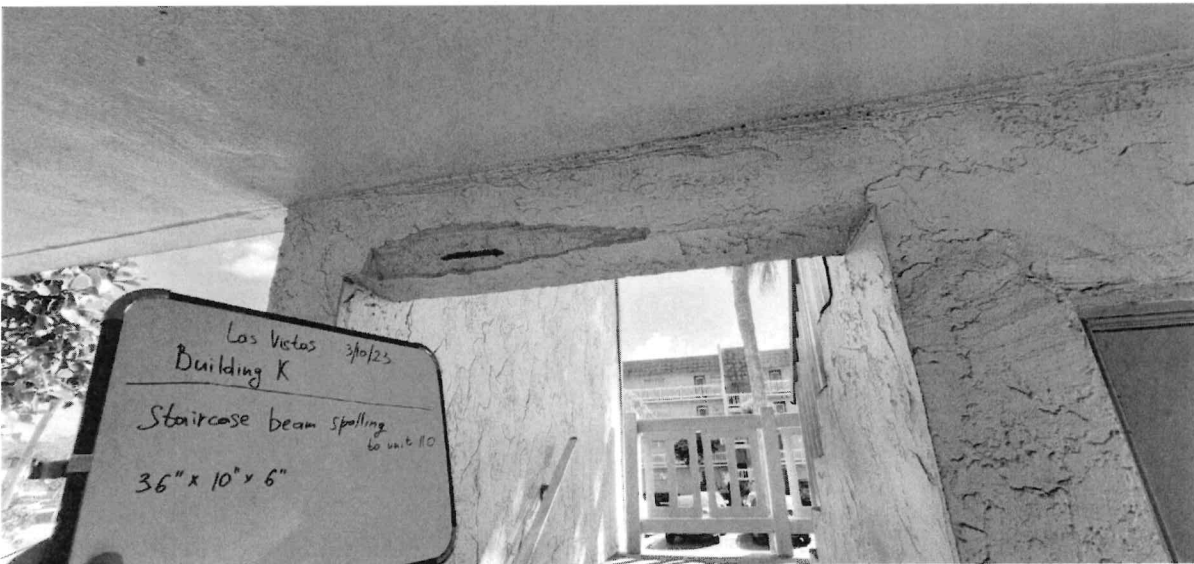
The exterior concrete stairs were observed in fair condition. However, spalled sections were found at multiple locations.

Photo 6: Staircase beam spalling to unit 110, notice rusted exposed bar: 36"x10"x6"

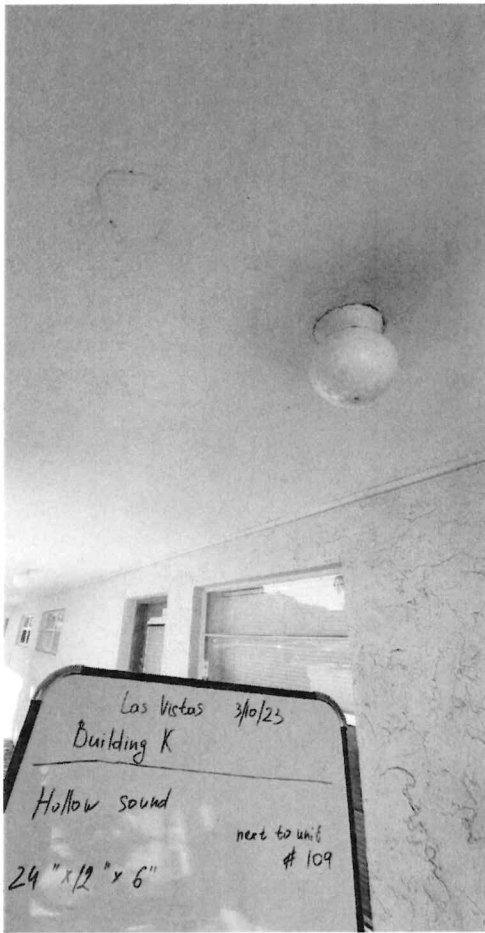
Photo 7: Hollow sound ceiling plaster/stucco: 24"x12"x6" next to unit 109

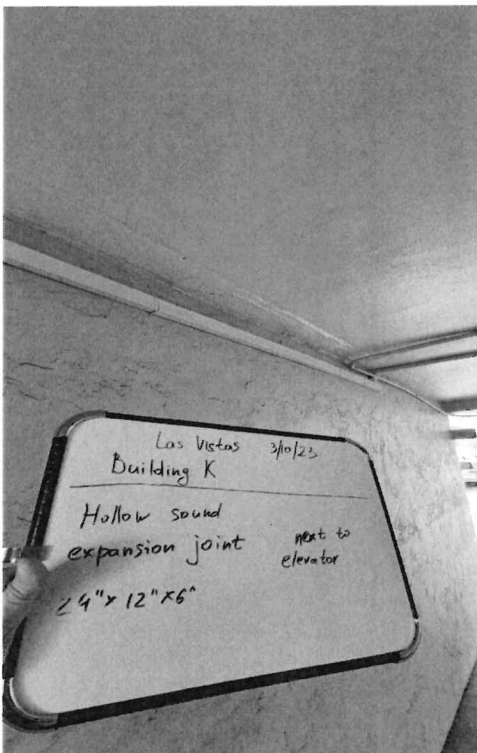
Photo 8: Hollow sound at expansion joint next to the elevator 24"x12"x6"

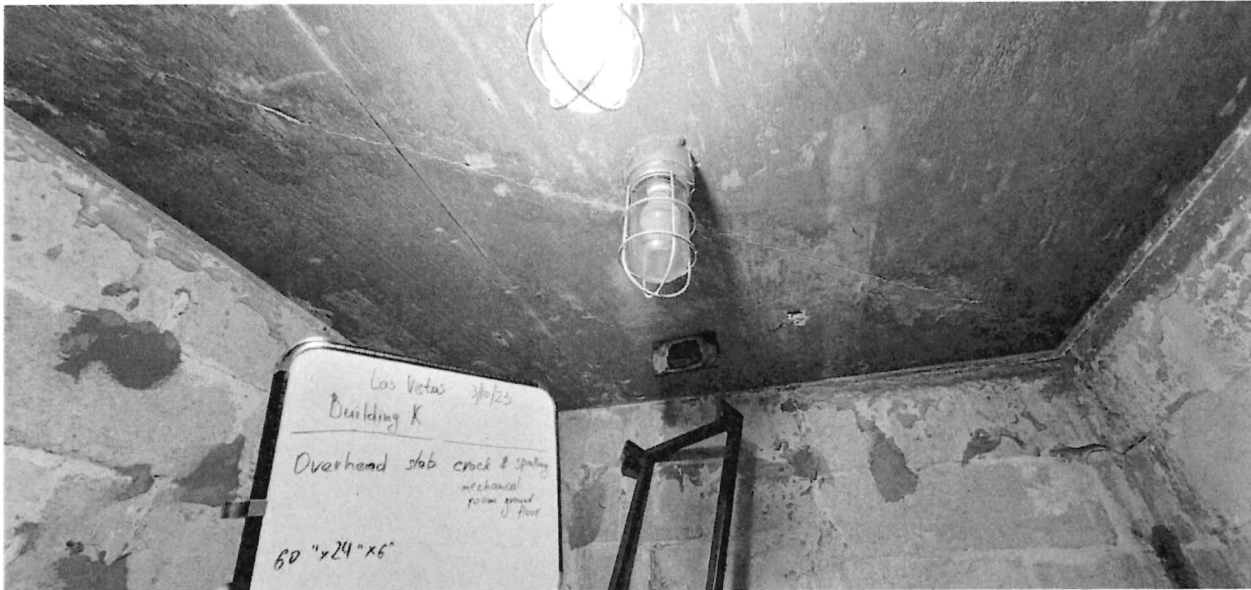
Photo 9: Overhead concrete slab crack & spalling at mechanical room ground floor 60"x24"x6"

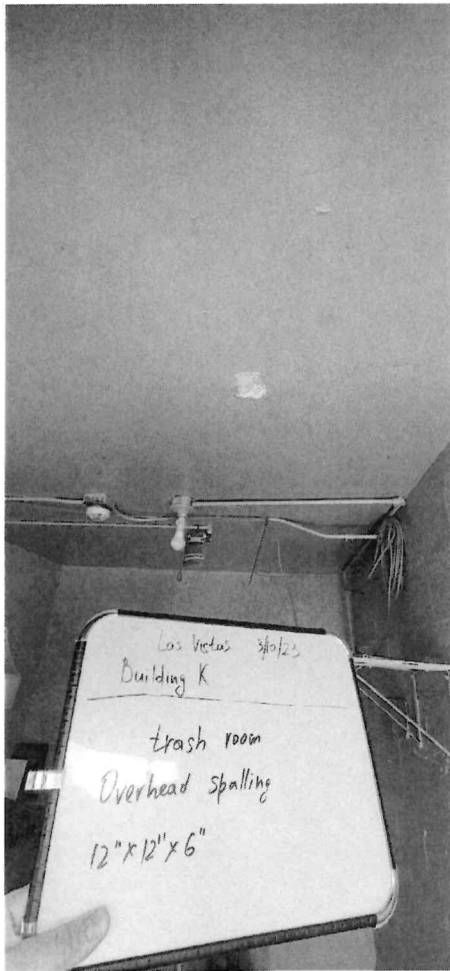
Photo 11: Overhead Spalling at trash room 12"x12"x6"

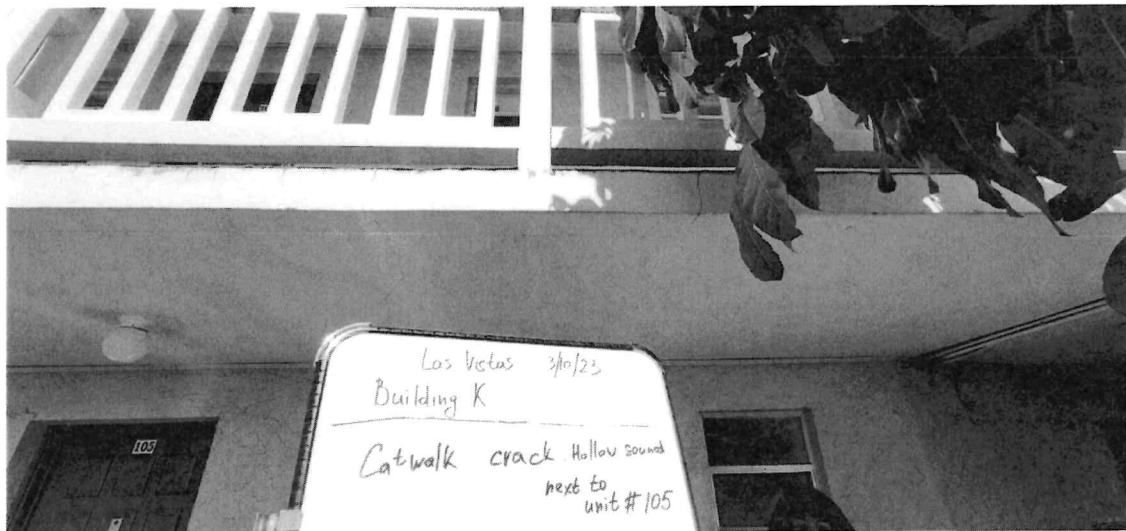
Spalling of the catwalk and balcony slabs was observed in multiple locations.

Photo 12: Catwalk slab edge crack. Hollow sound next to unit 105.

Spalling of the catwalk and balcony slabs was observed in multiple locations. All repairs must be performed in accordance with plans prepared by an engineer and approved by the local building department.

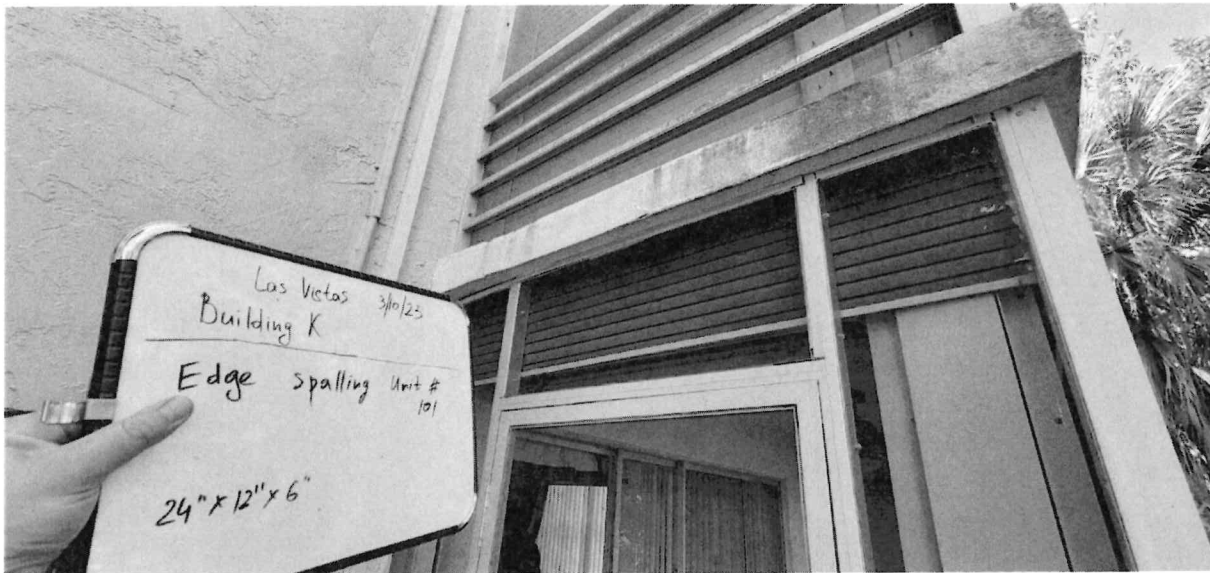
The balconies at the rear of the building are composed of a structural reinforced concrete slab system (6-7) inches in thickness. Concrete spalling of the balcony slabs was observed in multiple locations.

Photo 13: Balcony edge spalling unit 101; 24"x12"x6"

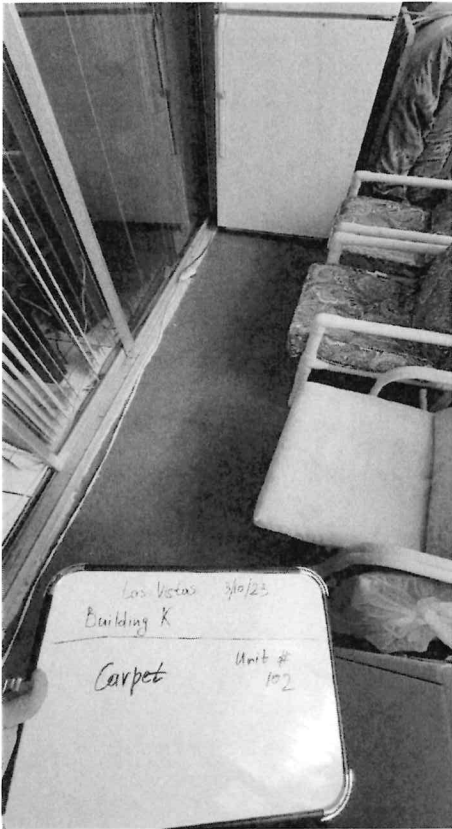
Photo 15: Carpet, unit 102.

The building is structurally safe for its intended use and occupancy, but requires repairs as described in the report. All repairs must be performed in accordance with plans prepared by an engineer and approved by the local building department. The carpet along the catwalks must be removed and concrete spalling repaired.

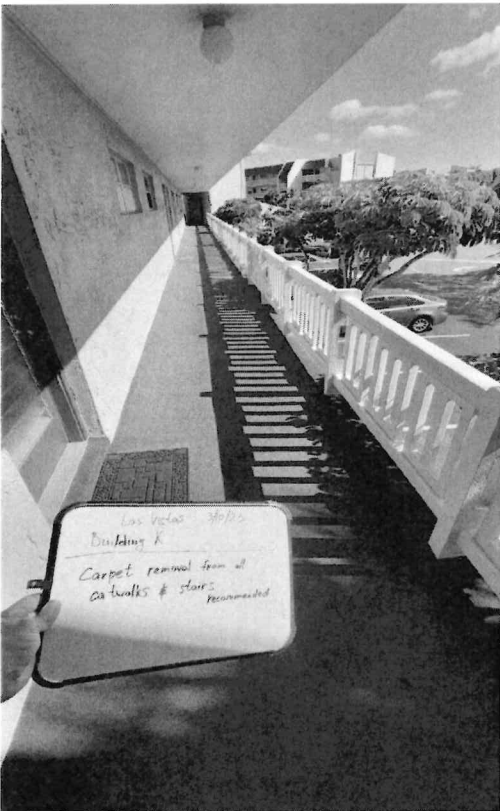
Photo 16: Carpet removal recommended from all catwalks & stairs.

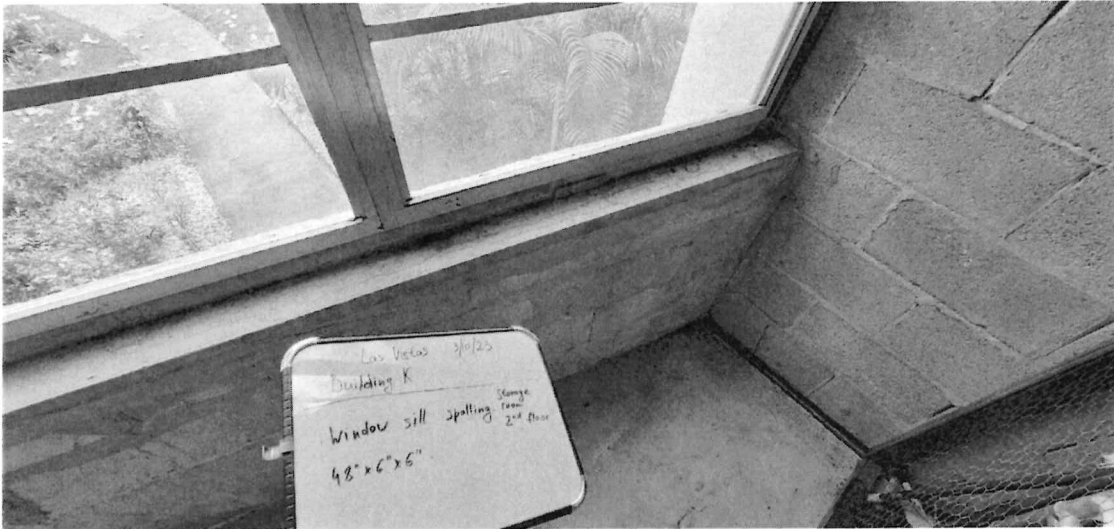
Photo 17: Window sill spalling at storage room 2nd floor: 48"x6"x6"

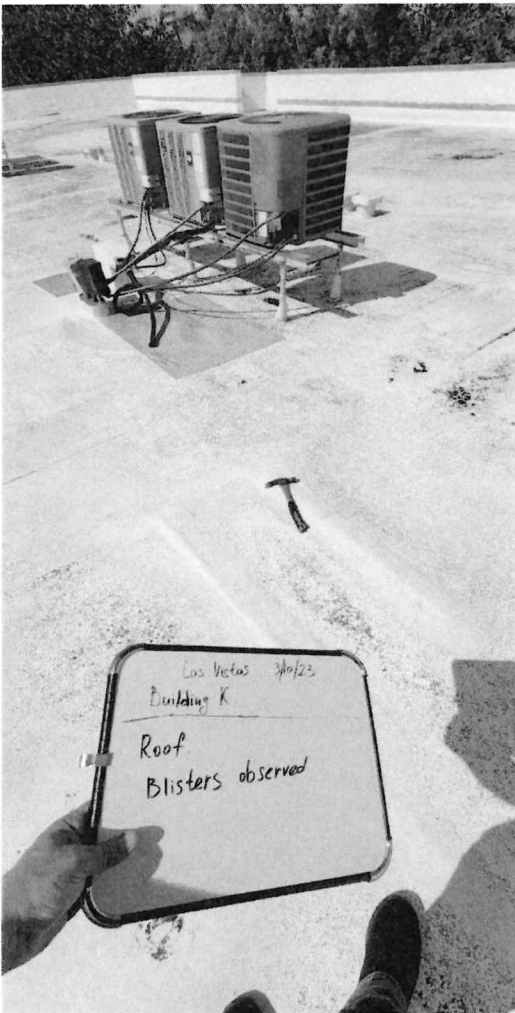
Flat single ply roof system over the concrete deck was observed to be in fair condition.

Photo 18: Roof Blisters observed.

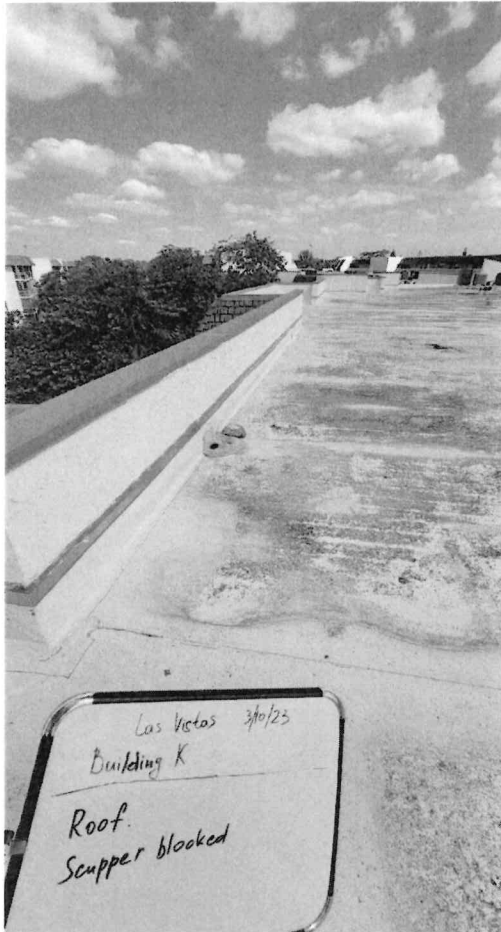
Photo 19: Roof Scupper Blocked

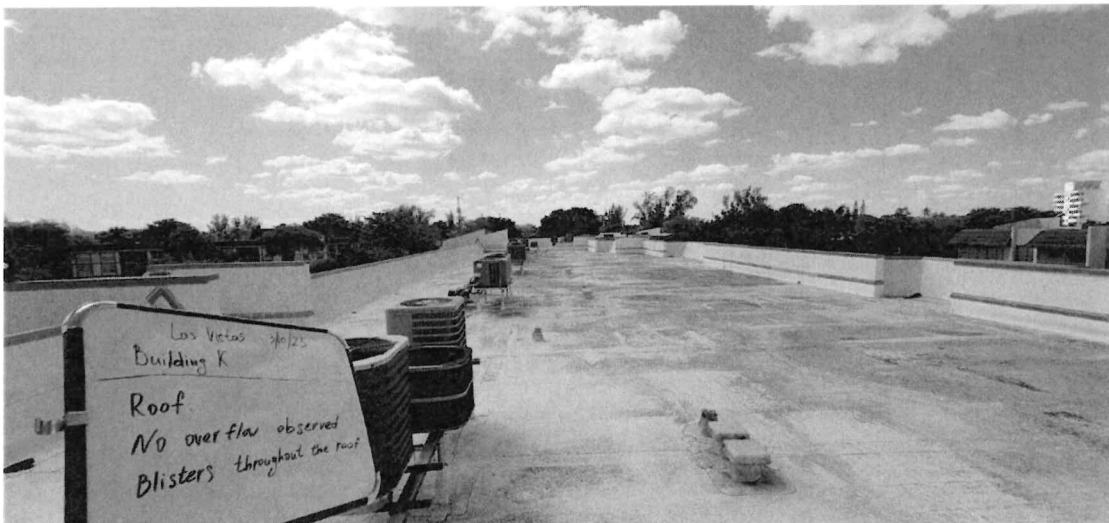
Photo 20: Roof No overflow observed & Blisters evident throughout the roof.

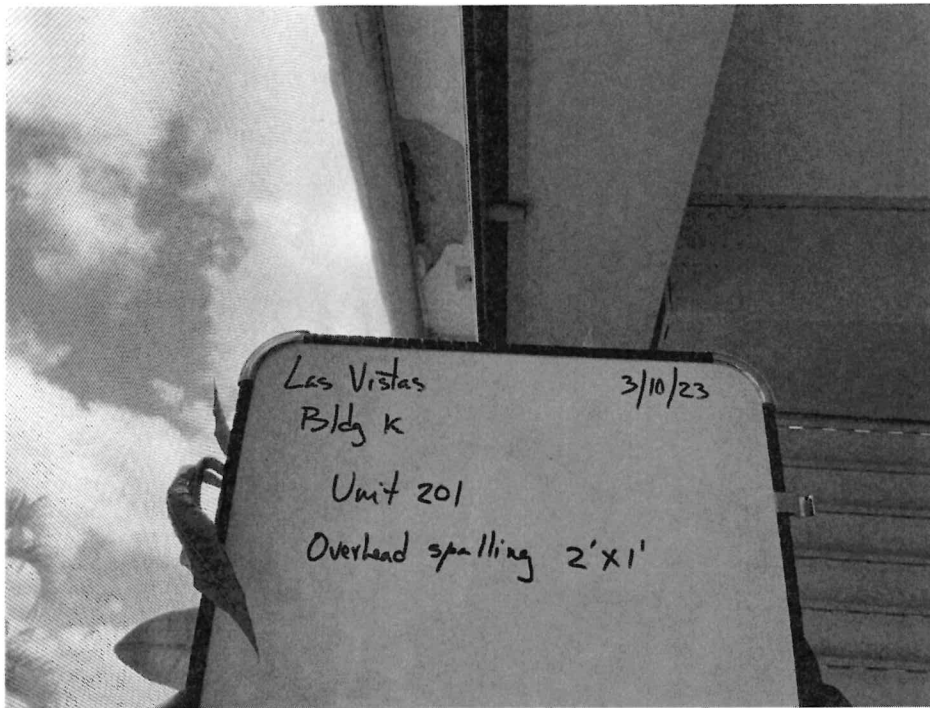
Photo 21: Unit 201 Overhead spalling 2'x1'

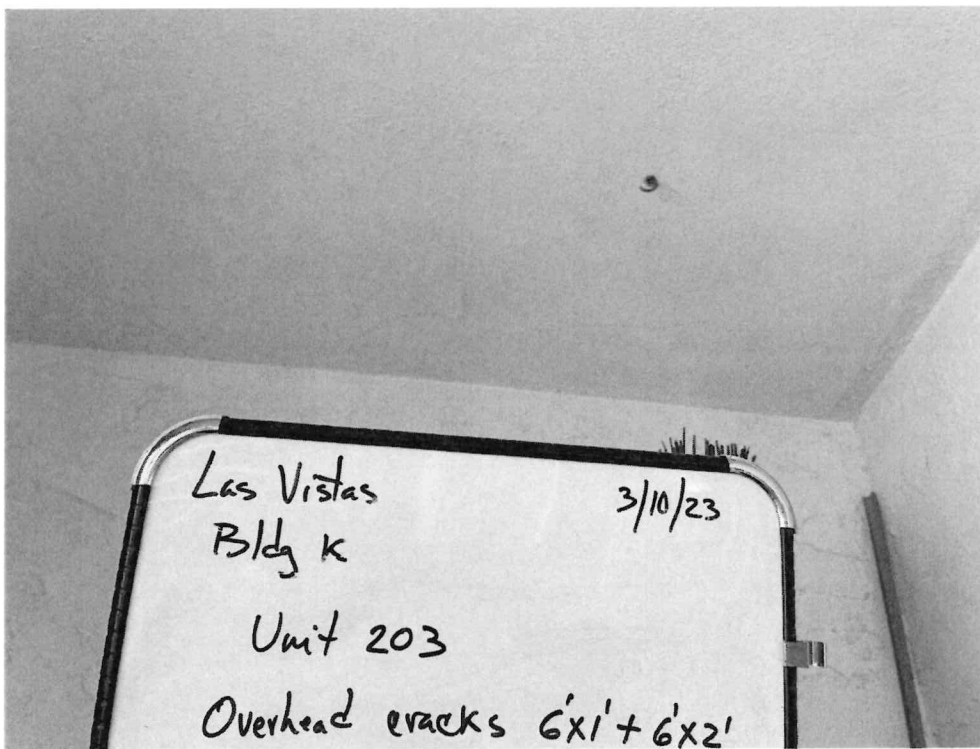
Photo 22: Overhead Cracks 6'x1'+6'x2'

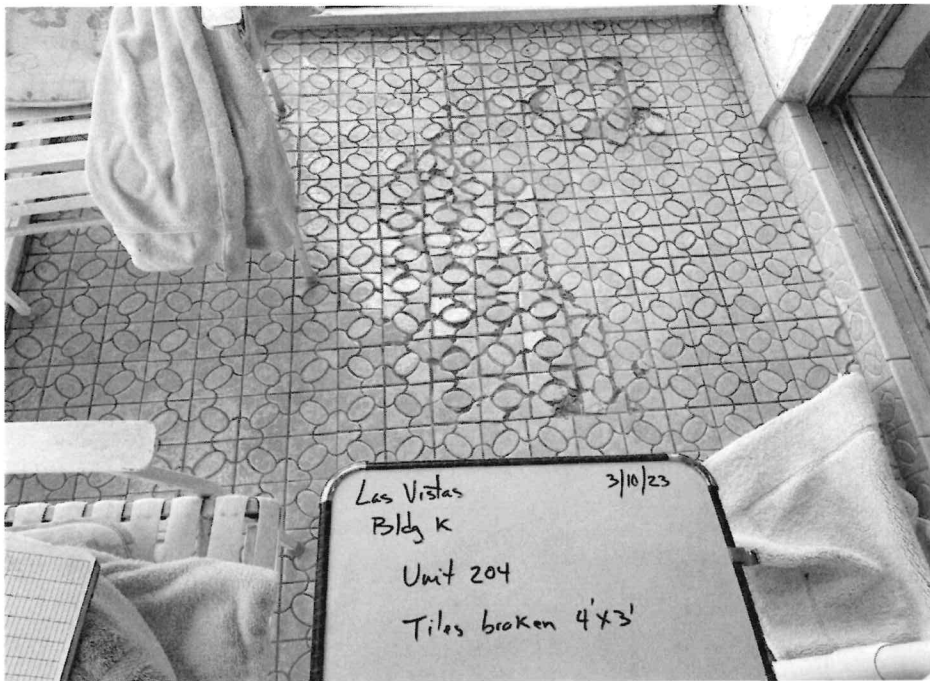
Photo 23: Tiles broken observed at unit 204, 4'x3'

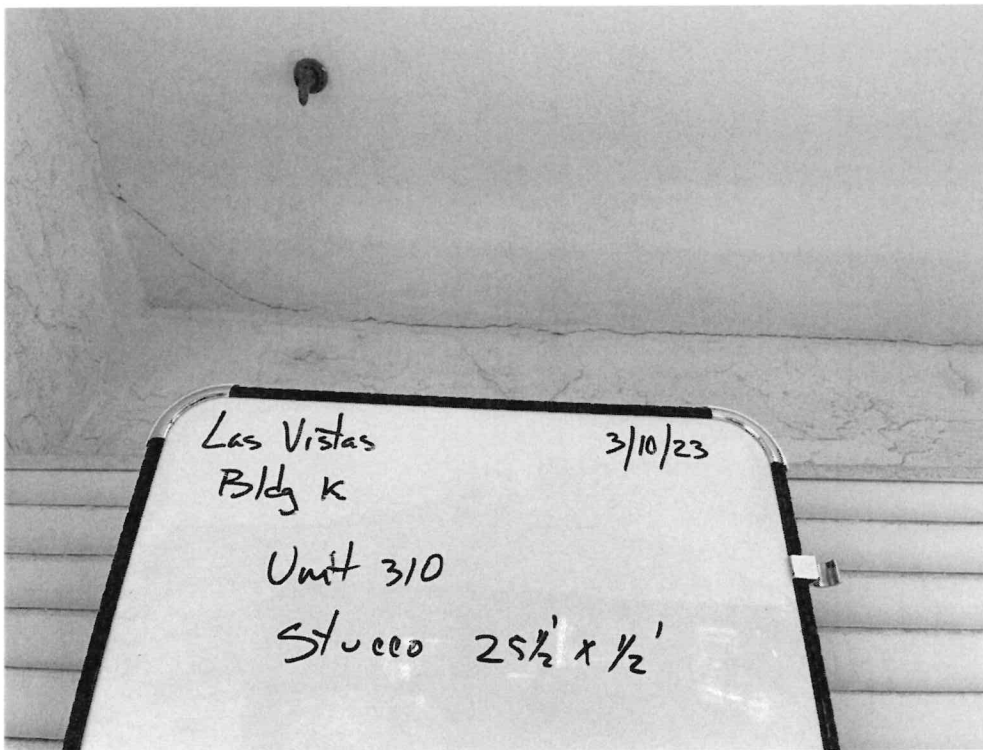
Photo 24: Stucco crack at unit 310; 25 1/2' x 1/2'.

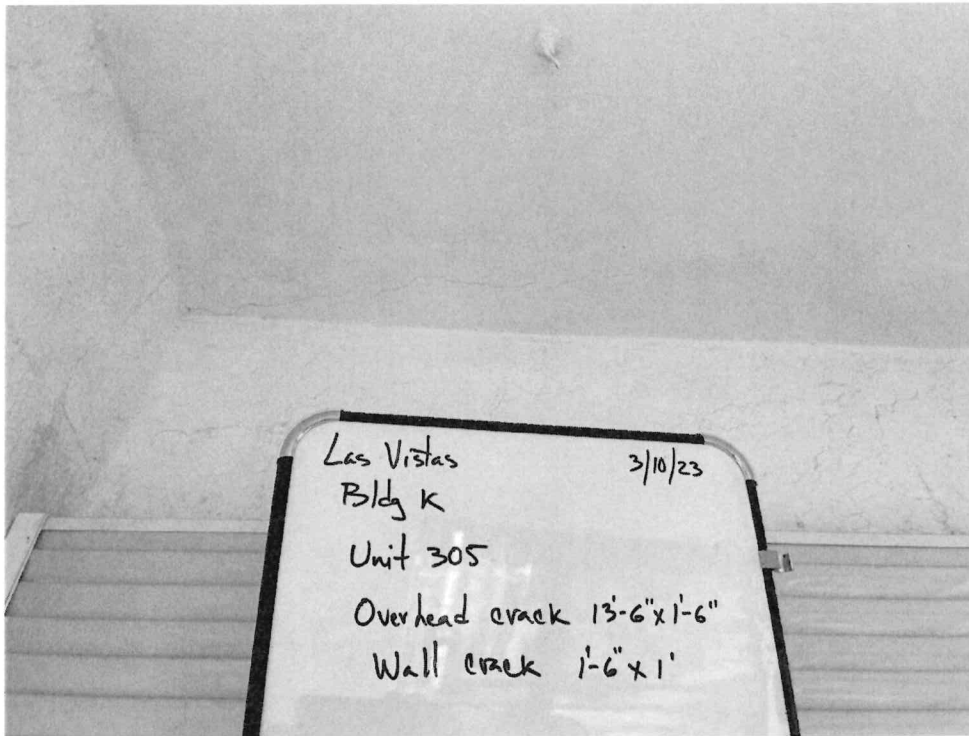
Photo 25: Unit 305: Overhead crack 13'-6' x 1'-6" - Wall crack- 1'-6"x1'
