# AKOURI CONSULTING ENGINEERS

RE Summary of repairs and recommendations obtained from the Milestone Phase 1 and 2 for  
the building located at:

Las Vistas in Inverrary Condominium Association Inc.  
3501 Inverrary Dr Bldg L, Lauderdale, FL 33319

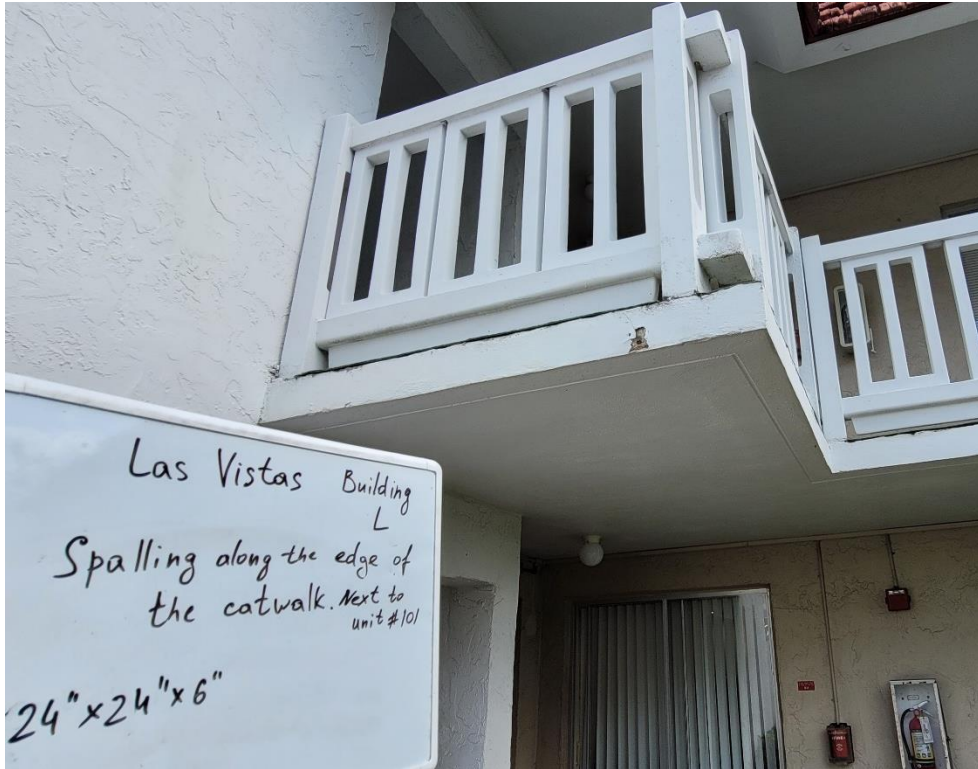
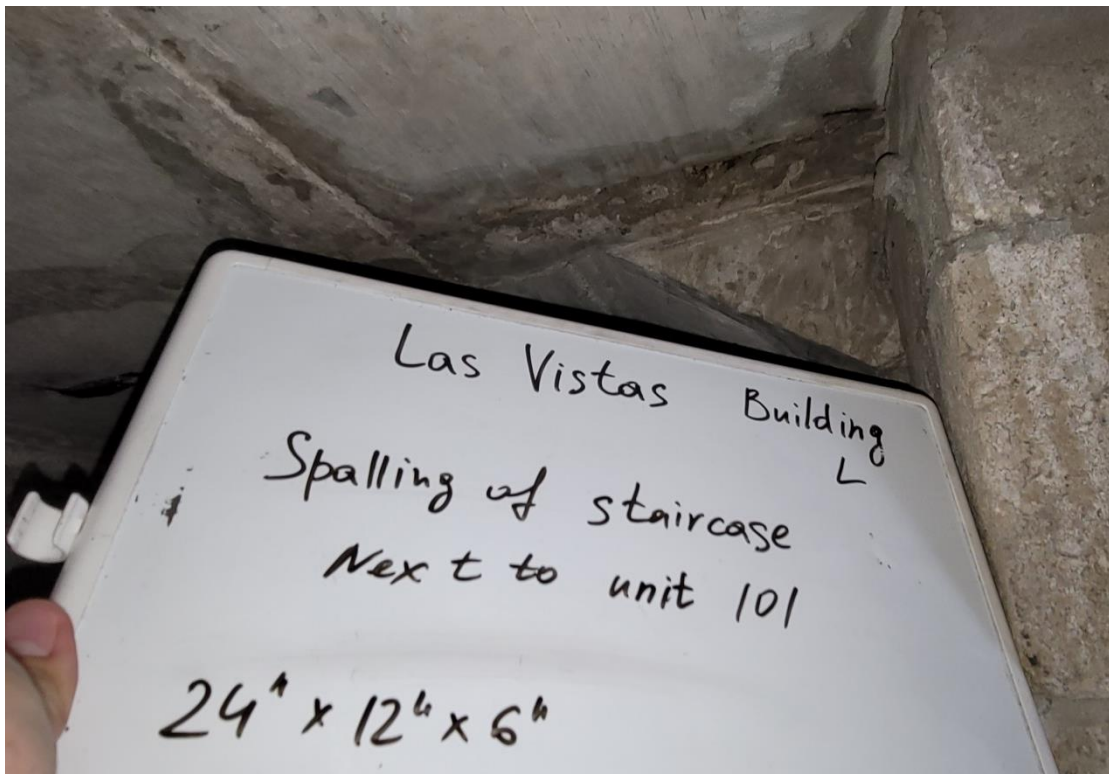
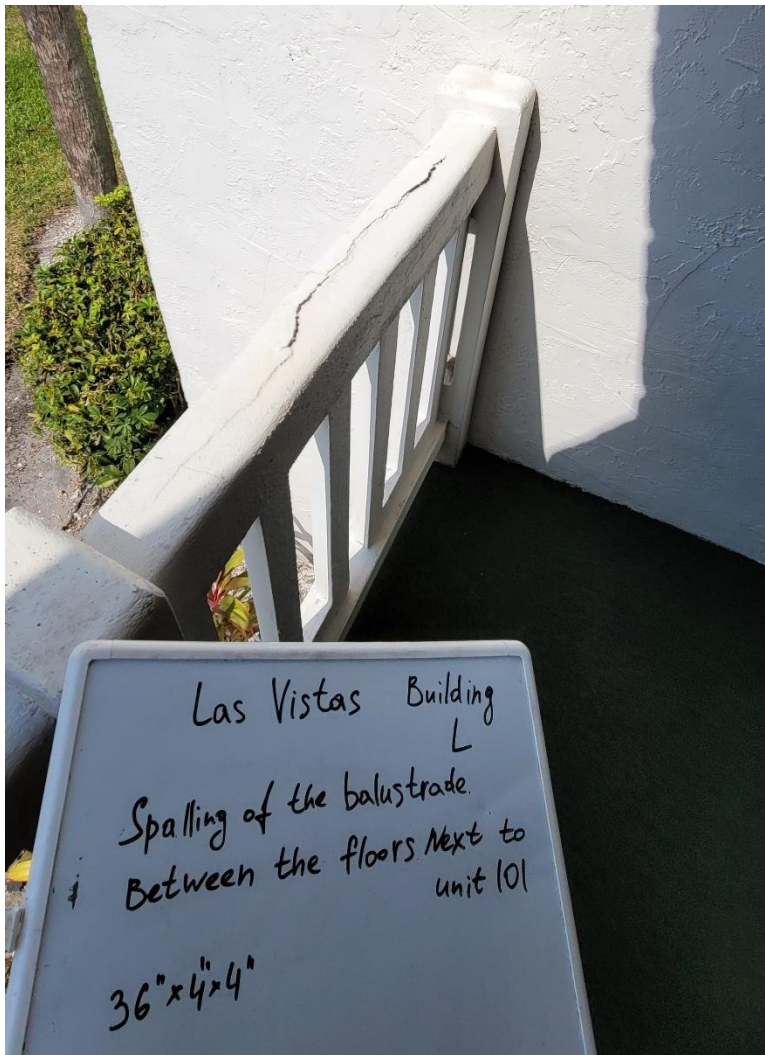
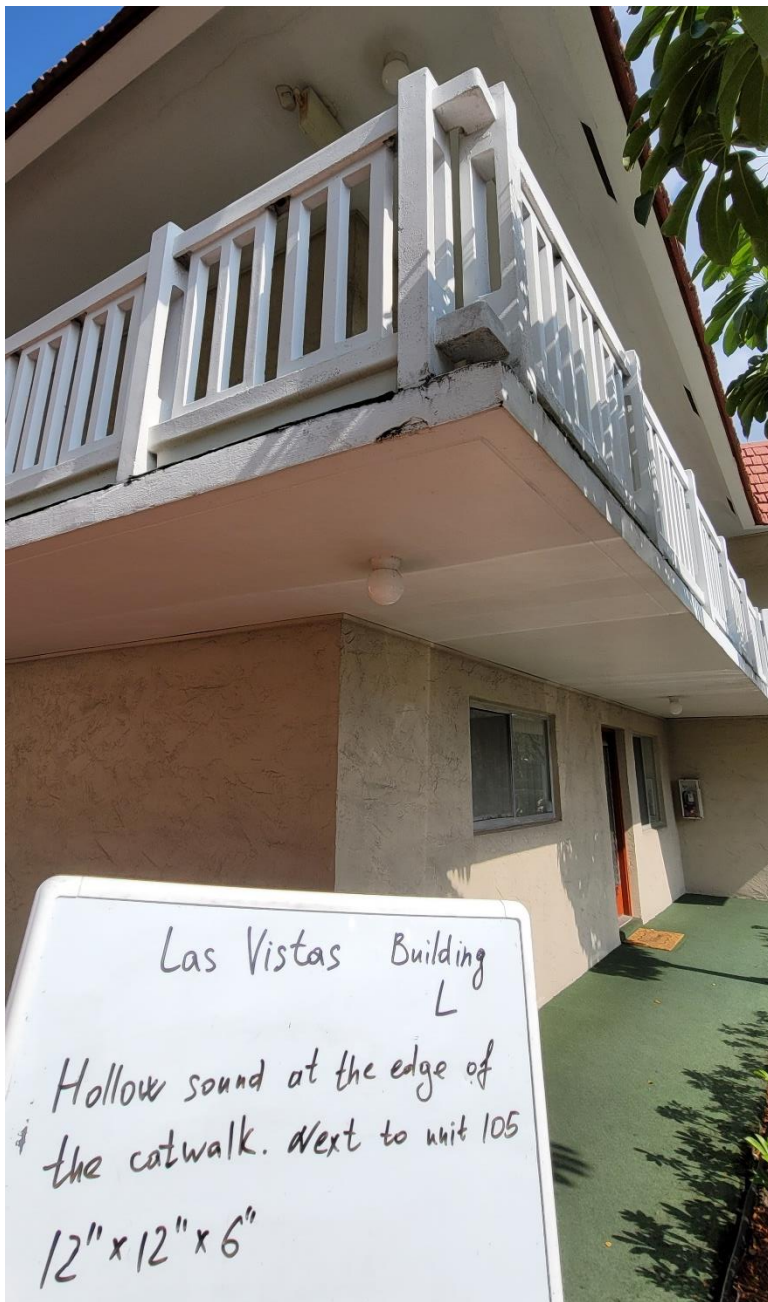
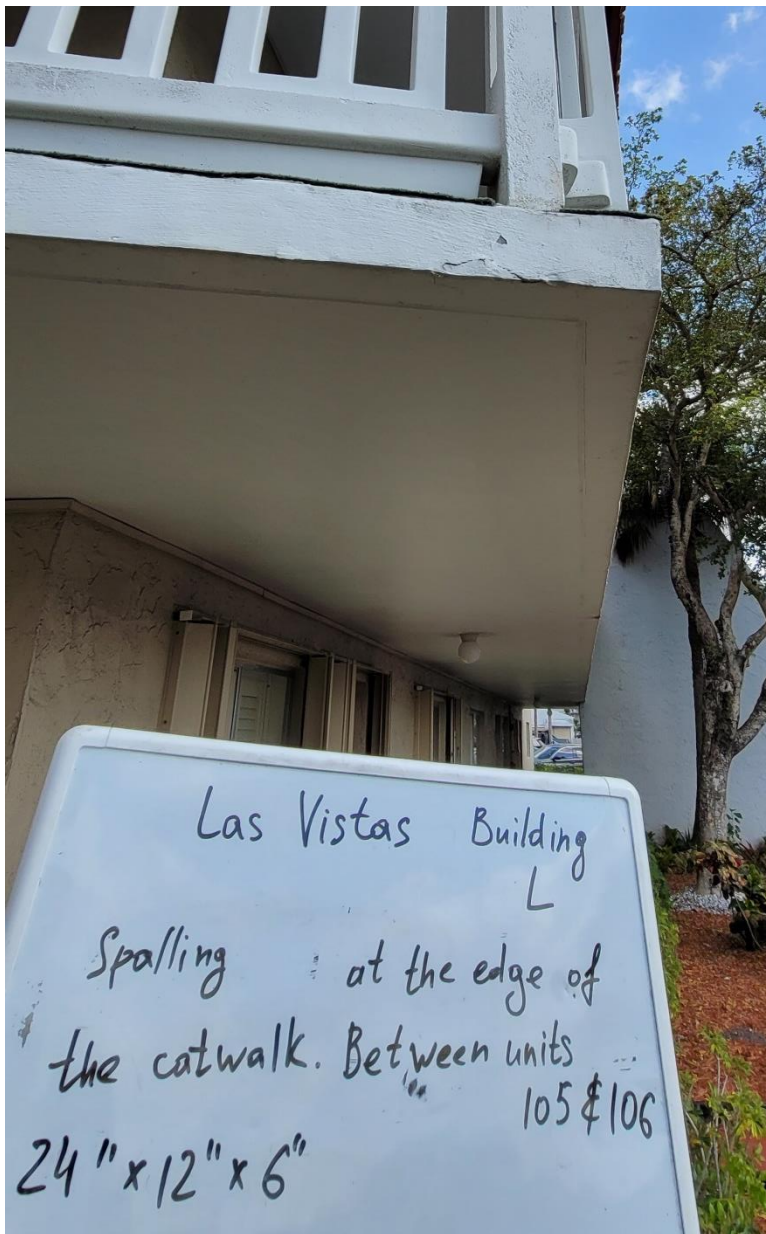
Spalling along the edge of the catwalk next to Unit 101

The listed deficiencies below must be corrected in accordance with a concrete restoration bid package prepared by a structural engineer and approved by the Local Building Department.

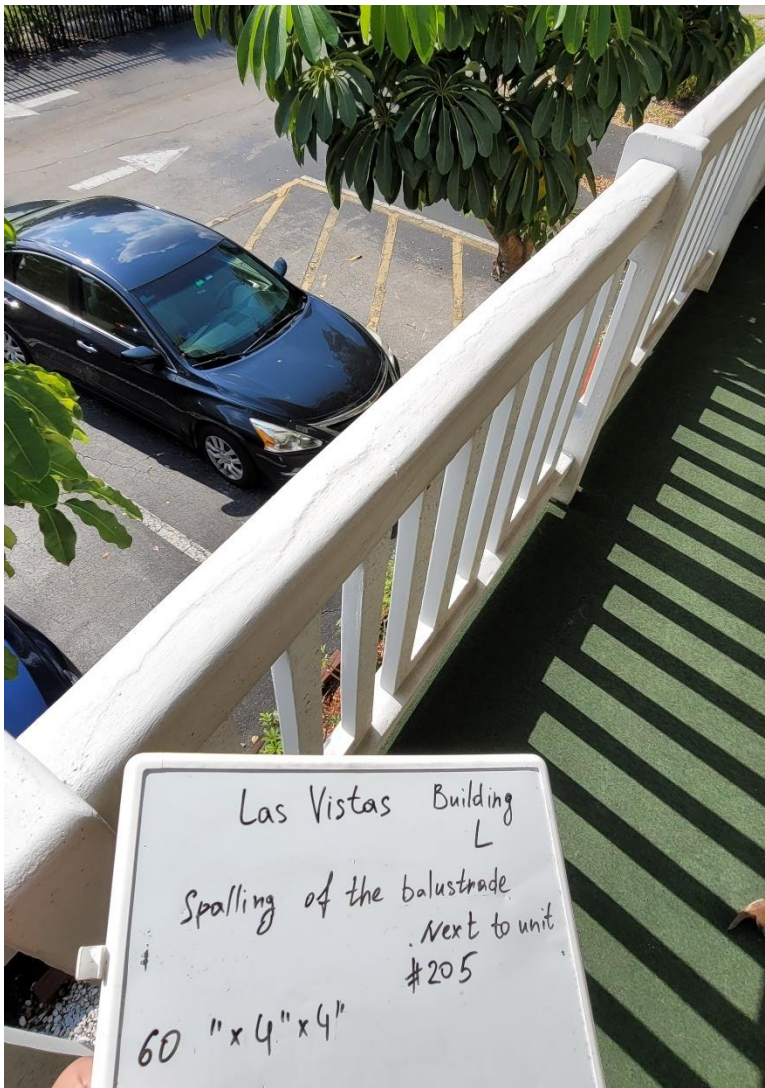
Spalling of the balustrade next to Unit 205

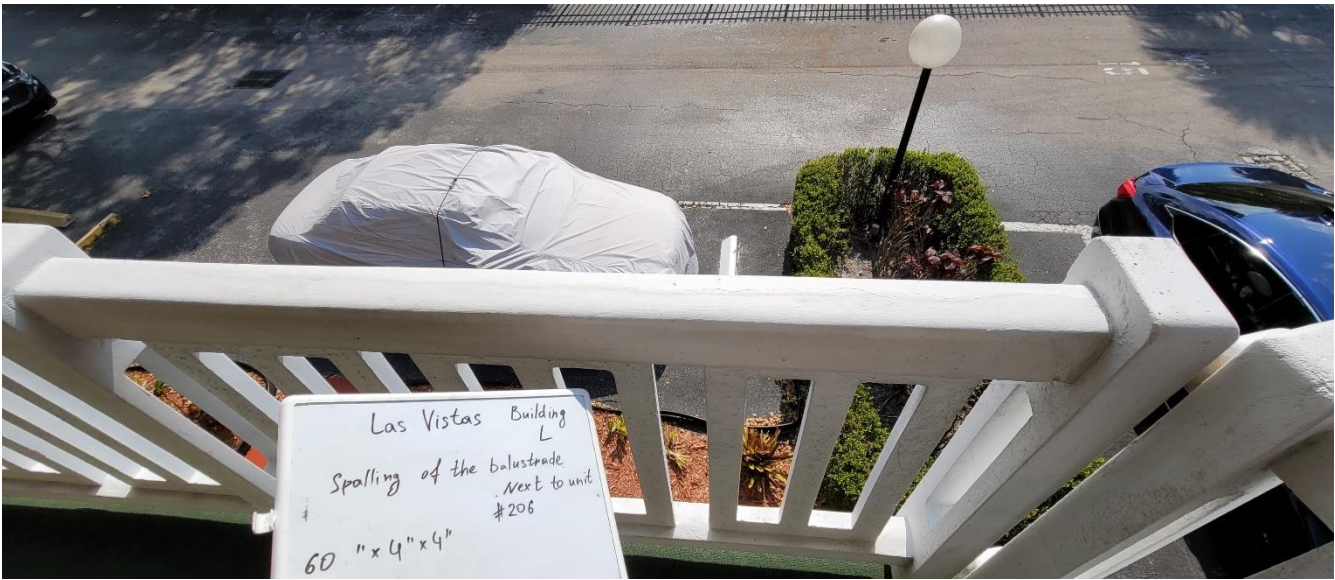
Spalling of the balustrade next to Unit 206

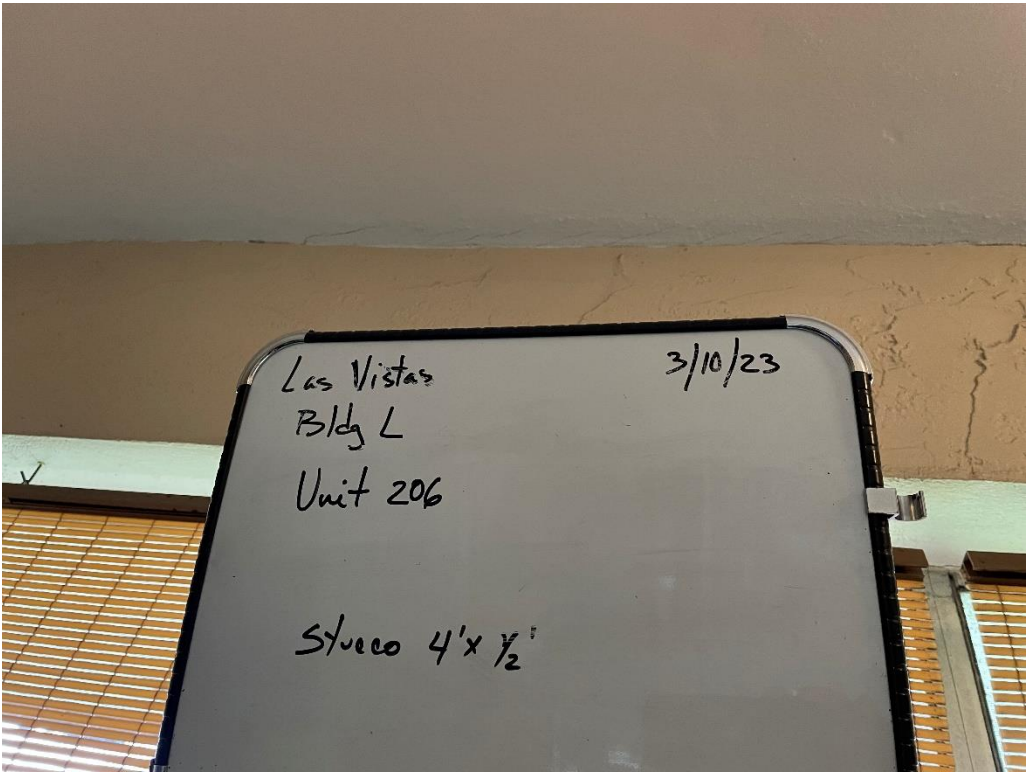
Stucco Unit 206

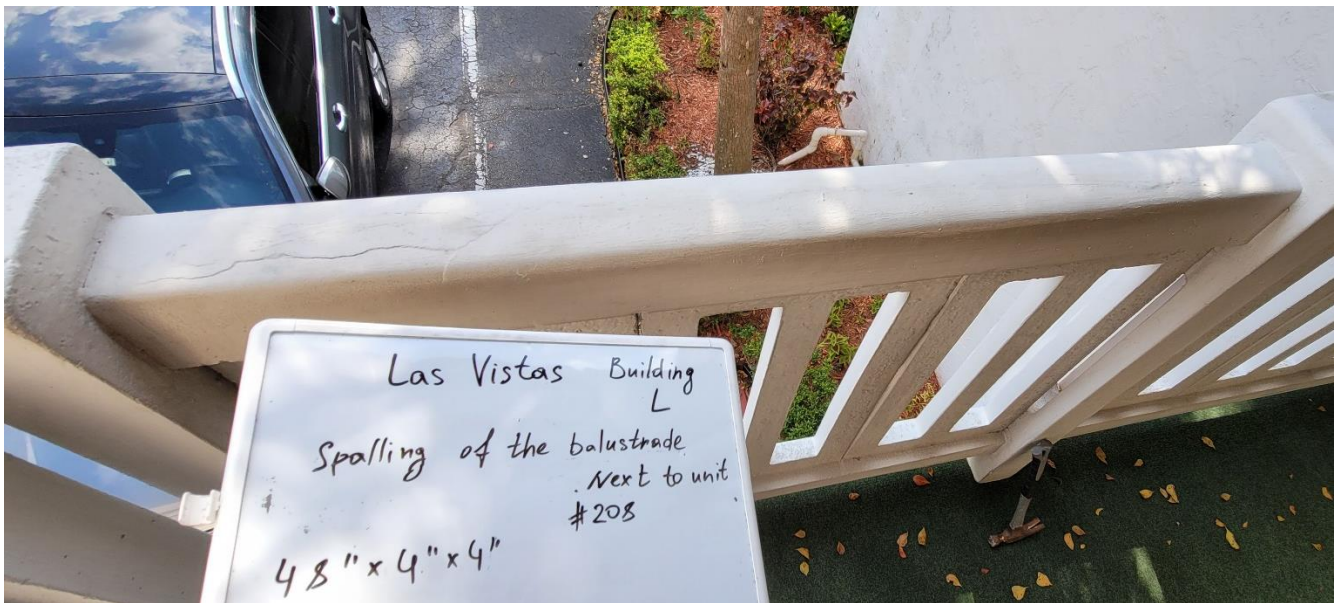
Spalling of the balustrade next to Unit 208

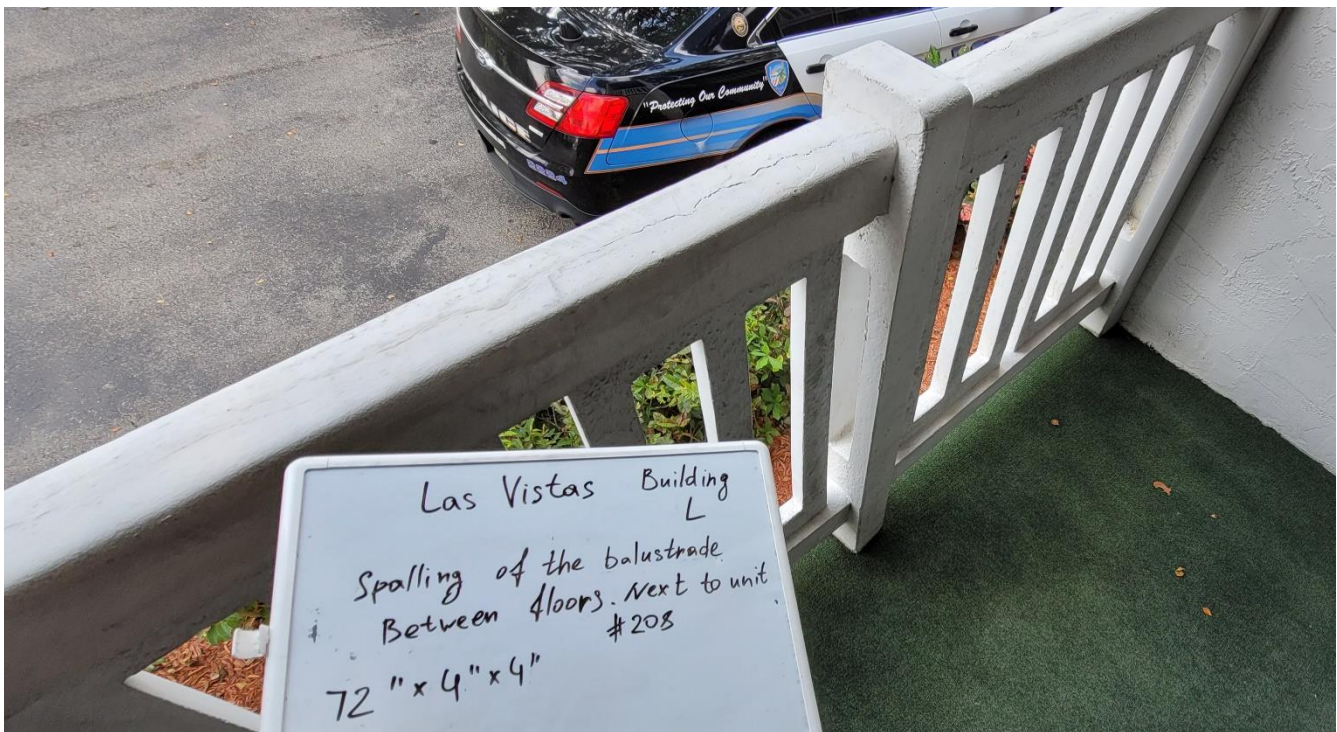
Spalling of the balustrade between floors next to Unit 208

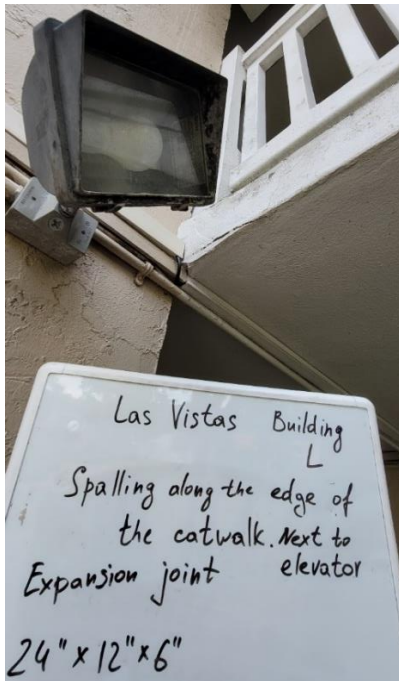
Spalling along the edge of the catwalk next to elevator

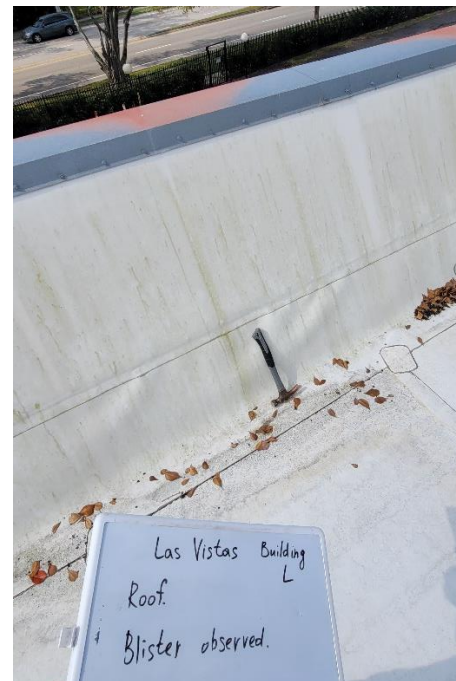
Roof (Single-ply roofing system with blisters)

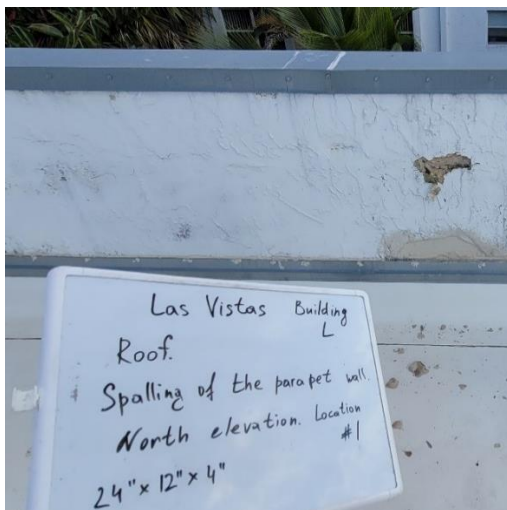
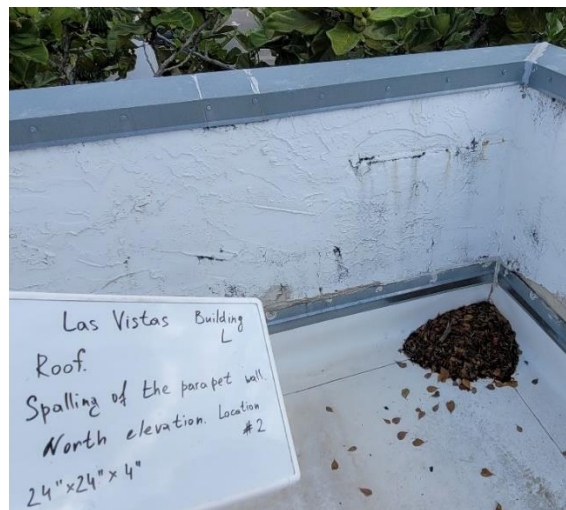
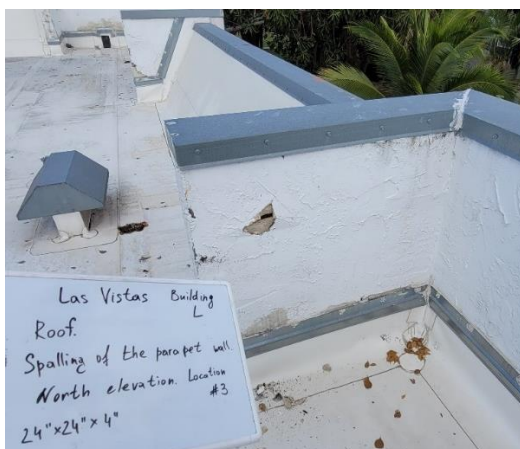
Spalling of the parapet North side

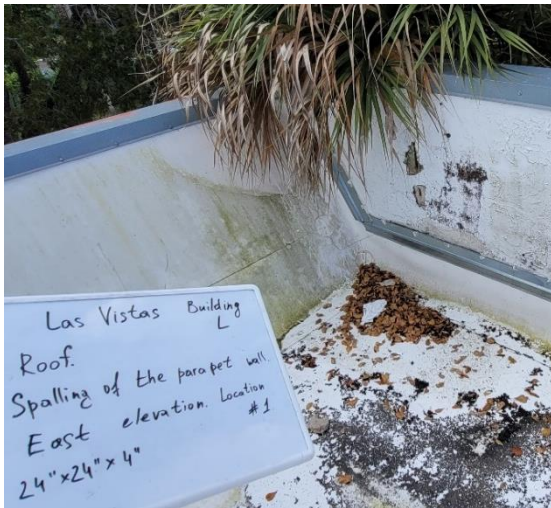
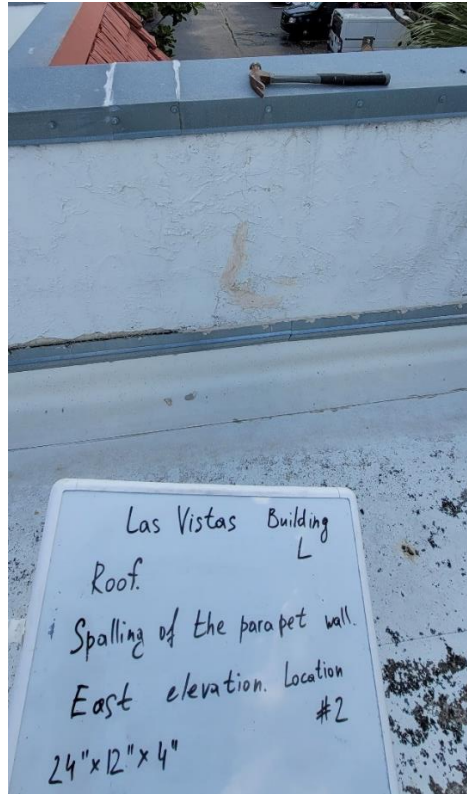
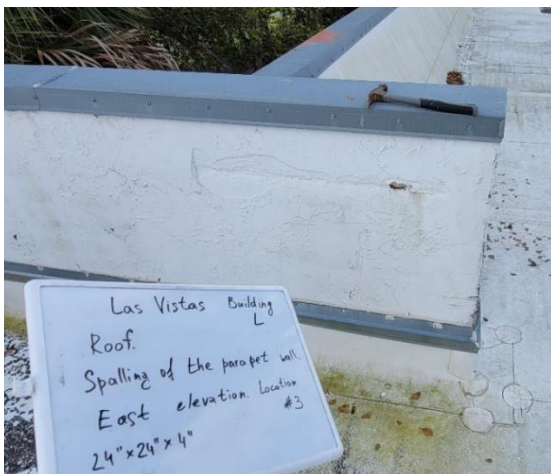
## Spalling of the parapet East side

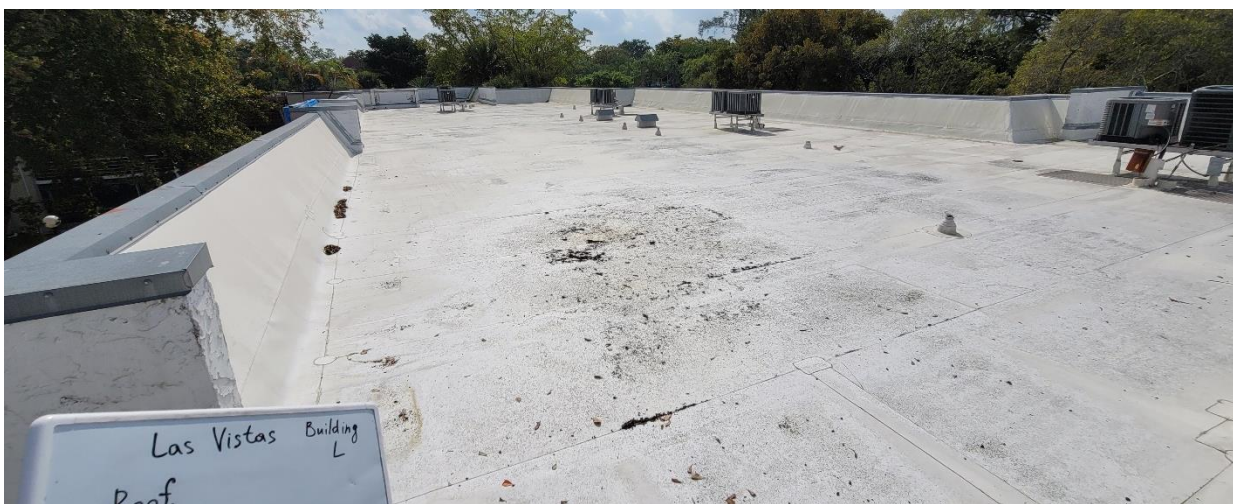
Roof (Roof system must be repaired)
