## STRUCTURAL SAFETY INSPECTION REPORT FORM

a. Name on Title: LAS VISTAS IN INVERRARY CONDOMINIUM ASSOCIATION, INC.b. Street Address: 3531 Inverrary Dr Bldg H, Lauderhill, FL 33319. Building H.c. Legal Description: LAS VISTAS H IN INVERRARY CONDO PER CDO BK/PG: 5956/309d. Owner's Name: LAS VISTAS IN INVER CONDO ASSNe. Owner's Mailing Address: 3533 Inverrary Dr, Lauderhill, FL 33319-5921.f. Email Address: Contact Number: Dwayne Griffin, Office Manager (954-731-8484), accounting@lasvistascondo.comg. Folio Number of Property on which building is located: 4941 23 CH 0010 (Reference)h. Building Code Occupancy Classification: R-2 FBC 2023, Type III residentiali. Present Use: Condominium Buildingj. General Description: Type of Construction: This is a (4) story concrete building Type of Construction: IIIk. Square Footage: Approximately: 11,500 SF Number of Stories: (4)

## Photo Report

Property Address: 3531 Inverrary Dr, Lauderhill, FL 33319. **Building H.**

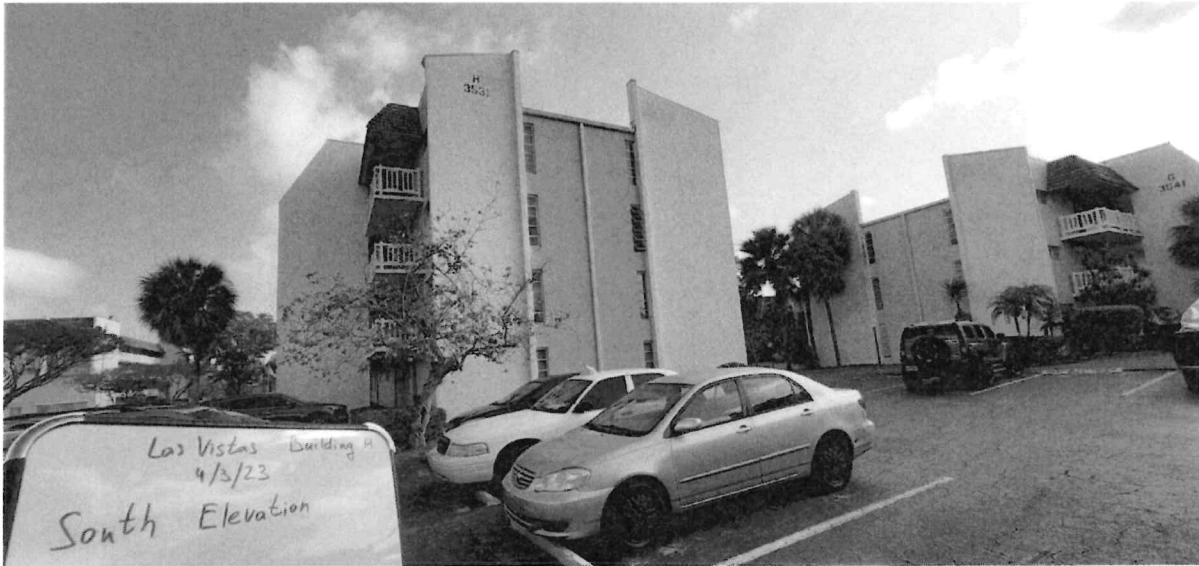
Photo 1: South Side View.

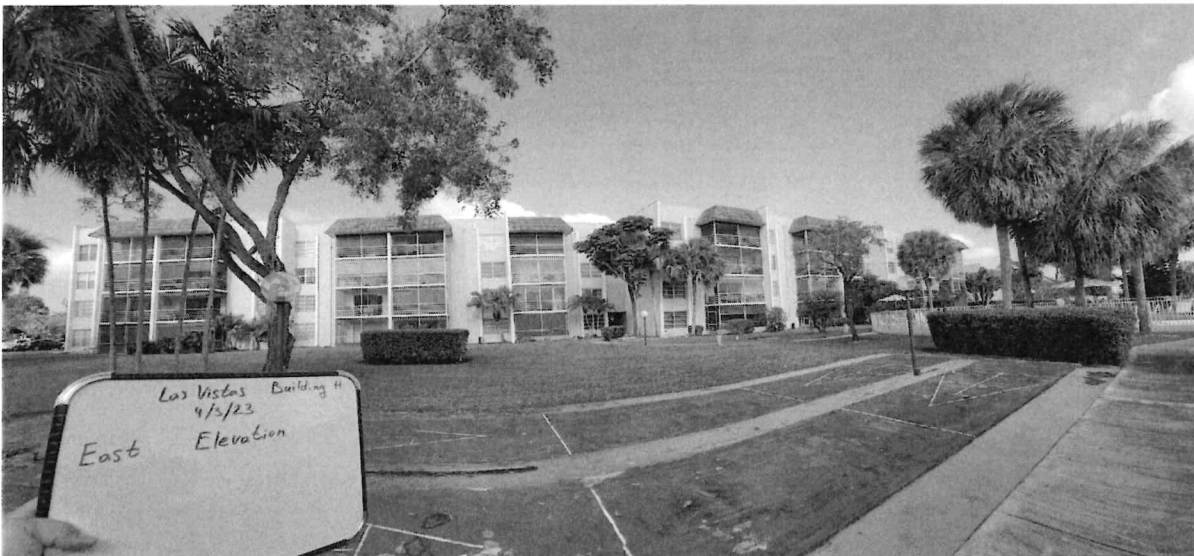
Photo 2: East Side View.

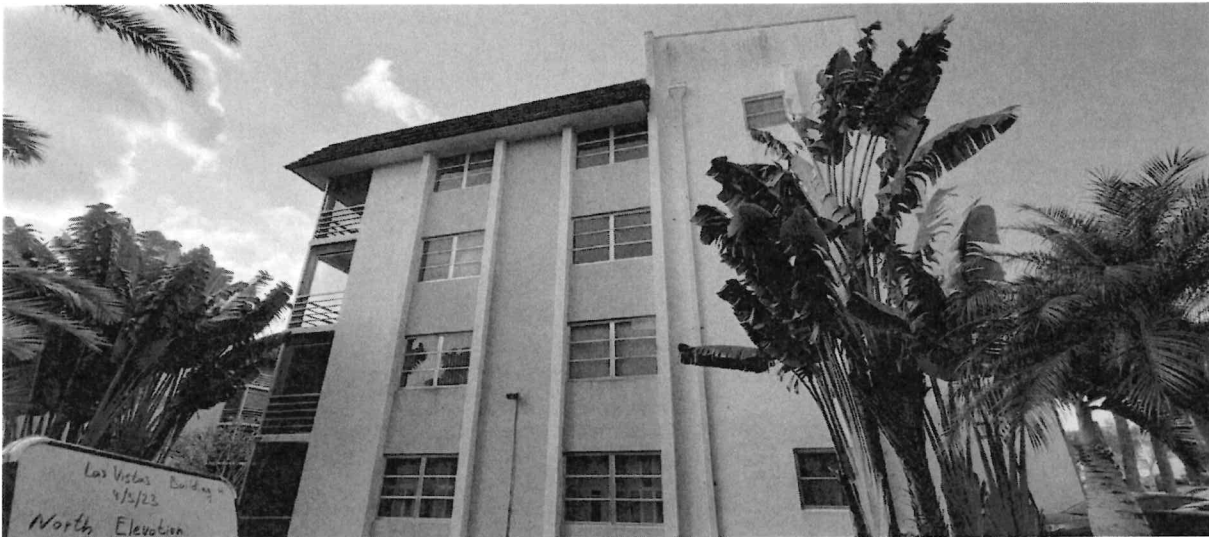
Photo 3: North Side View.

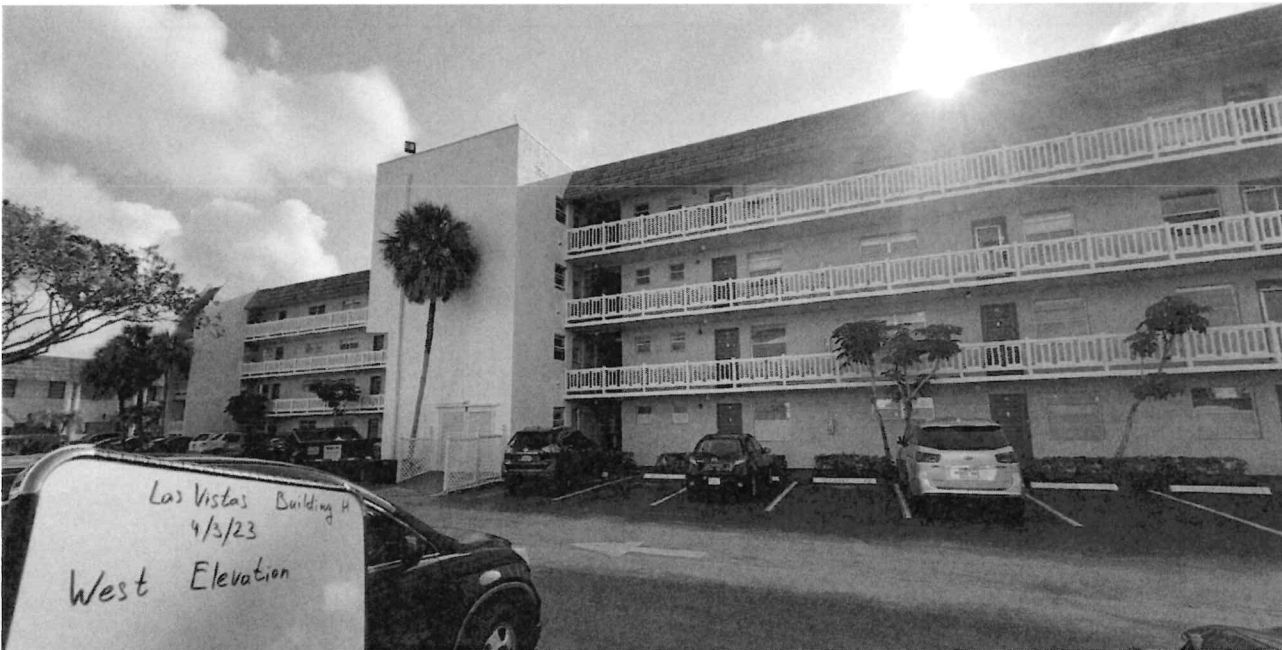
Photo 4: West Side View.

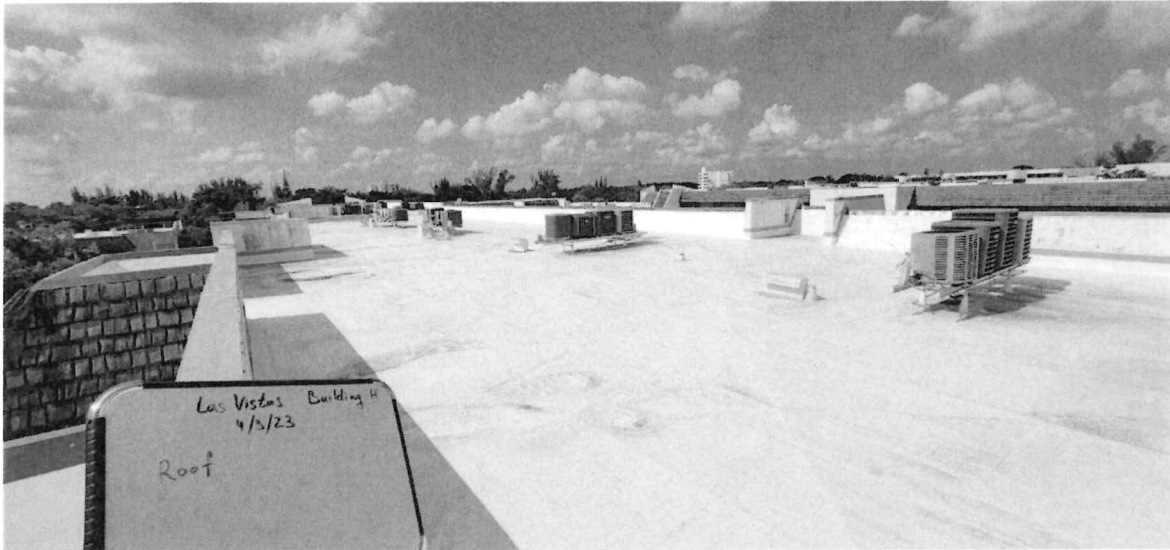
Photo 5: Roof View. No overflows observed.

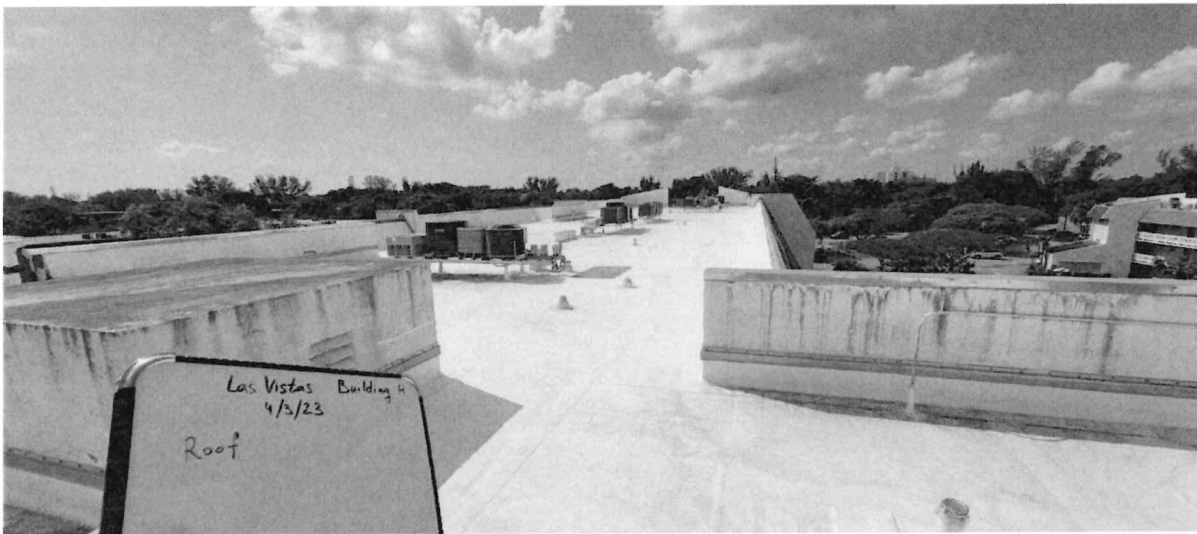
Flat single ply roof system over the concrete deck was observed to be in fair condition.

Photo 6: Roof View.

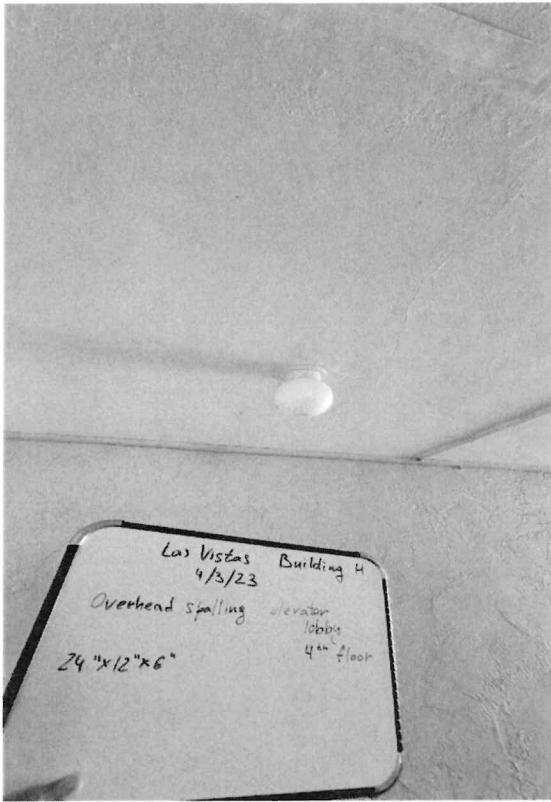
Photo 7: Overhead spalling - Elevator Building lobby 4th floor 24"x12"x6"

Spalling of the catwalk and balcony slabs was observed in multiple locations. All repairs must be performed in accordance with plans prepared by an engineer and approved by the local building department.

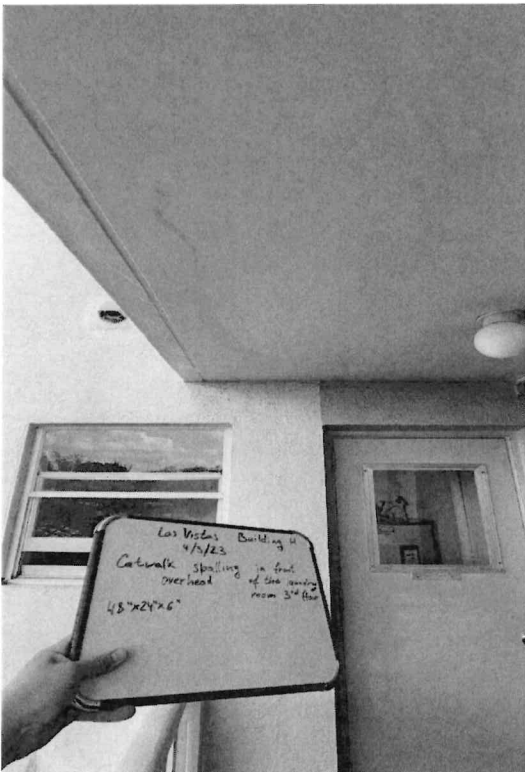
Spalling of the catwalk and balcony slabs was observed in multiple locations.

Photo 8: Catwalk-Overhead spalling in front of the laundry room 3rd floor 48"x24"x6"

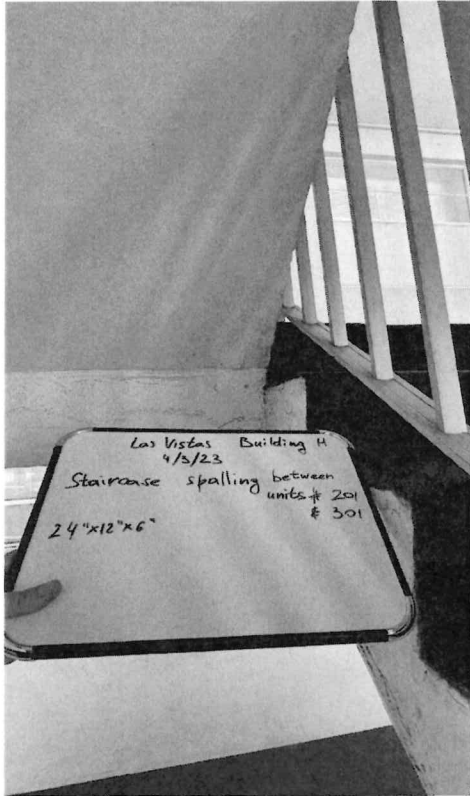
The exterior concrete stairs were observed in fair condition. However, spalled sections were found at multiple locations.

Photo 9: Staircase - spalling between units 201& 301 24"x12"x6"

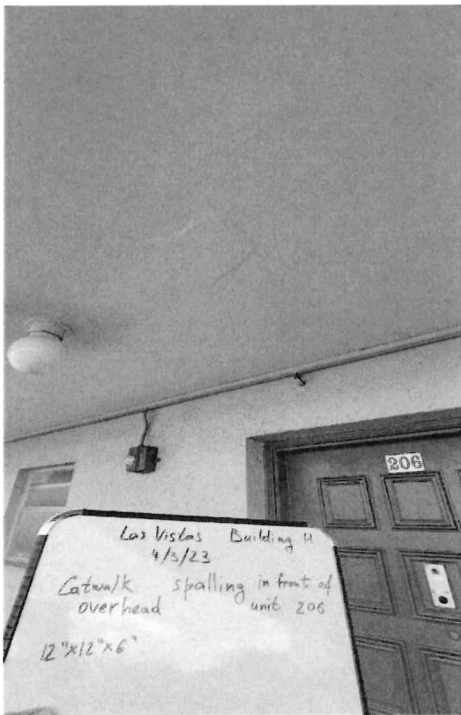
Photo 10: Catwalk - overhead spalling in front of unit 206 12"x12"x6"

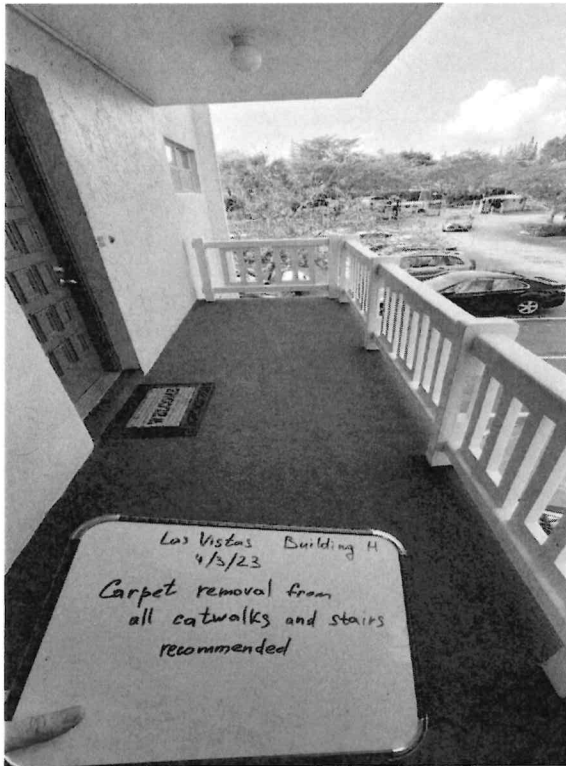
Photo 11: Carpet - Removal from all catwalks and stairs recommended

The building is structurally safe for its intended use and occupancy, but requires repairs as described in the report. All repairs must be performed in accordance with plans prepared by an engineer and approved by the local building department. The carpet along the catwalks must be removed and concrete spalling repaired.

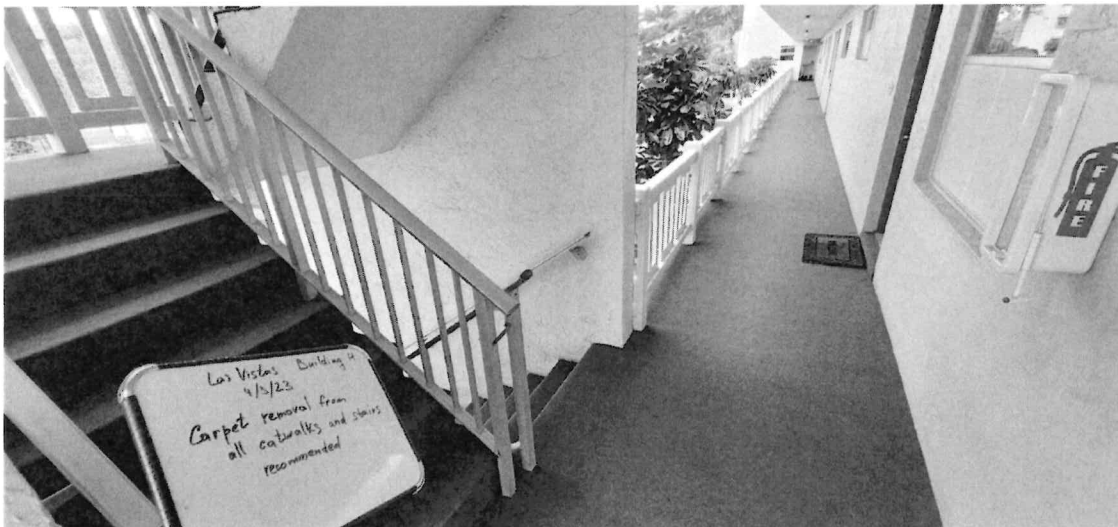
Photo 12: Carpet - Removal from all catwalks and stairs recommended

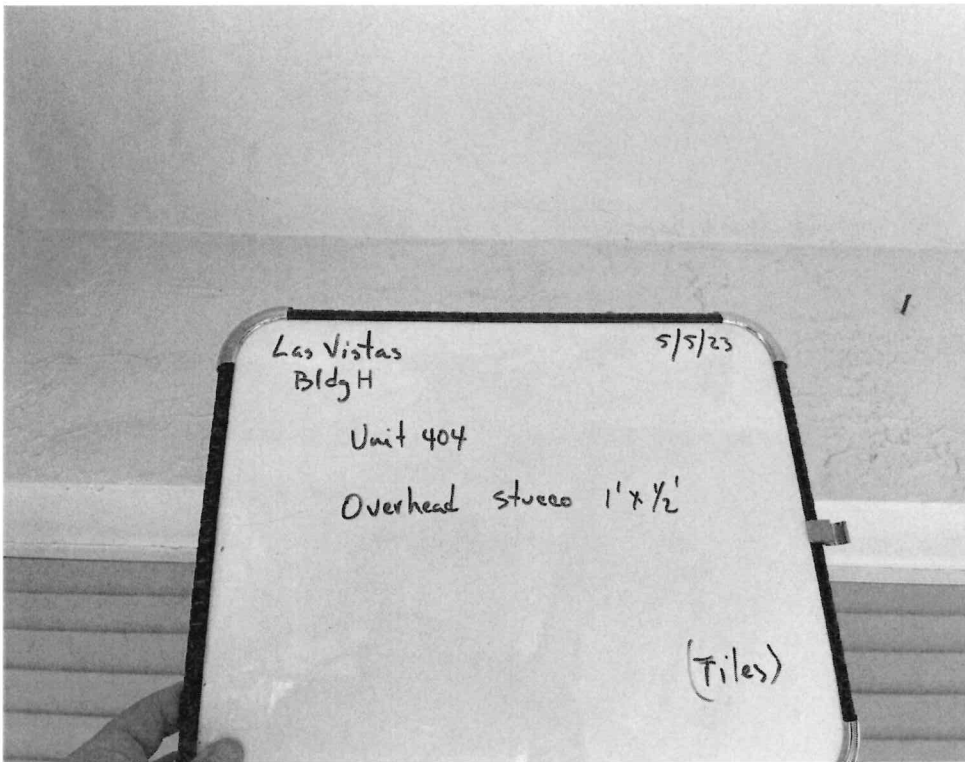
Photo 13: Overhead stucco unit 404 (tiles) 1'x1/2'

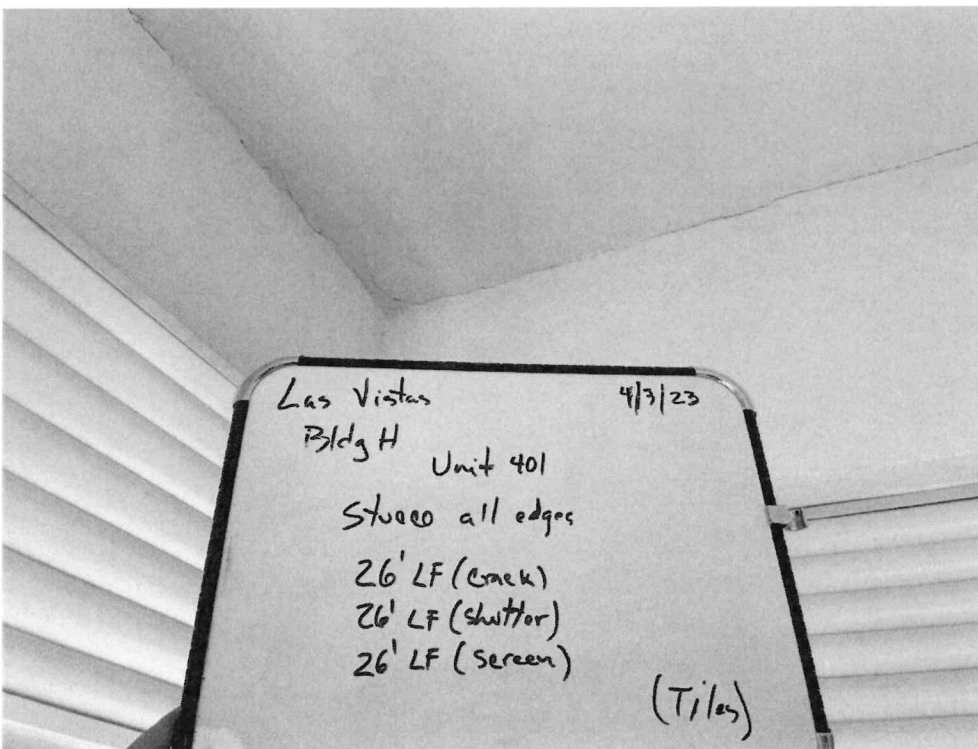
Photo 14: Stucco all edges 26' LF ( Crack) 26' LF (shutter) 26' LF (screen) unit 401 (tiles)

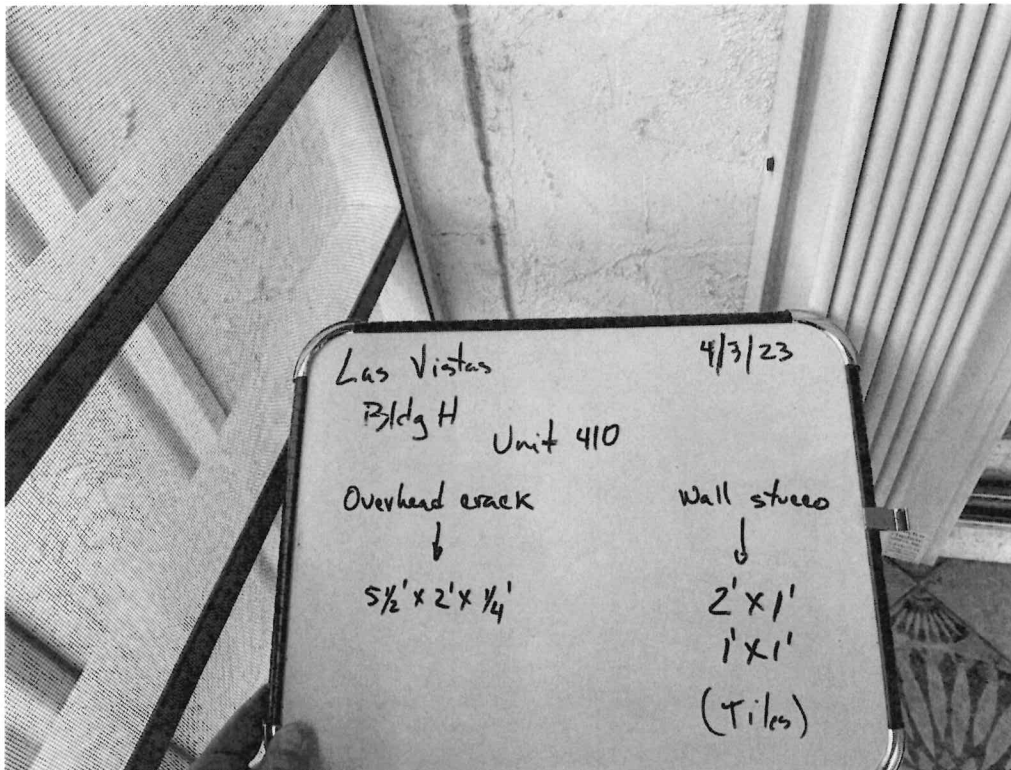
Photo 15: Overhead crack 5 1/2' x 2' x 1/4' - wal stucco 2' x 1' 1'x1' (tiles)
