## STRUCTURAL SAFETY INSPECTION REPORT FORM

**1. DESCRIPTION OF STRUCTURE**a. Name on Title: LAS VISTAS IN INVERRARY CONDOMINIUM ASSOCIATION, INC.b. Street Address: 3601 Inverrary Dr Lauderhill Bldg A, FL, 33319c. Legal Description: LAS VISTAS A IN INVERRARY CONDO PER CDO BK/PG: 5956/57d. Owner's Name: LAS VISTAS IN INVER CONDO ASSNe. Owner's Mailing Address: 3533 Inverrary Dr, Lauderhill, FL 33319-5921. Building A.f. Email Address: Contact Number: Dwayne Griffin, Office Manager (954-731-8484), accounting@lasvistascondo.comg. Folio Number of Property on which building is located: 4941 23 CA 0000 (Reference)h. Building Code Occupancy Classification: R-2 FBC 2023, Type III residentiali. Present Use: Condominium Buildingj. General Description: Type of Construction: This is a (4) story concrete building Type of Construction: IIIk. Square Footage: Approximately: 17,000 S.F. Number of Stories: (4)

## **Photo Report**

**Name:** LAS VISTAS IN INVERRARY CONDOMINIUM ASSOCIATION, INC.

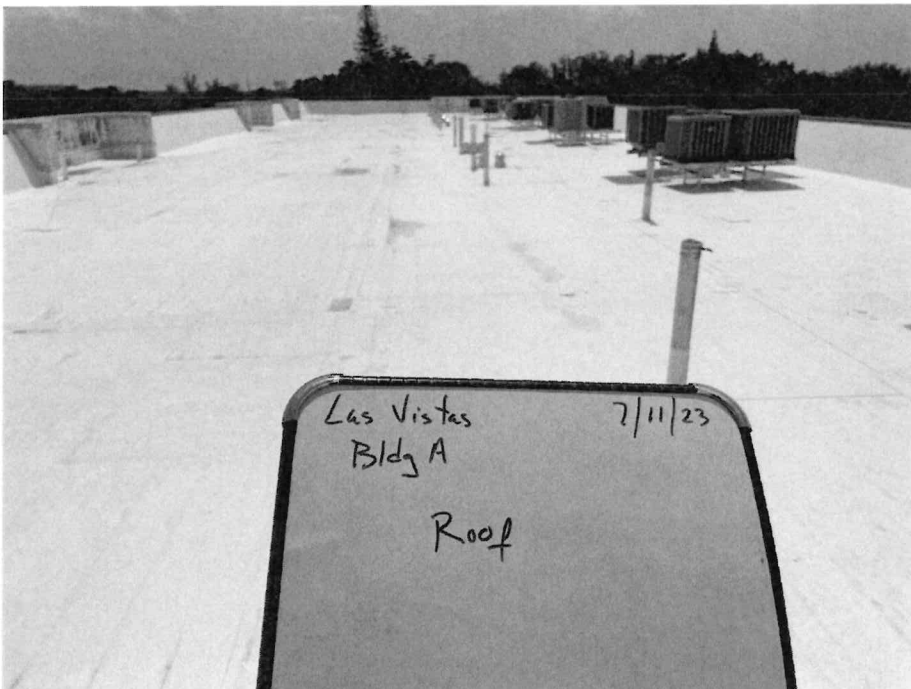
Photo 5: Roof View.

Flat single ply roof system over concrete deck was observed to be in good condition.

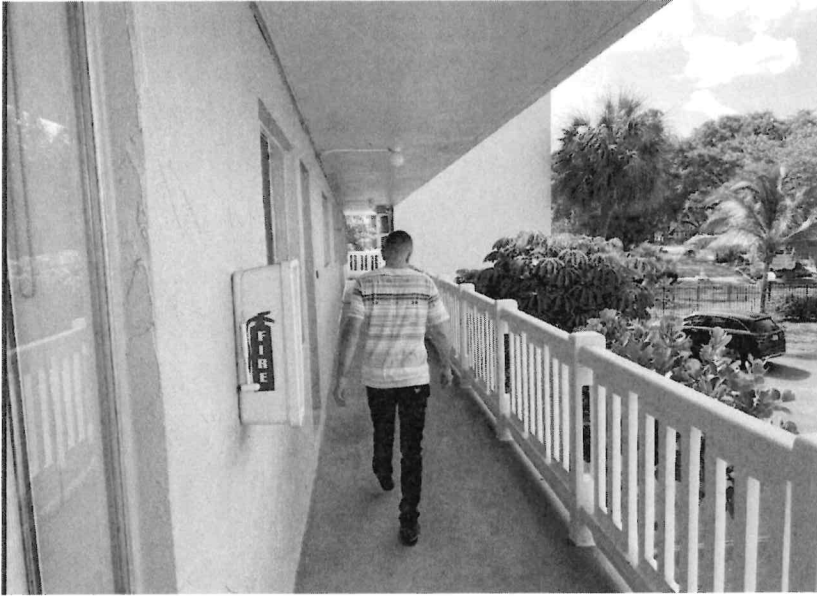
The guardrails at the catwalks are composed of concrete precast rails and found in fair condition. The rails at the exterior stairs are metal and were found in fair condition.

Photo 6: Catwalk view. No damage found.
