## STRUCTURAL SAFETY INSPECTION REPORT FORM

**1. DESCRIPTION OF STRUCTURE**a. Name on Title: LAS VISTAS IN INVERRARY CONDOMINIUM ASSOCIATION, INC.b. Street Address: 3551 Inverrary Dr Lauderhill, FL, 33319c. Legal Description: LAS VISTAS F IN INVERRARY CONDO UNIT 101 PER CDO BK/PG: 5956/225d. Owner's Name: LAS VISTAS IN INVER CONDO ASSNe. Owner's Mailing Address: 3551 Inverrary Dr., Lauderhill, FL 33319. Building F.f. Email Address: Contact Number: Dwayne Griffin, Office Manager (954-731-8484), accounting@lasvistascondo.comg. Folio Number of Property on which building is located: 4941 23 CG 0010 (Reference)h. Building Code Occupancy Classification: R FBC 2023, Type III residentiali. Present Use: Condominium Buildingj. General Description: Type of Construction: This is a (4) story concrete building Type of Construction: IIIk. Square Footage: Approximately: 14,258 SF Number of Stories: (4)

## Photo Report

Property Address: 3551 Inverrary Dr., Lauderdale, FL 33319. **Building F.**

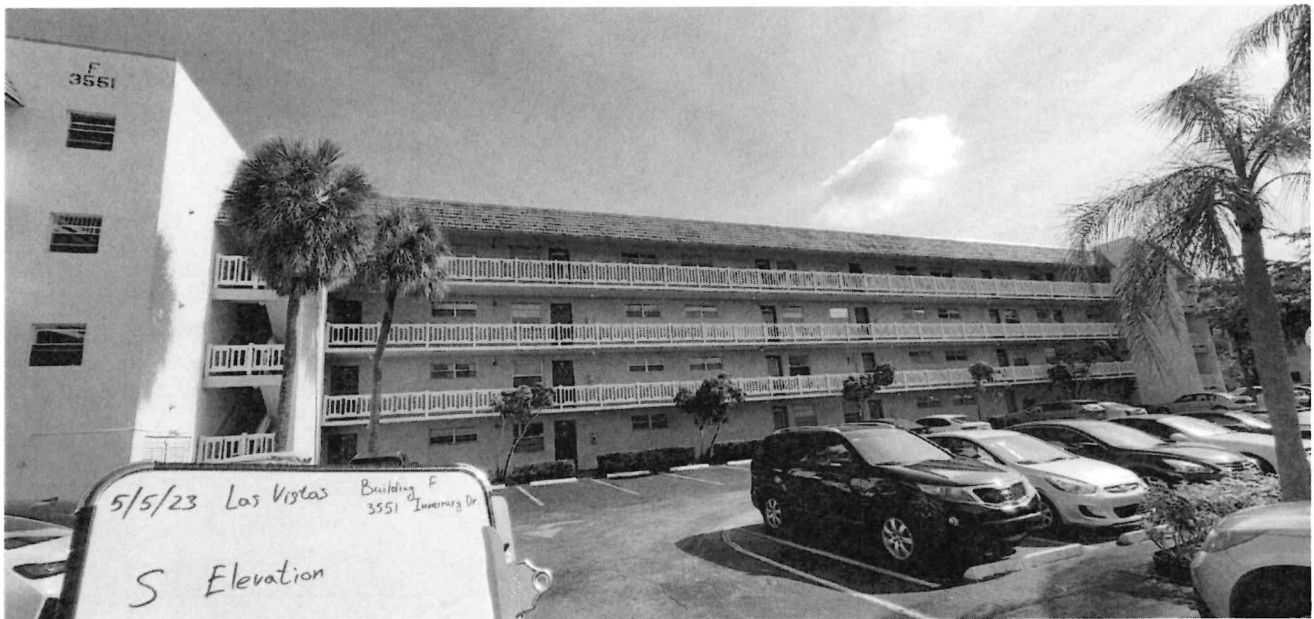
Photo 1: South Side View.

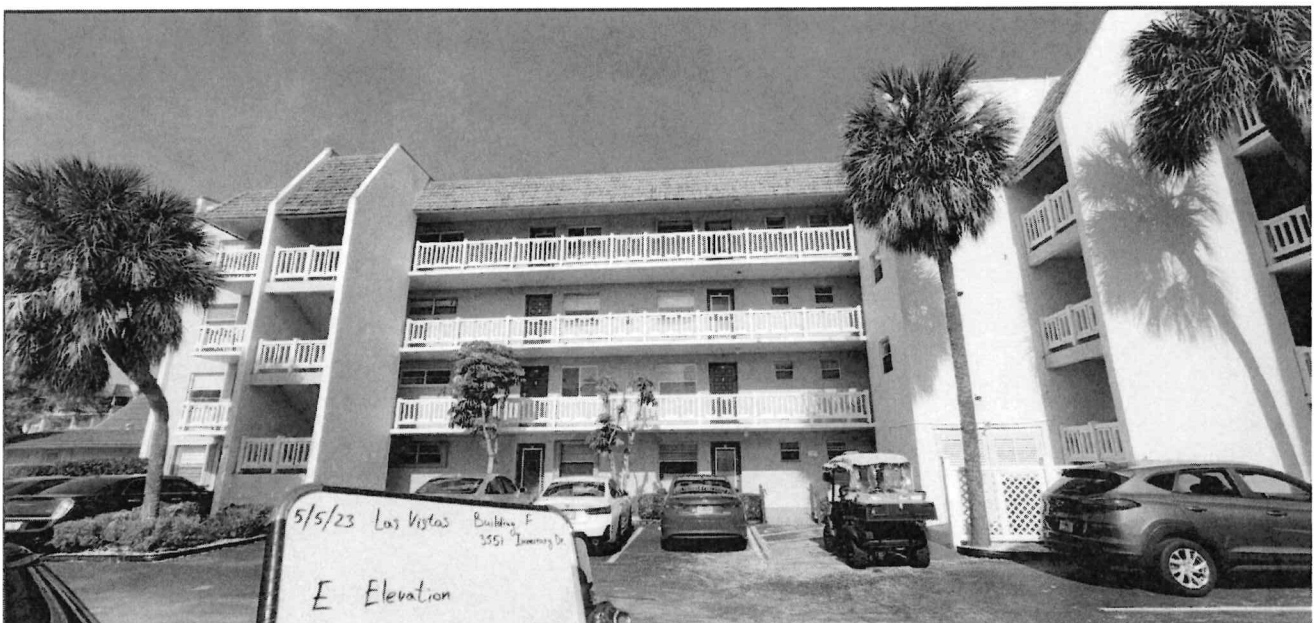
Photo 2: East Side View.

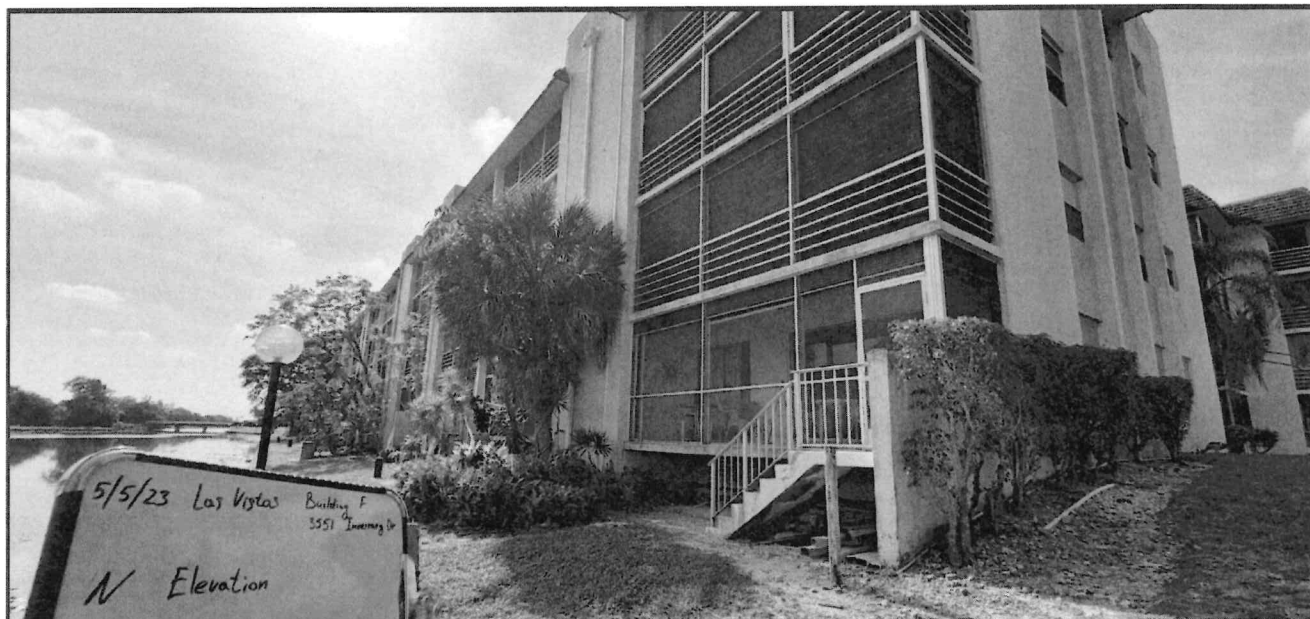
Photo 3: North Side View.

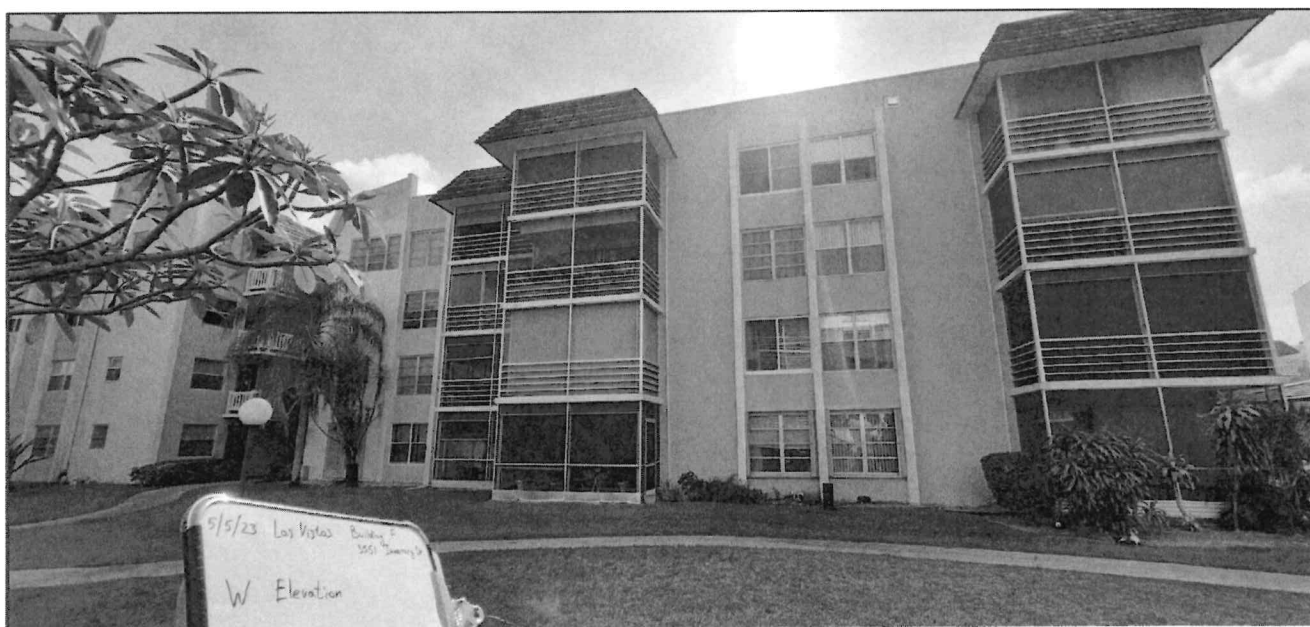
Photo 4: West Side View.

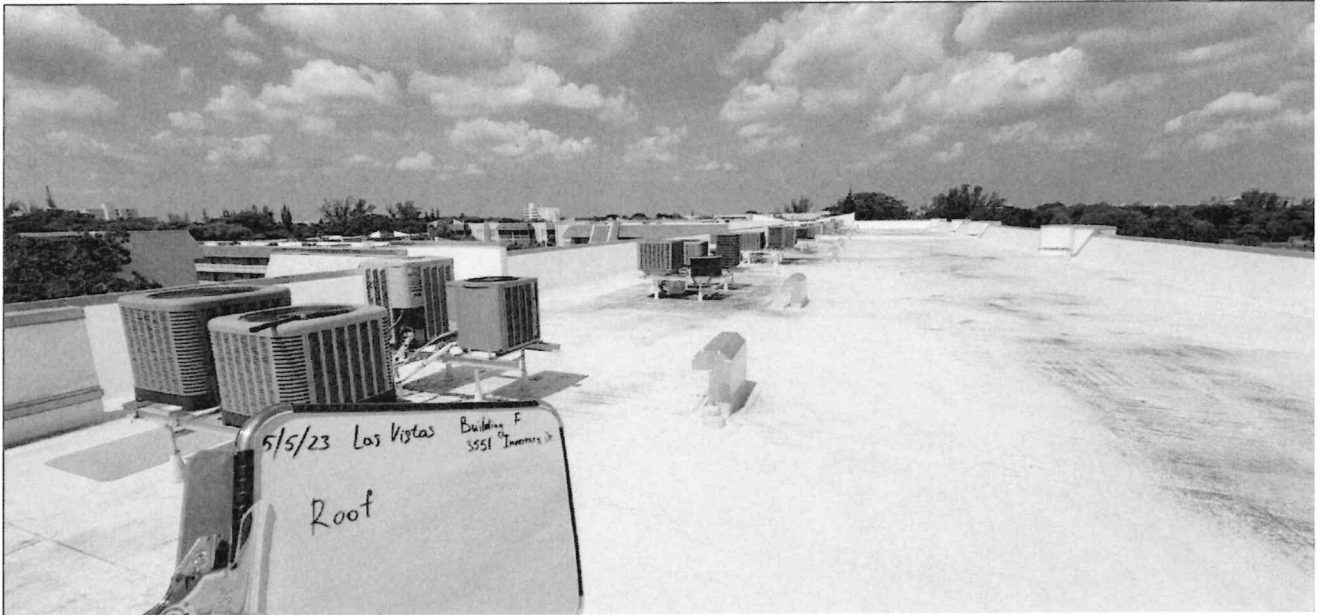
Flat single ply roof system over the concrete deck was observed to be in fair condition.

Photo 5: Roof View.

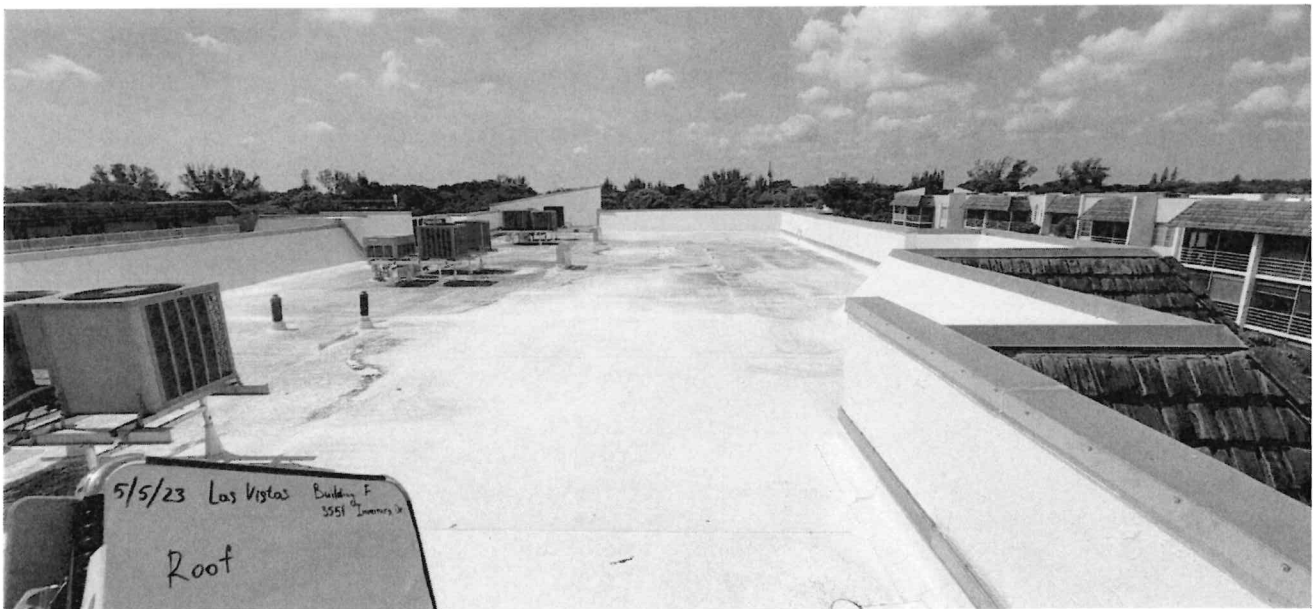
The concrete tile roof along the mansard roof was observed generally in fair condition. Although there was no access To confirm the condition of the underlying structural system, No visible deficiencies were noted during the inspection.

Photo 6: Mansard Roof and flat roof view.

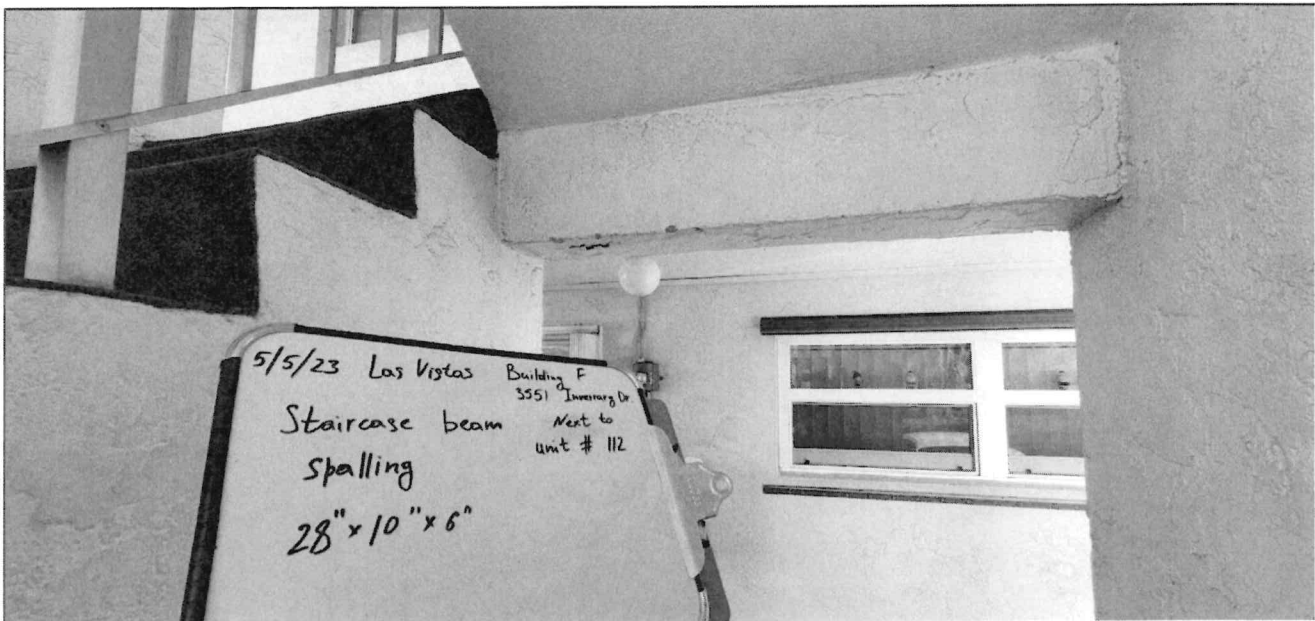
Photo 7: Concrete staircase beam spalling next to unit #112.

Spalling of the catwalk and balcony slabs was observed in multiple locations. All repairs must be performed in accordance with plans prepared by an engineer and approved by the local building department.

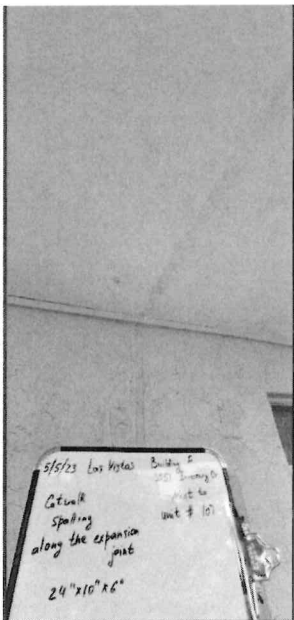
Spalling of the catwalk and balcony slabs was observed in multiple locations.

Photo 8: Concrete catwalk spalling near expansion joint next to unit #107.

The building is structurally safe for its intended use and occupancy, but requires repairs as described in the report. All repairs must be performed in accordance with plans prepared by an engineer and approved by the local building department. The carpet along the catwalks must be removed and concrete spalling repaired.

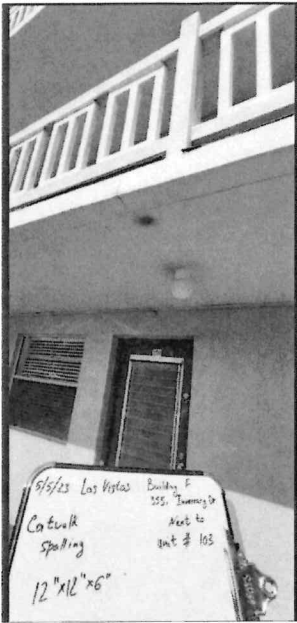
Photo 8: Concrete catwalk spalling next to unit #103

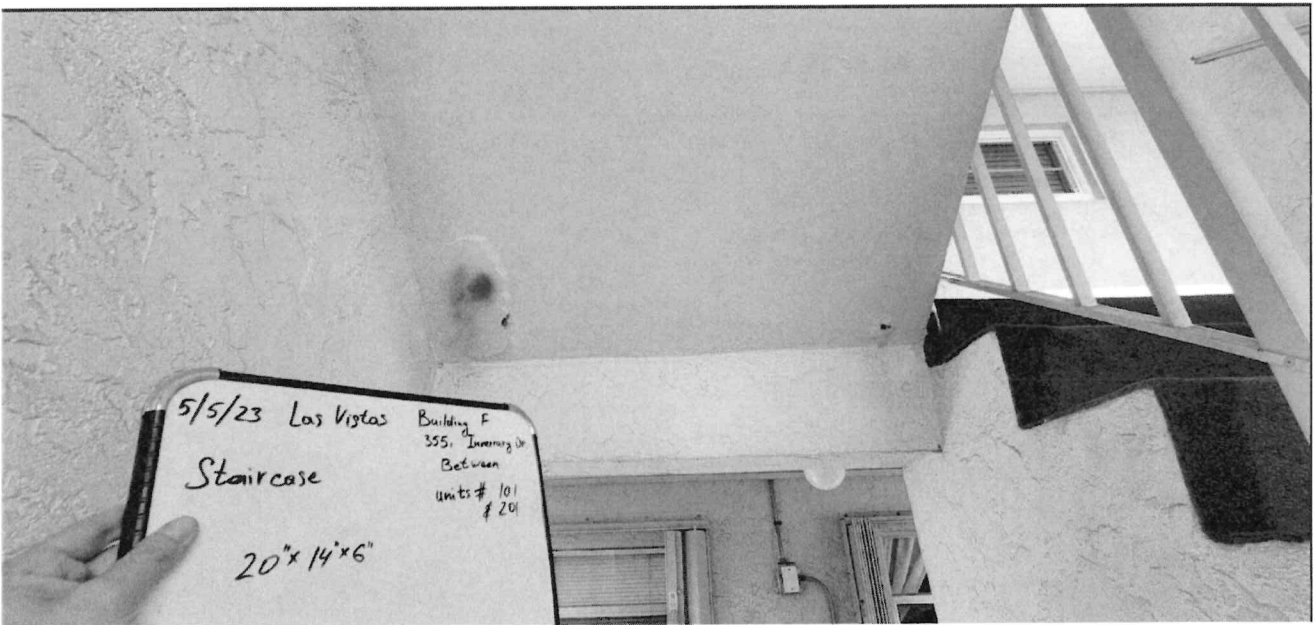
Photo 9: Concrete staircase spalling next to unit #101 and #201.

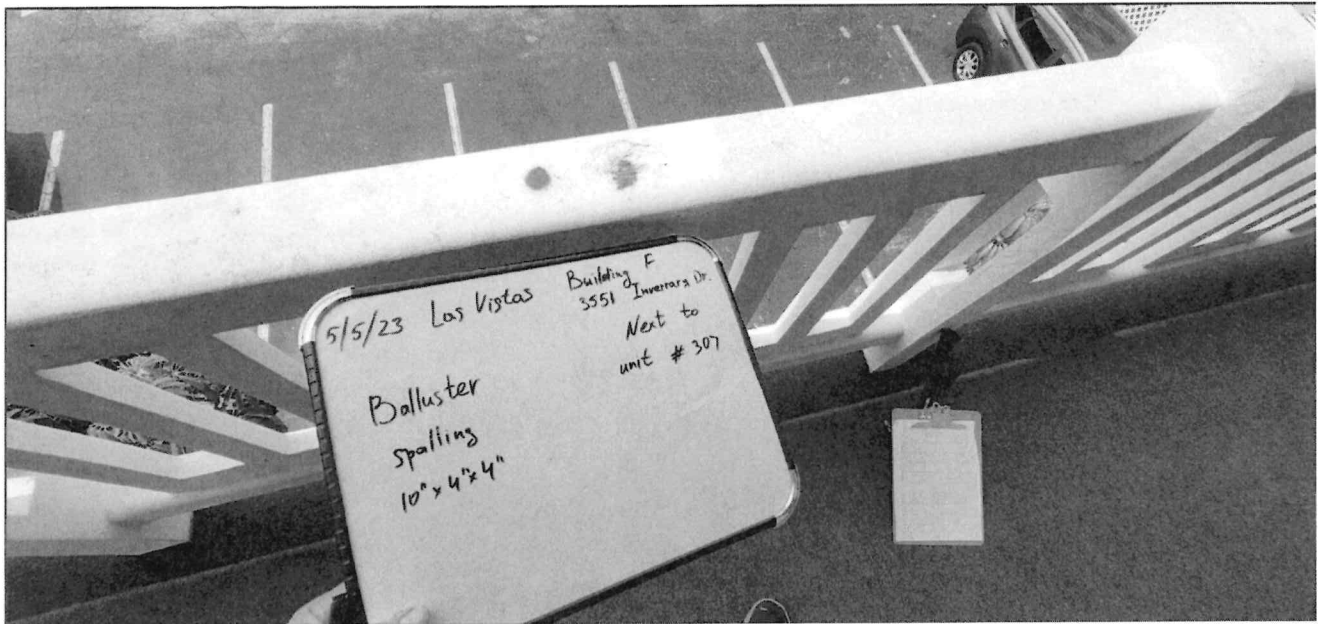
Photos 12: Concrete Rail/balustrade spalling near unit #307.
