**STRUCTURAL SAFETY INSPECTION REPORT FORM**

**1. DESCRIPTION OF STRUCTURE**a. Name on Title: LAS VISTAS IN INVERRARY CONDOMINIUM ASSOCIATION, INC.b. Street Address: 3533 Inverrary Boulevard Club House, Lauderhill, FL 33319.c. Legal Description: LAS VISTAS OF INVERRARY 80-12 B THAT PT OF TR A AS DESC IN OR 5713/166 A/K/Ad. Owner's Name: LAS VISTAS IN INVER CONDO ASSNe. Owner's Mailing Address: 3533 Inverrary Dr, Lauderhill, FL 33319-5921f. Email Address: Contact Number: Dwayne Griffin, Office Manager (954-731-8484), accounting@lasvistascondo.comg. Folio Number of Property on which building is located: 4941 23 13 0020 (Reference)h. Building Code Occupancy Classification: B FBC 2023 , Type III residentiali. Present Use: Condominium Buildingj. General Description: Type of Construction: This is a (2) story concrete building Type of Construction: IIIk. Square Footage: Approximately: 5,500 S.F. Number of Stories: (2)

Photo Report

Name: Las Vistas in Inverrary Condominium Association Inc.

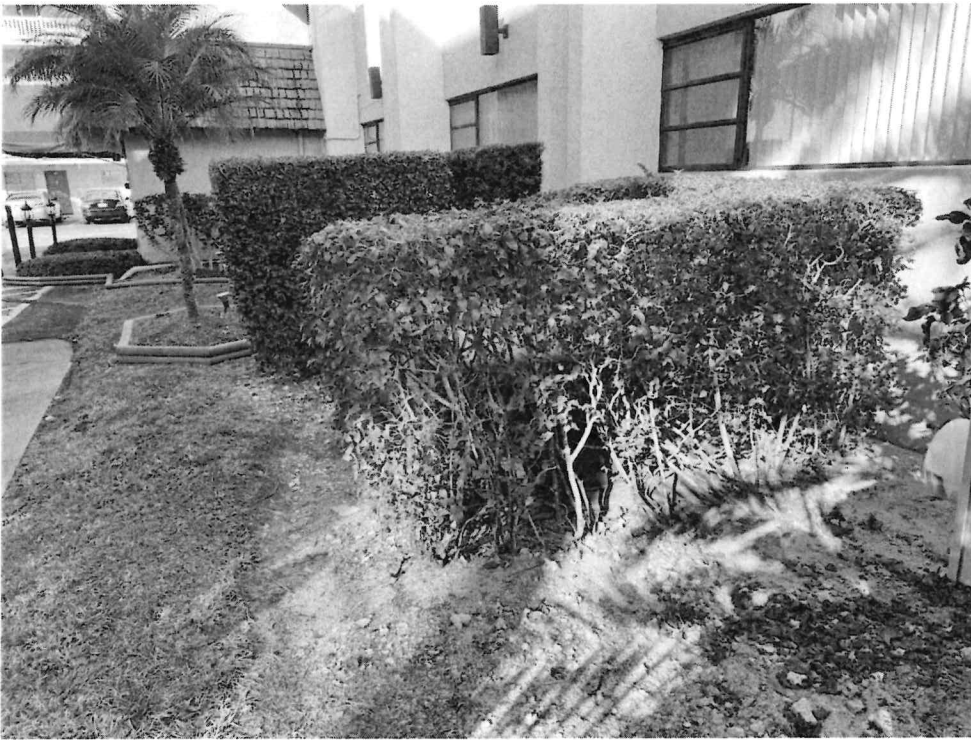
Photo 1: South Side View.

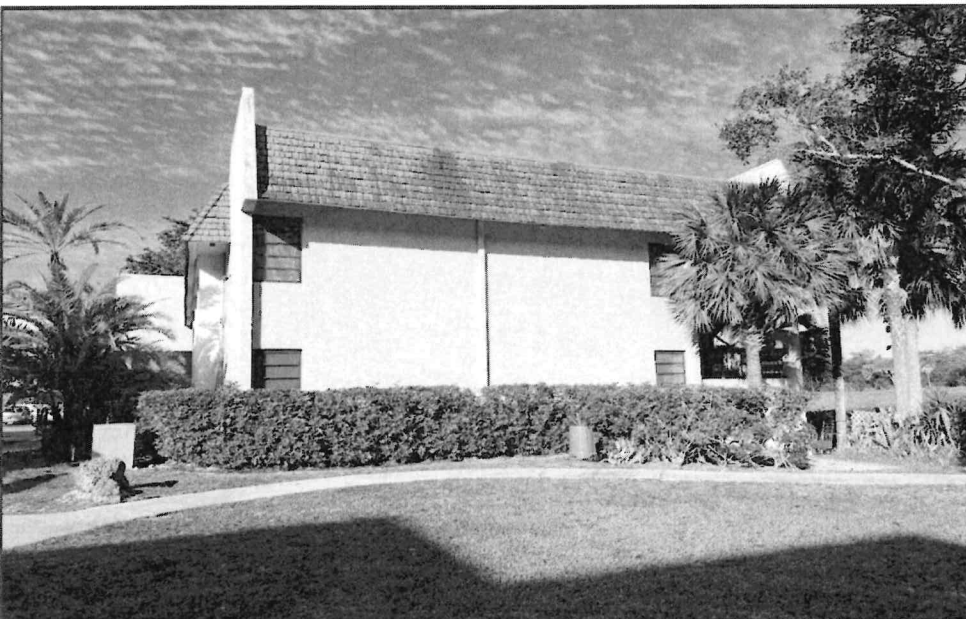
Photo 2: East Side View.

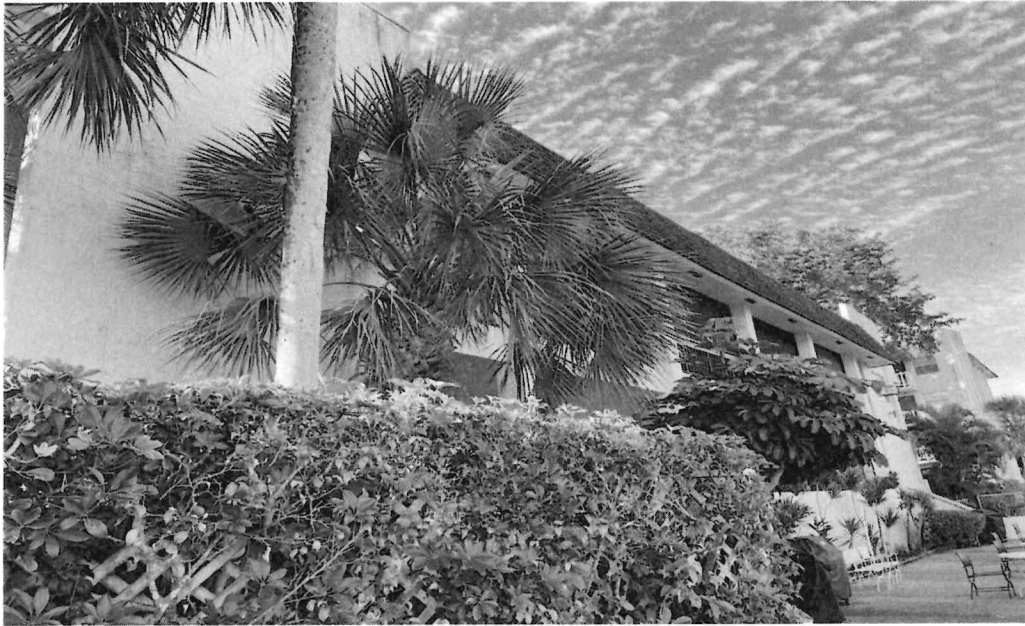
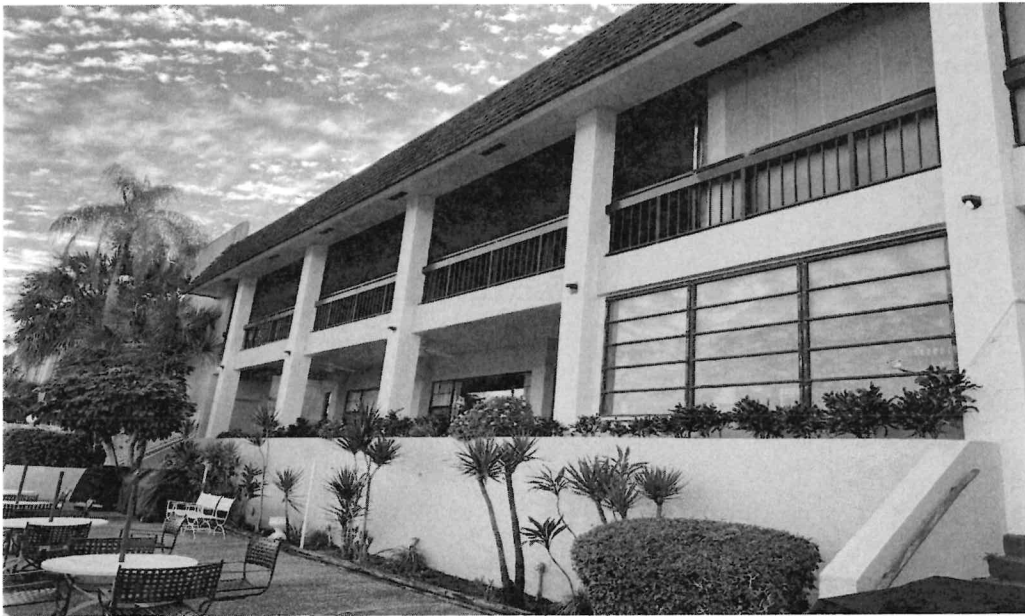
Photo 3&4: North Side view

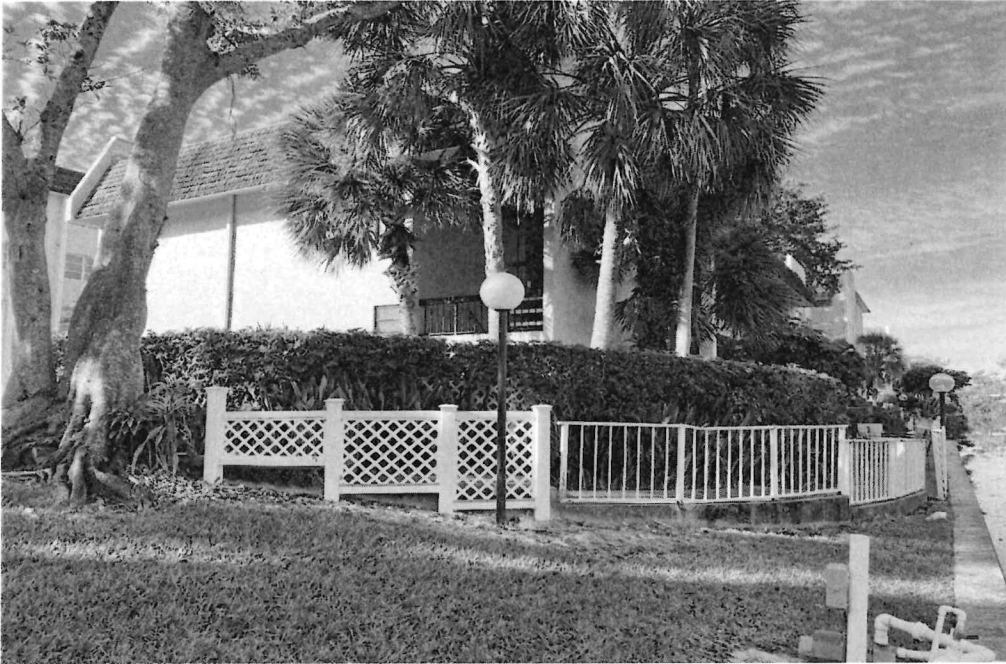
Photo 5: North East Side View.

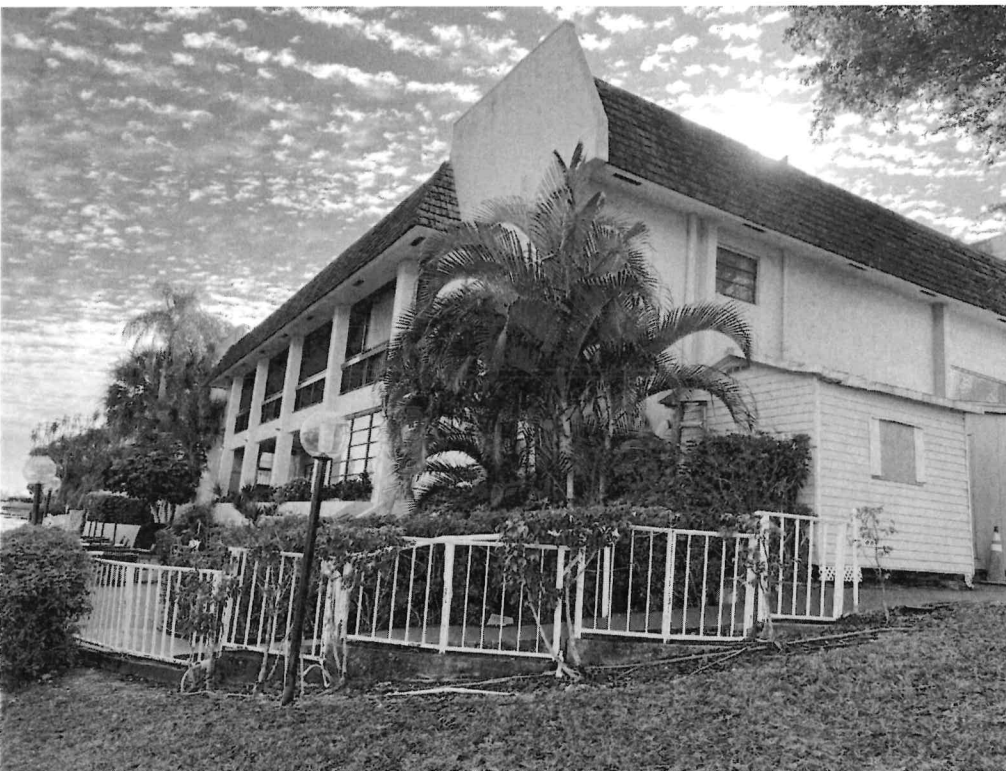
The rails at the exterior balconies and stairs are aluminum and were found in fair condition.

Photo 6: West Side View. Notice aluminum guardrails at balconies.

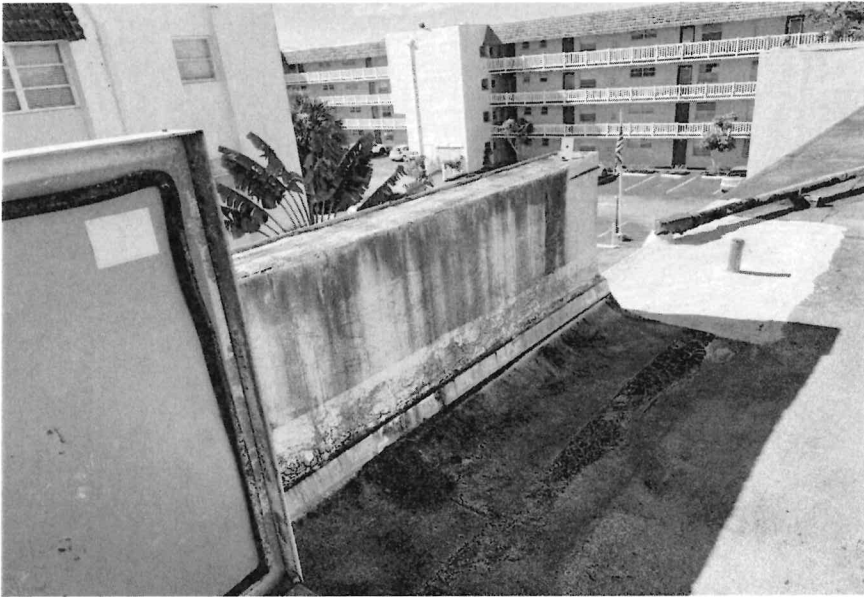
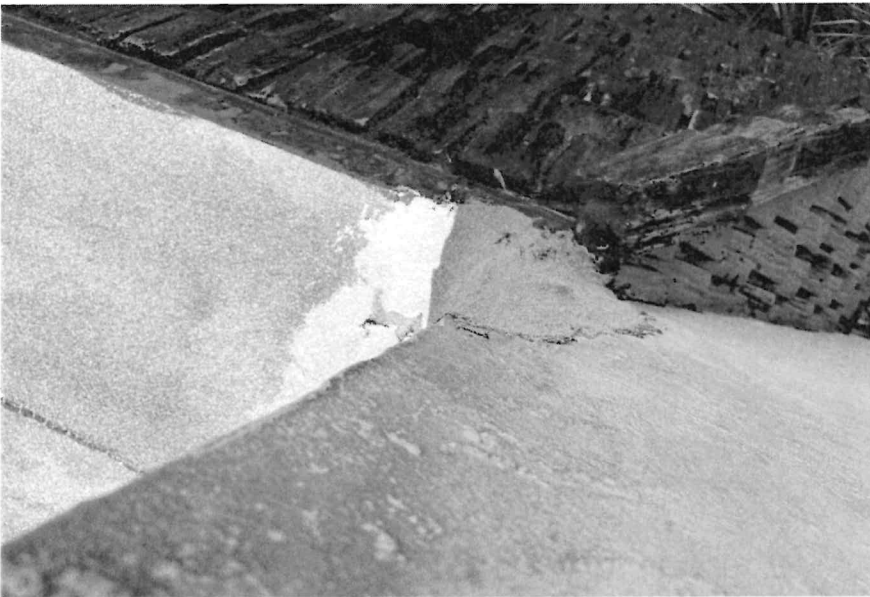
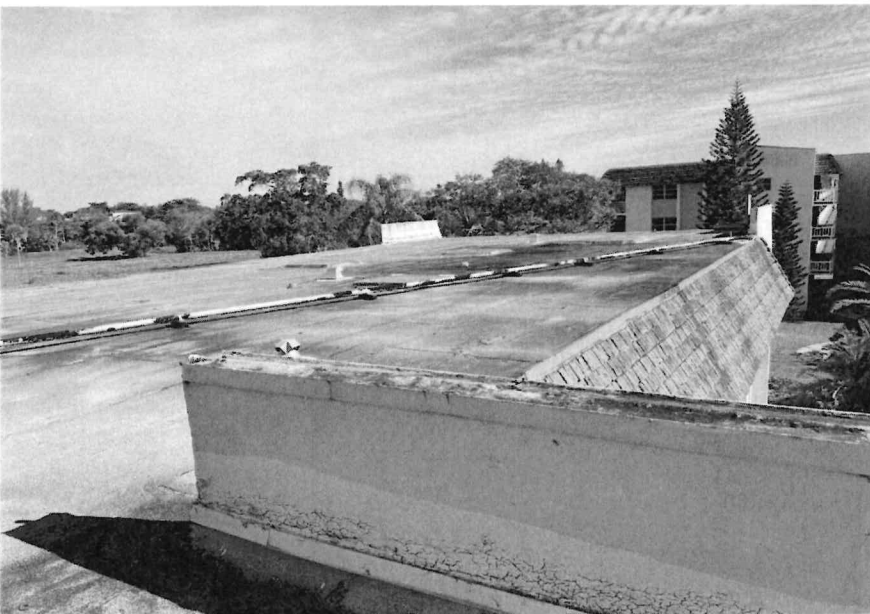
Flat roof with no parapets , interior drains , water ponding and draining thru the interior drains and over the edge, Found in fair condition.

Photos: 7&8&9: Roof View. No overflows observed.Found Roof drains.

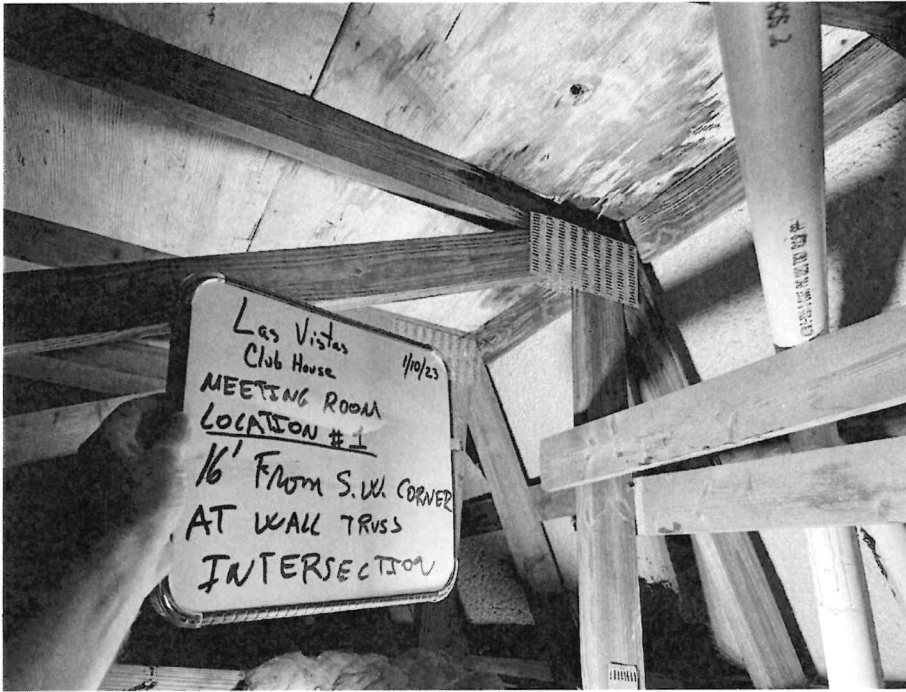
The concrete tile roof along the mansard roof was observed generally in fair condition. Although there was limited access To confirm the condition of the underlying structural system, No major visible deficiencies were noted during the inspection, with the exception of certain wood trusses found damaged due to water leaks as well as damaged wood deck..

Photo 10: Meeting room location #1. Observed damaged wood top truss chord and wood deck due to water leaks.

Spalling of the balcony slabs was observed in multiple locations. All repairs must be performed in accordance with plans prepared by an engineer and approved by the local building department. Also repairs are required to sloped mansard roof wood trusses due to certain damaged wood trusses, chords and plywood deck sheathing.

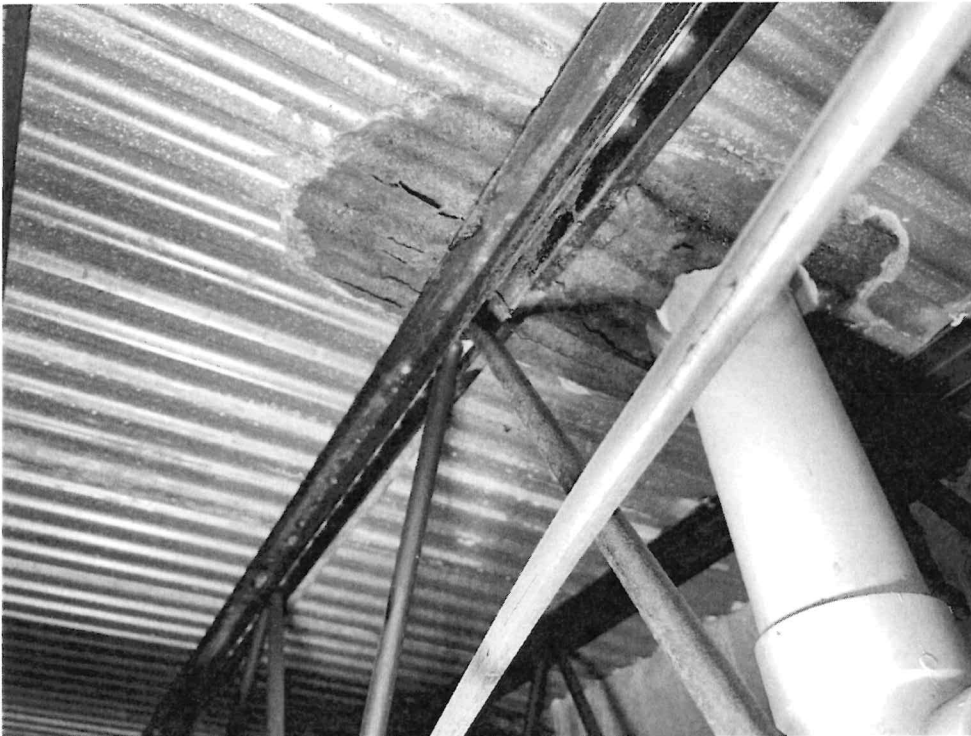
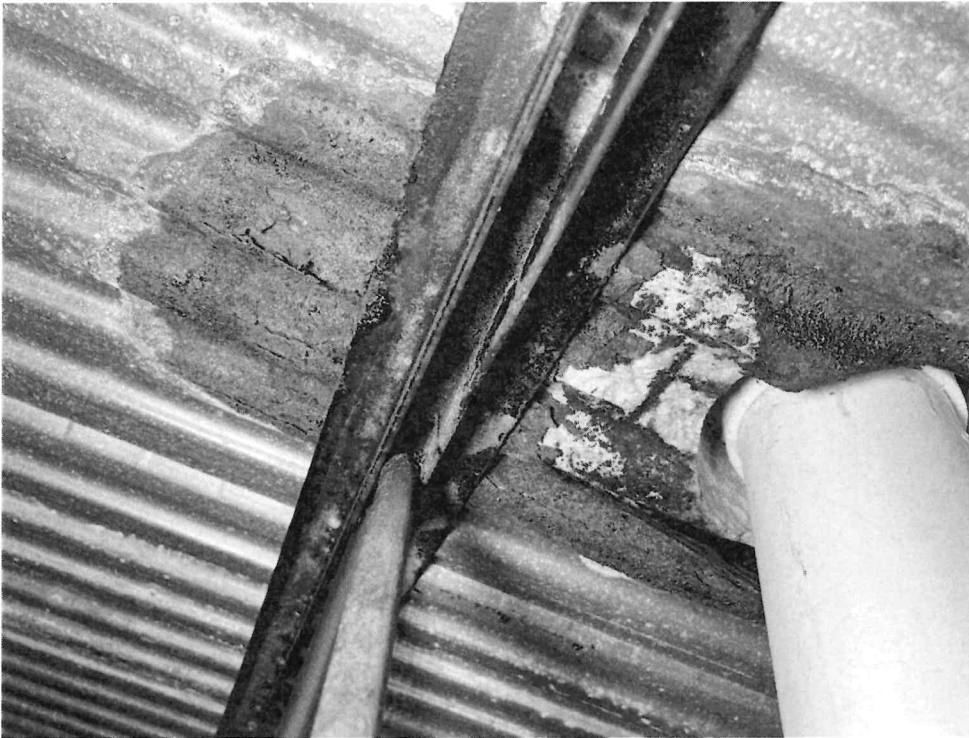
This is a concrete building. The open steel web joists were found in fair condition, however there were sections of the Corrugated steel roof deck found rusted especially at PVC pipe penetrations.

Photos: 11&12: Rusty flat roof corrugated metal deck that must be repaired or replaced.  
Also observed rusty open web steel joist top section.

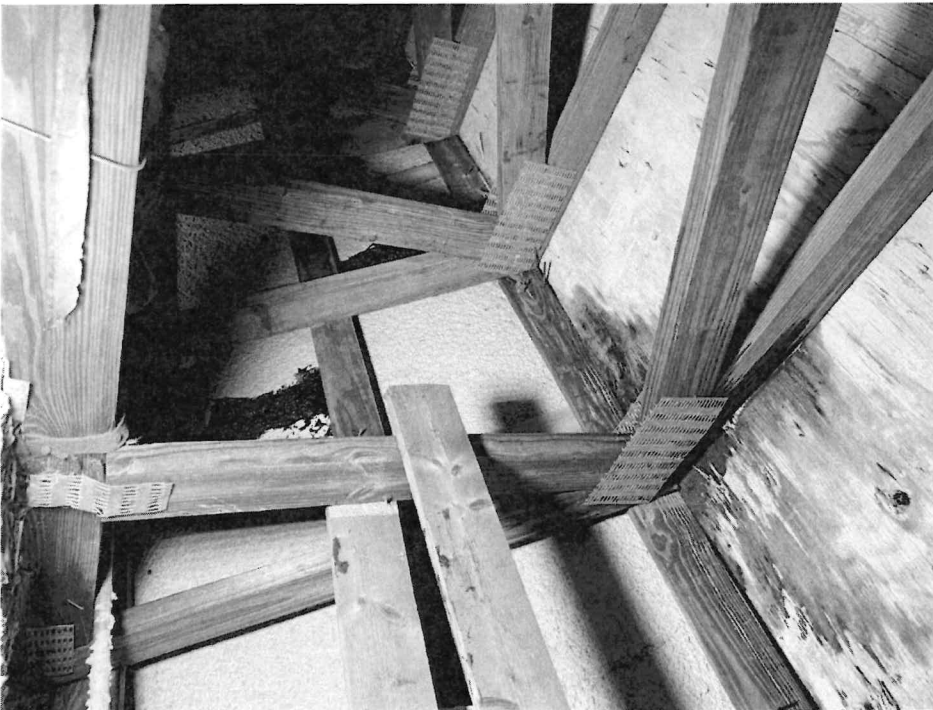
Photo 13: Repair damaged plywood. Observed damaged wood top truss chord and wood deck due to water leaks.

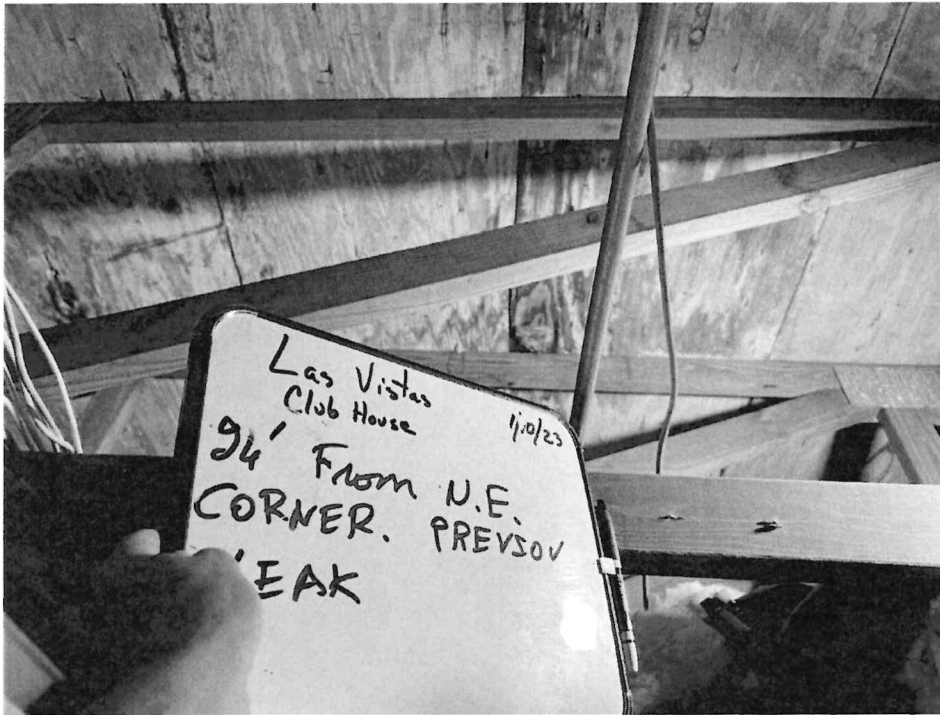
Photo 14: 24' Photo from N.E. Corner attic. Observed damaged wood top truss chord and plywood deck due to water leaks.

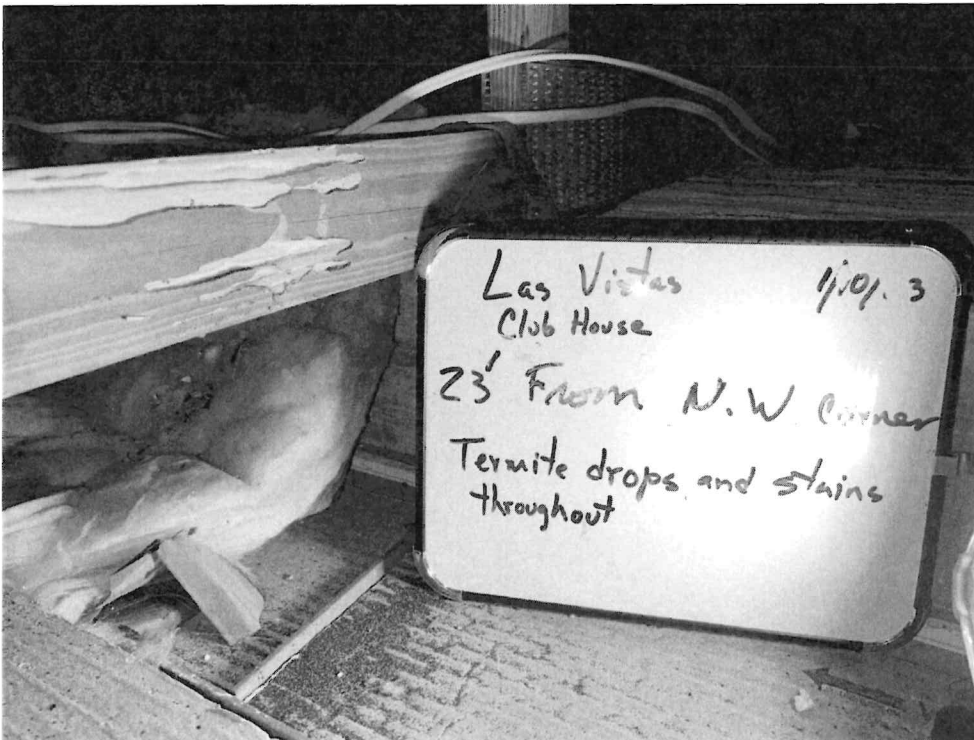
Photos: 15: 23' From N.E. Corner, observed signs of termite activity, wood termite damage and stains throughout. Repairs are required.

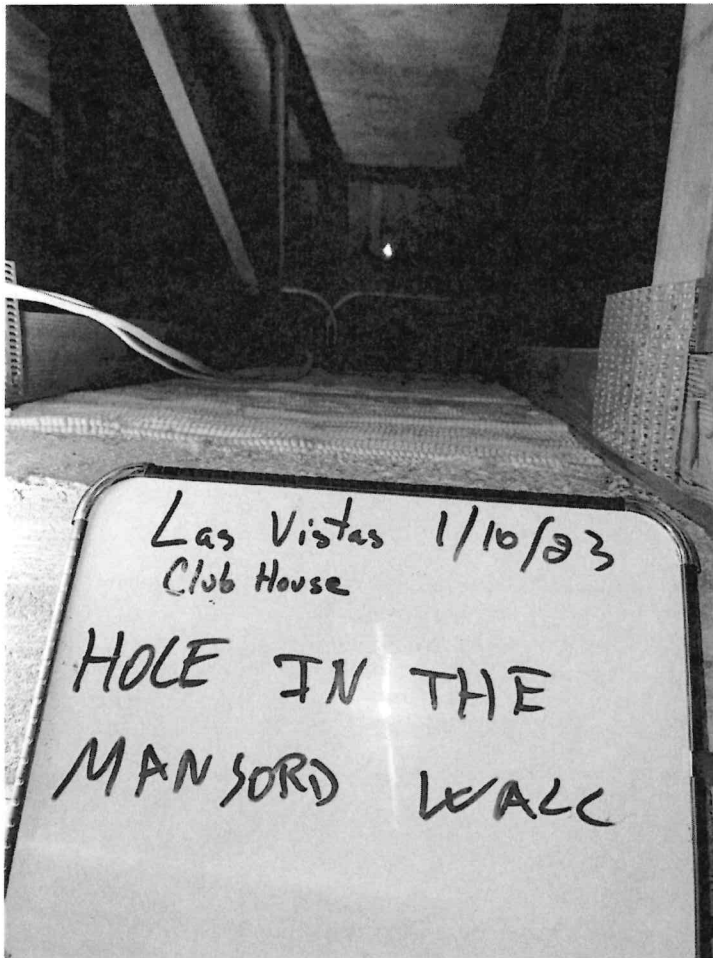
Photo 16: Observed a hole in the mansard wall, repair required.

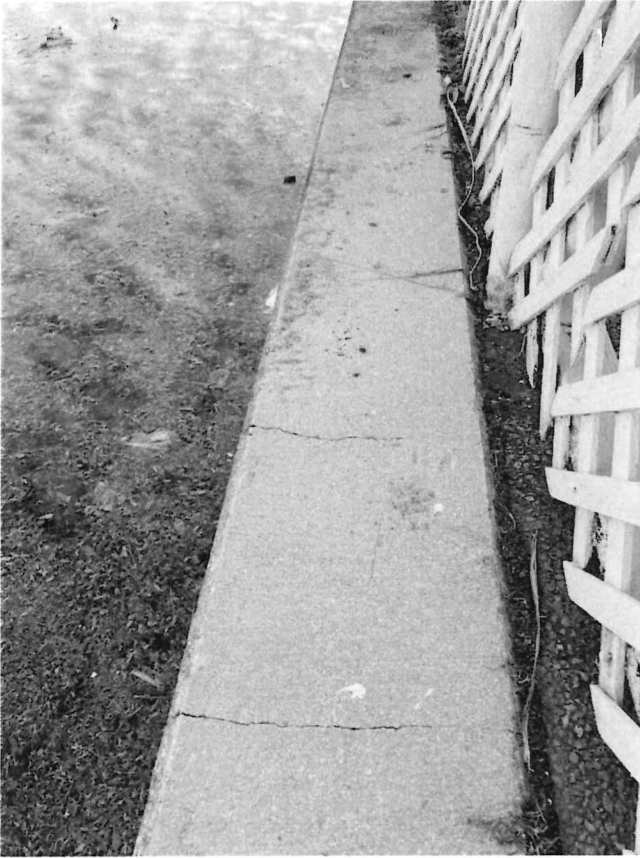
No cracks were observed and any hairline cracks if present were not noticeable. However, cracks were observed along the concrete Sea wall cap, which will require repairs.

Observed concrete sea wall along the north side with evidence of surface cracks along the top concrete cap. Repairs required.

Photo 17: Sea wall: observed several cracks at top of concrete cap north side. Repairs required to seal cracks.

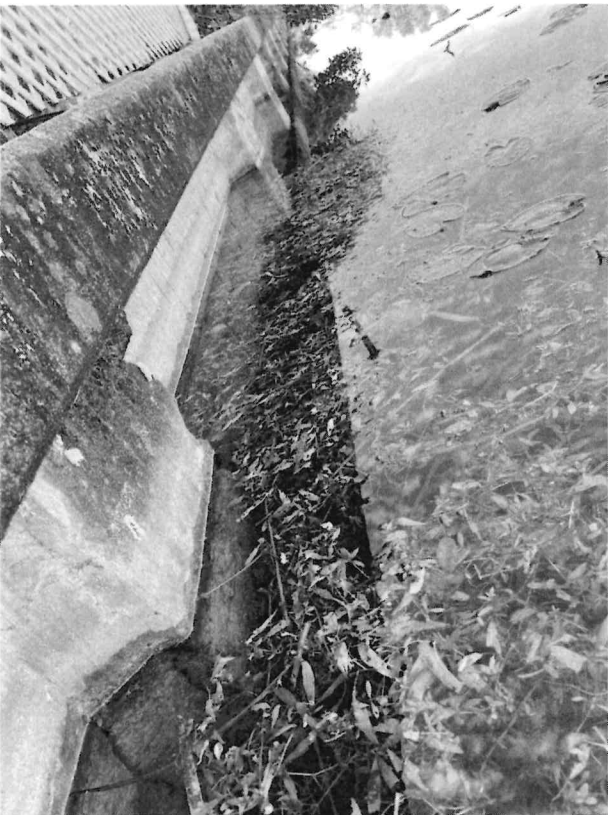
The concrete sea wall along the north side of the club house was found in fair condition.

Photo 18: Sea wall at North side.
