# AKOURI CONSULTING ENGINEERS

RE Summary of repairs and recommendations obtained from the Milestone Phase 1 and 2  
for the building located at:

Las Vistas in Inverrary Condominium Association Inc.  
3776 Inverrary Boulevard Bldg R, Lauderdale, FL 33319

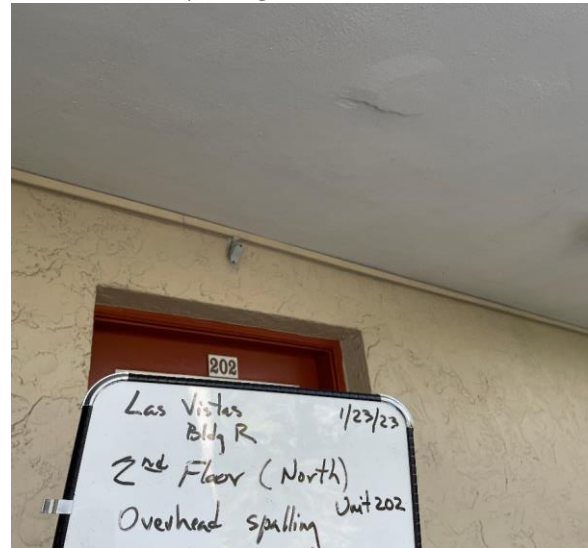
Overhead spalling in front of unit 202

The listed deficiencies below must be corrected in accordance with a concrete restoration bid package prepared by a structural engineer and approved by the Local Building Department.

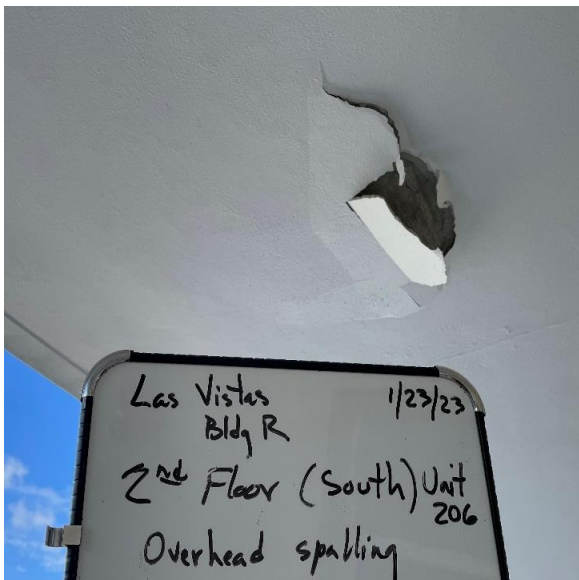
Overhead spalling in front of unit 206

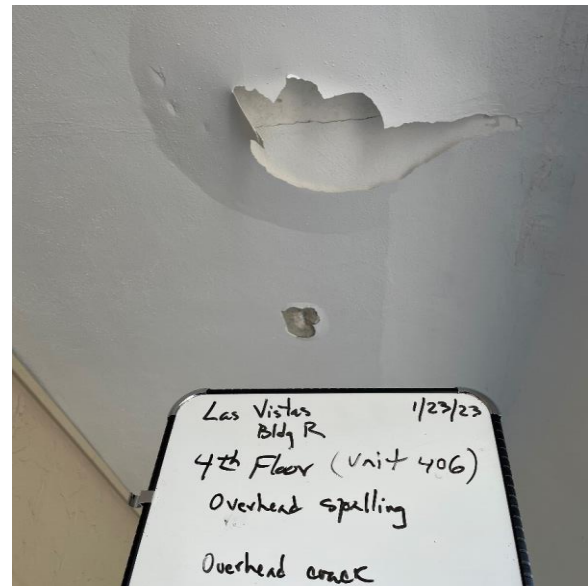
Overhead spalling in front of unit 406

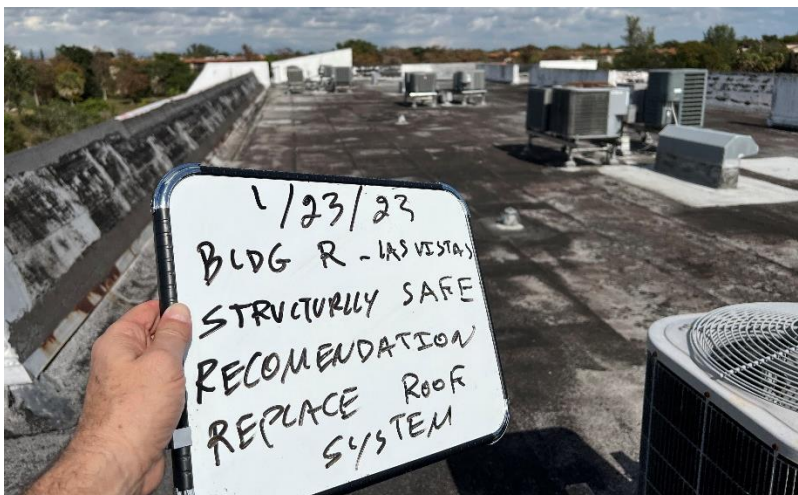
Roof with no remaining life (parapet walls and roof in poor conditions)
