# AKOURI CONSULTING ENGINEERS

RE Summary of repairs and recommendations obtained from the Milestone Phase 1 and 2 for  
the building located at:

Las Vistas in Inverrary Condominium Association Inc.  
3511 Inverrary Dr Bldg K, Lauderdale, FL 33319

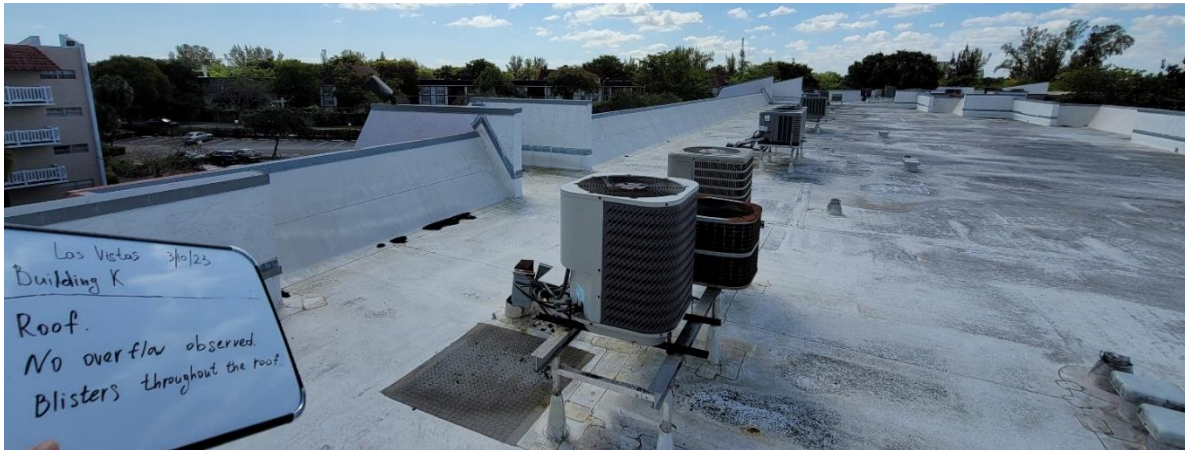
Roof: Blisters were observed throughout the roof. It must be replaced.

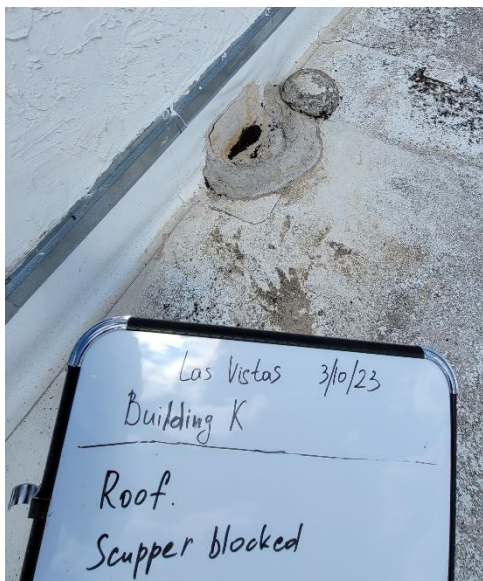
Roof (scupper blocked)
