**STRUCTURAL SAFETY INSPECTION REPORT FORM**

**1. DESCRIPTION OF STRUCTURE**a. Name on Title: LAS VISTAS IN INVERRARY CONDOMINIUM ASSOCIATION, INC.b. Street Address: 3541 Inverrary Dr Lauderhill, FL, 33319c. Legal Description: LAS VISTAS G IN INVERRARY CONDO UNIT 101 PER CDO BK/PG: 5956/267d. Owner's Name: LAS VISTAS IN INVER CONDO ASSNe. Owner's Mailing Address: 3541 Inverrary Dr., Lauderhill, FL 33319. Building G.f. Email Address: Contact Number: Dwayne Griffin, Office Manager (954-731-8484), accounting@lasvistascondo.comg. Folio Number of Property on which building is located: 4941 23 CH 0010 (Reference)h. Building Code Occupancy Classification: R FBC 2023, Type III residentiali. Present Use: Condominium Buildingj. General Description: Type of Construction: This is a (3) story concrete building Type of Construction: IIIk. Square Footage: Approximately: 11,795 SF Number of Stories: (3)

## Photo Report

Property Address: 3541 Inverrary Dr., Lauderhill, FL 33319. **Building G.**

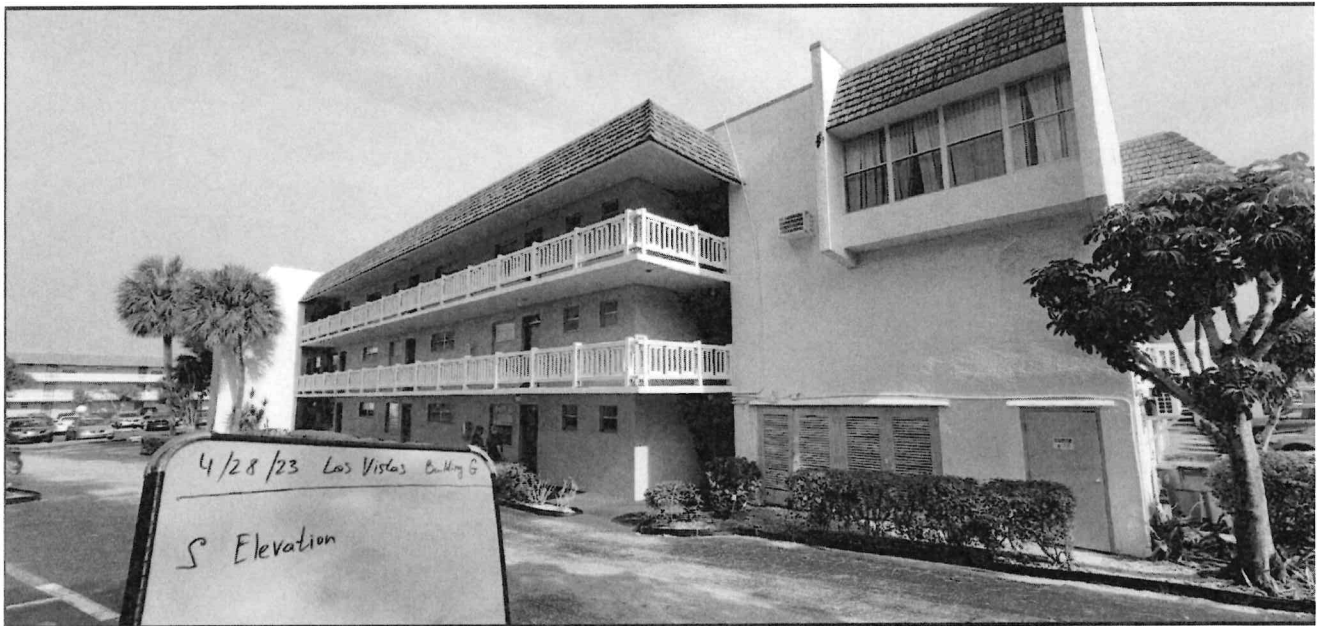
Photo 1: South Side View.

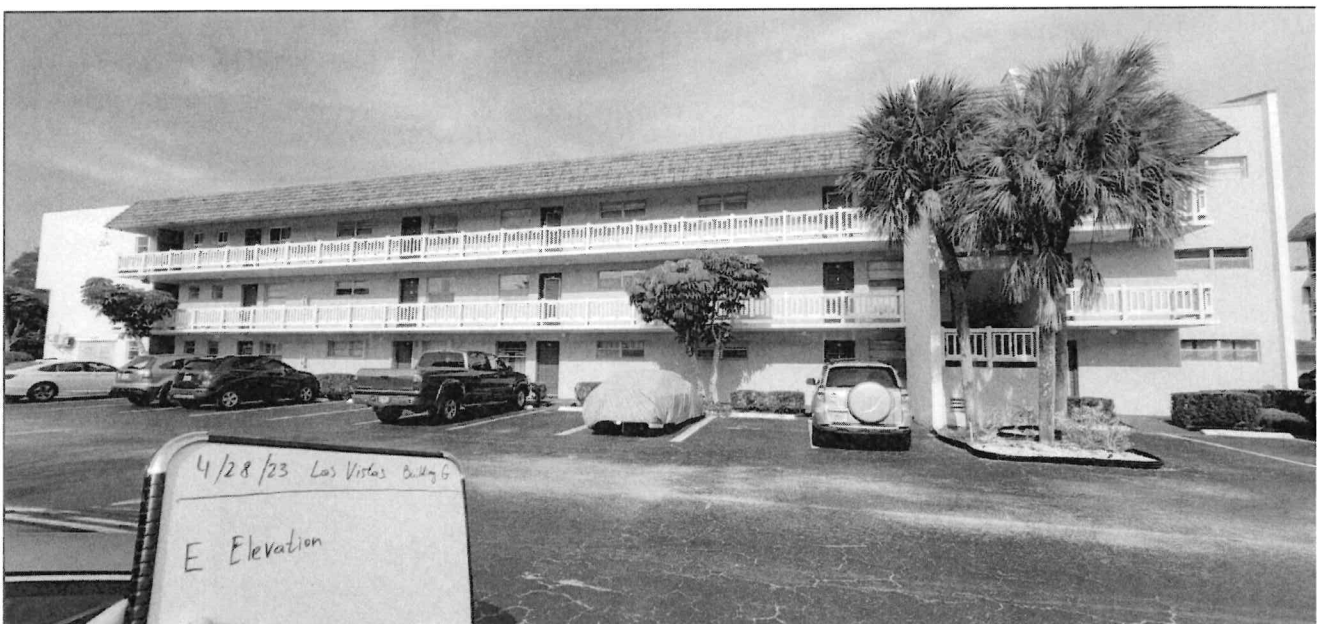
Photo 2: East Side View.

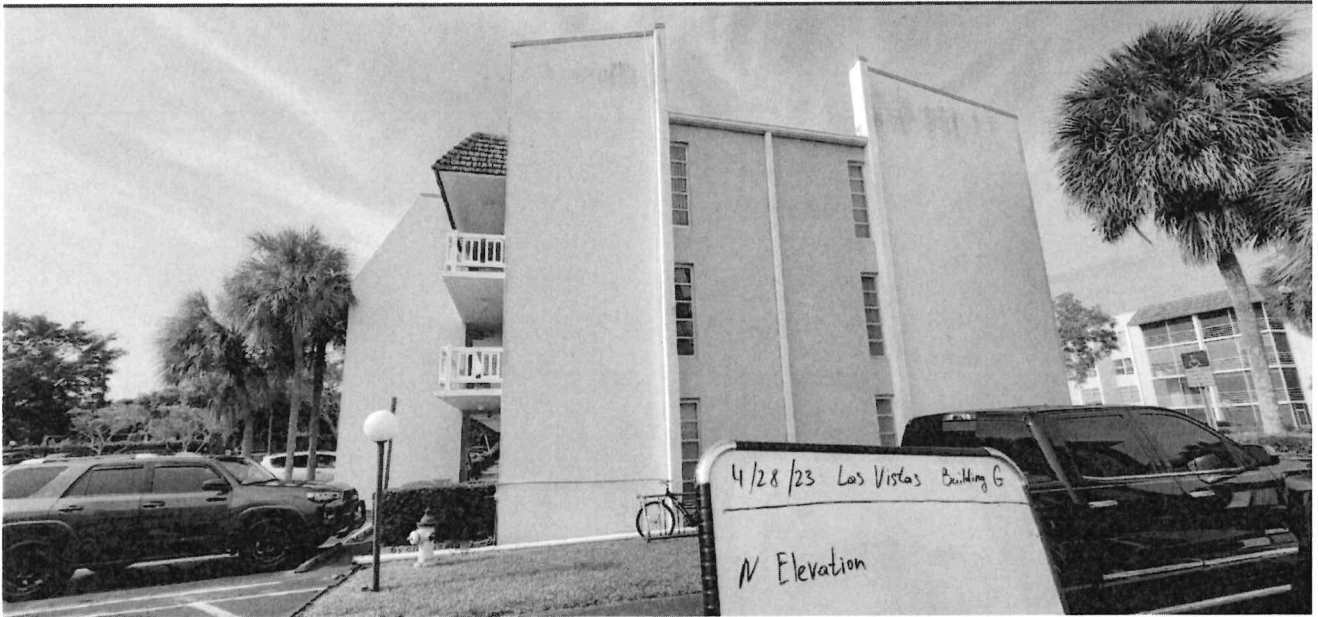
Photo 3: North Side View.

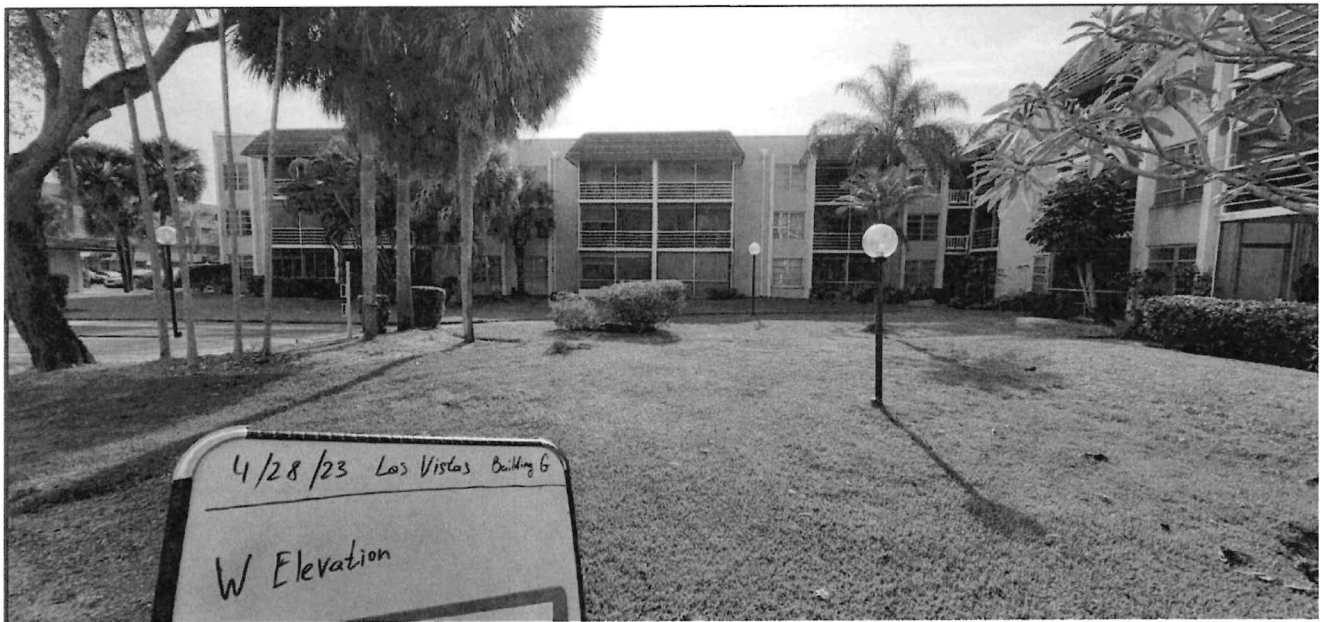
Photo 4: West Side View.

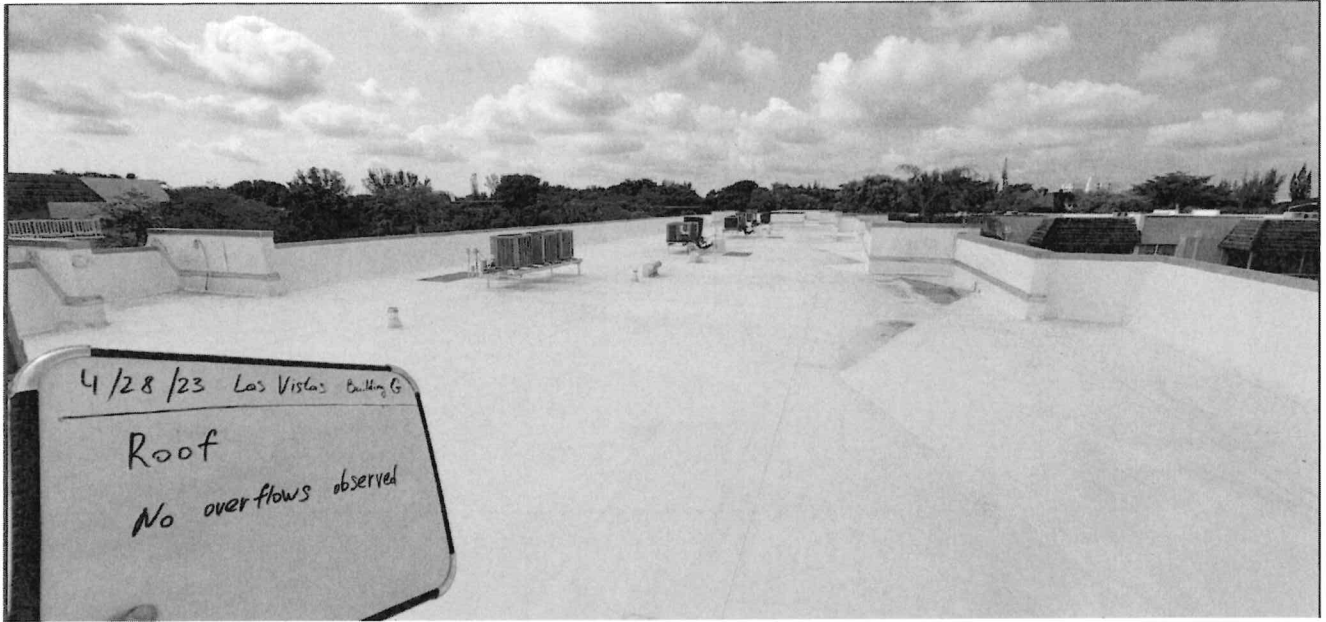
Photo 5: Roof View. No overflows observed.

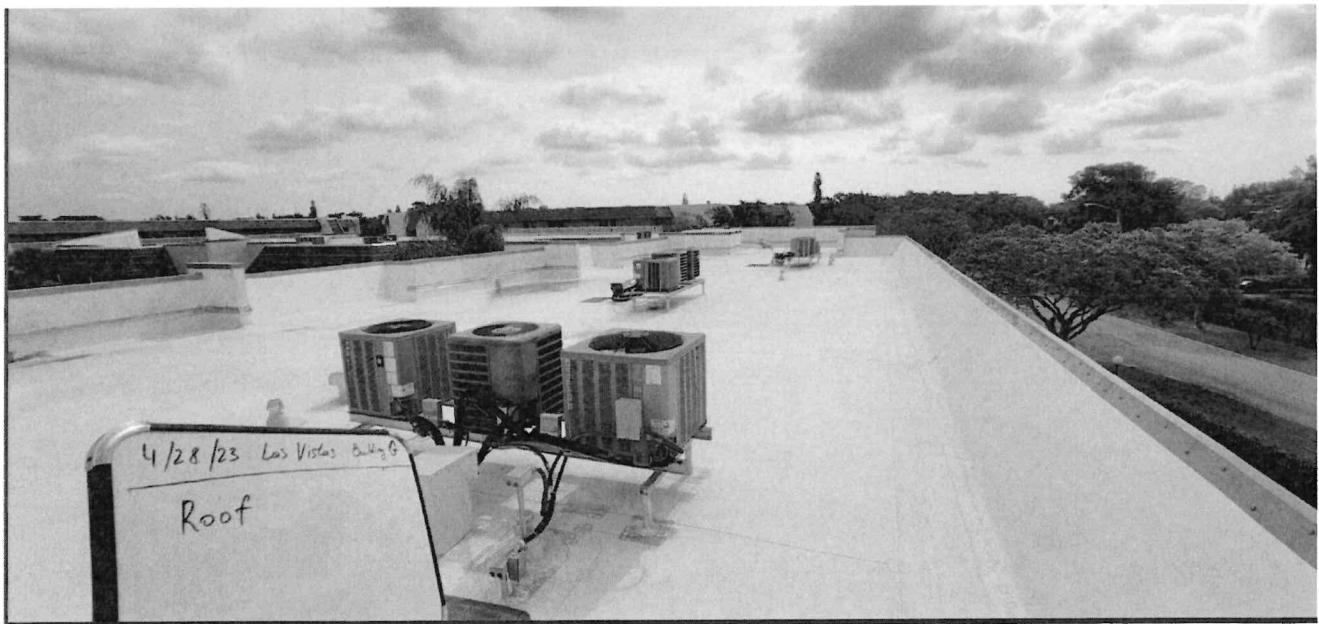
Photo 6: Roof View. No overflows observed.

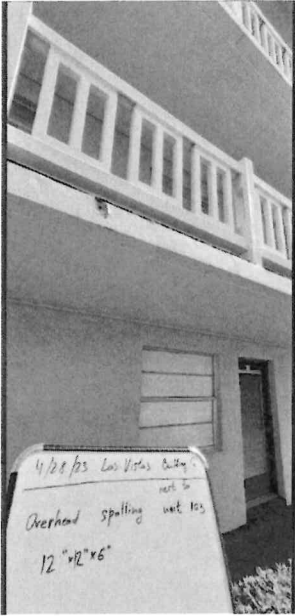
Photo 7: Concrete catwalk edge spalling next to unit #103.

The building is structurally safe for its intended use and occupancy, but requires repairs as described in the report. All repairs must be performed in accordance with plans prepared by an engineer and approved by the local building department. The carpet along the catwalks must be removed and concrete spalling repaired.

Spalling of the catwalk and balcony slabs was observed in multiple locations. All repairs must be performed in accordance with plans prepared by an engineer and approved by the local building department.

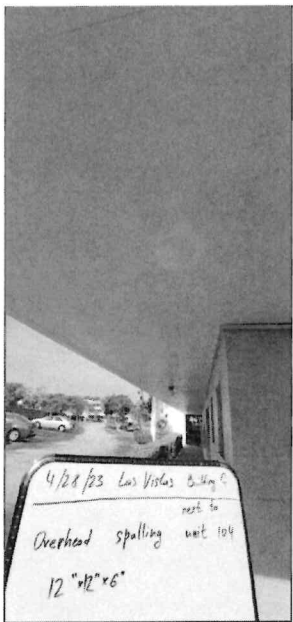
Photo 8: Concrete catwalk overhead spalling next to unit #104.

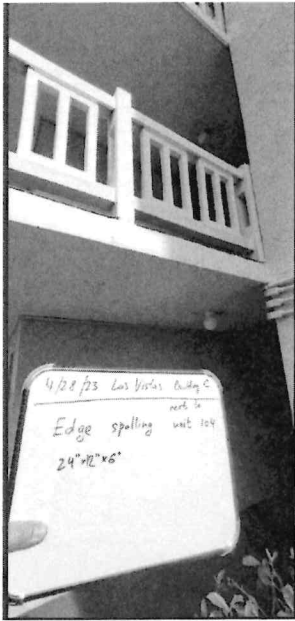
Photo 8: Concrete catwalk edge spalling next to unit #104.

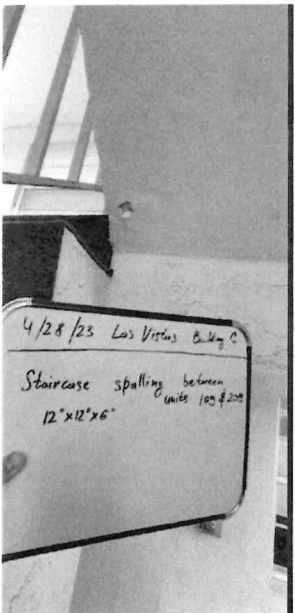
The exterior concrete stairs were observed in fair condition. However, spalled sections were found at multiple locations.

Photo 9: Concrete staircase spalling next to unit #109 and #209.
