RE Summary of repairs and recommendations obtained from the Milestone Phase 1 and 2  
for the building located at:

Las Vistas in Inverrary Condominium Association Inc.  
3533 Inverrary Boulevard Club House, Lauderdale, FL 33319

This letter summarizes the findings from the full milestone report. For more details, please refer to the report itself.

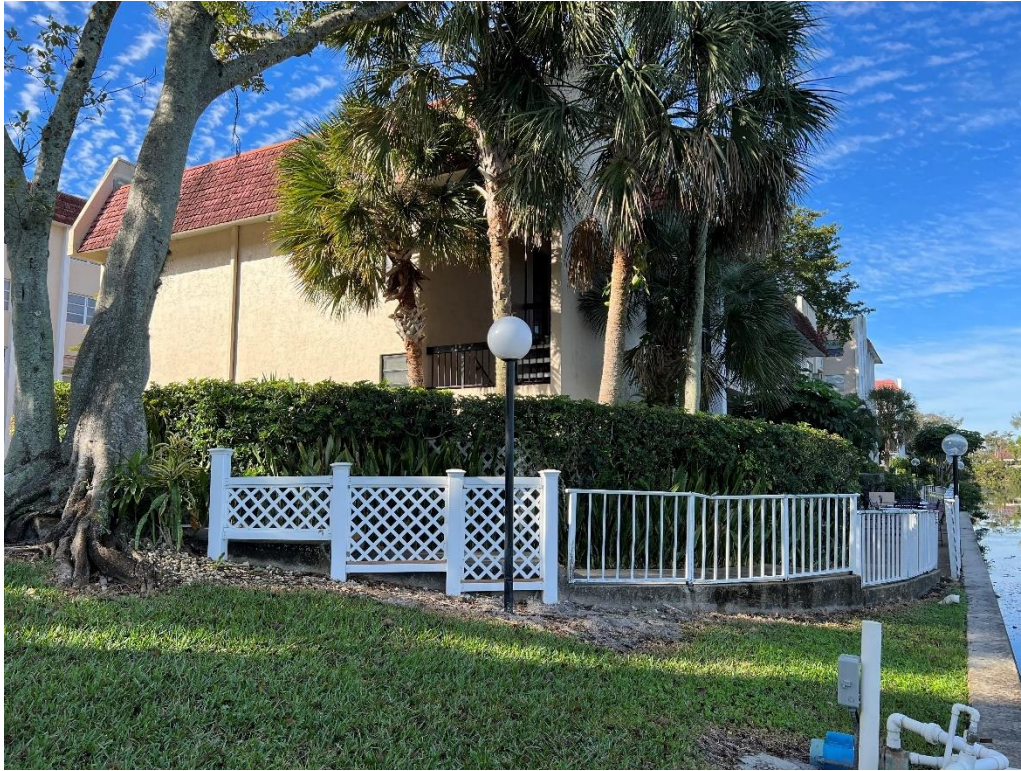
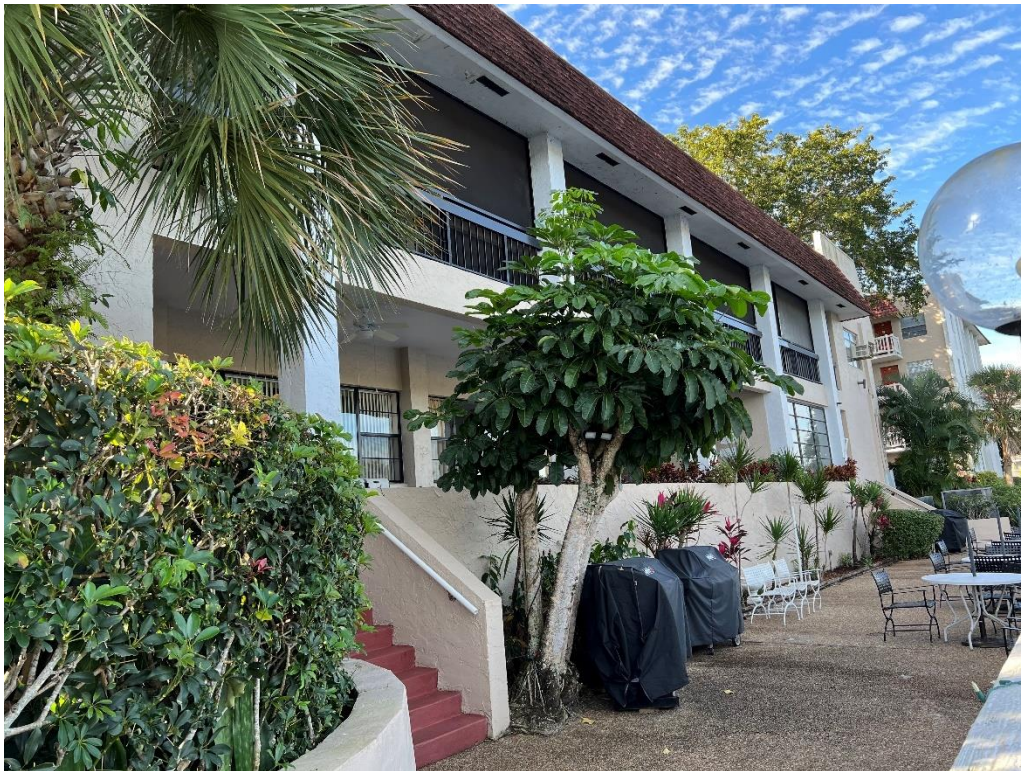
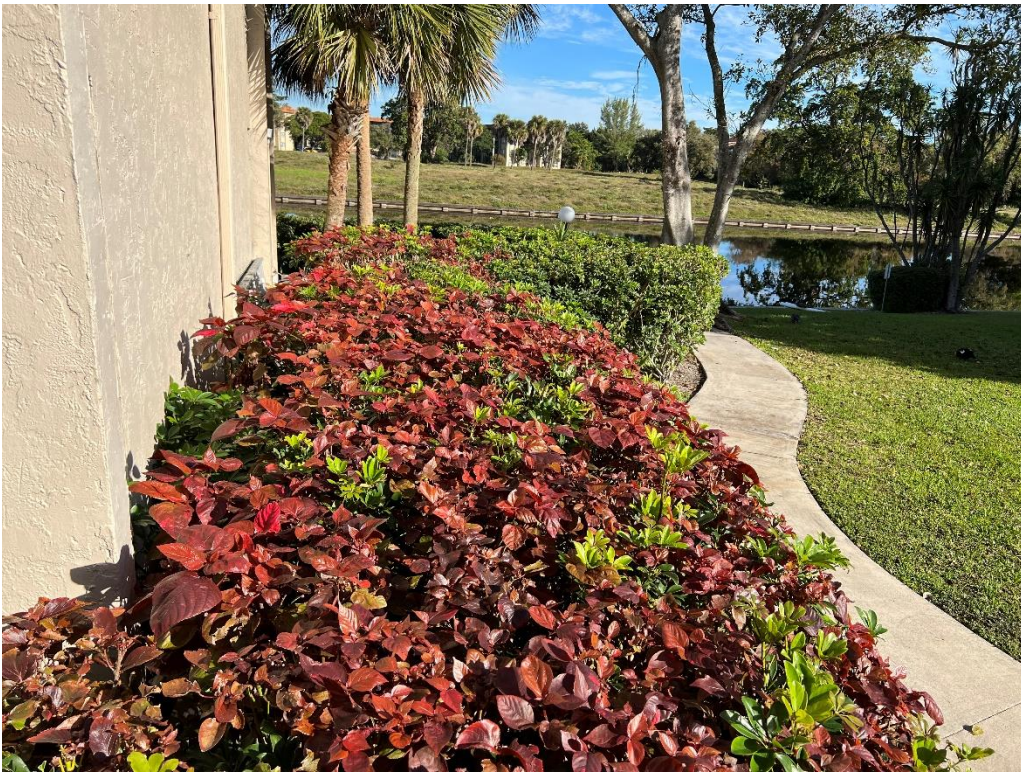
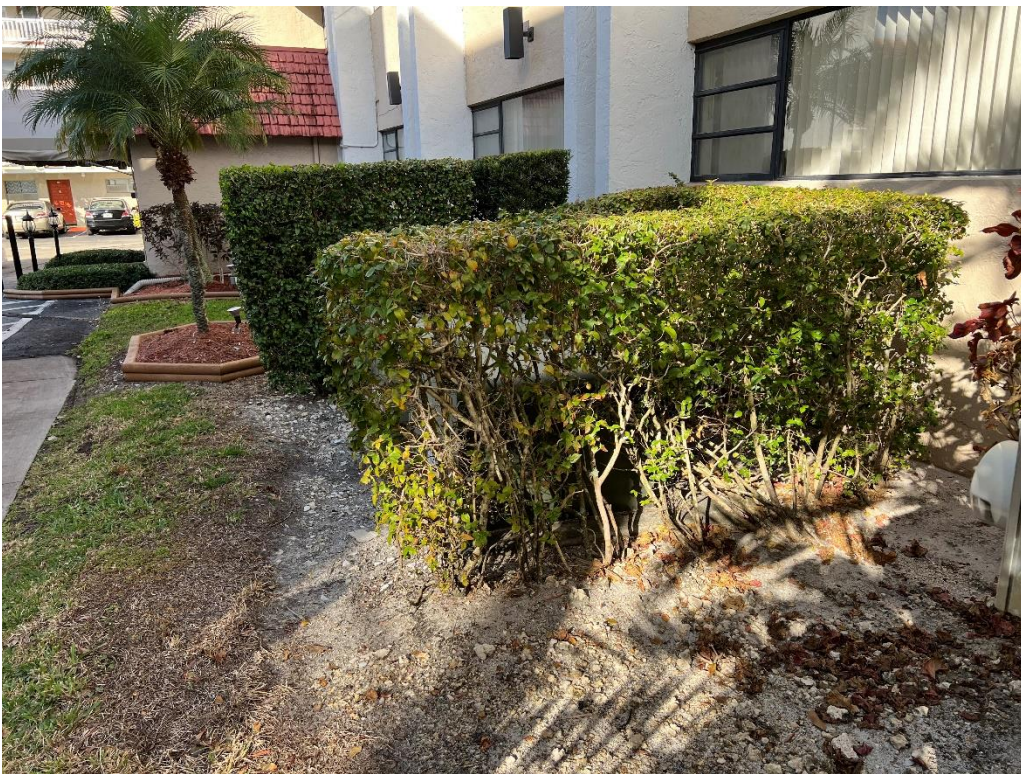
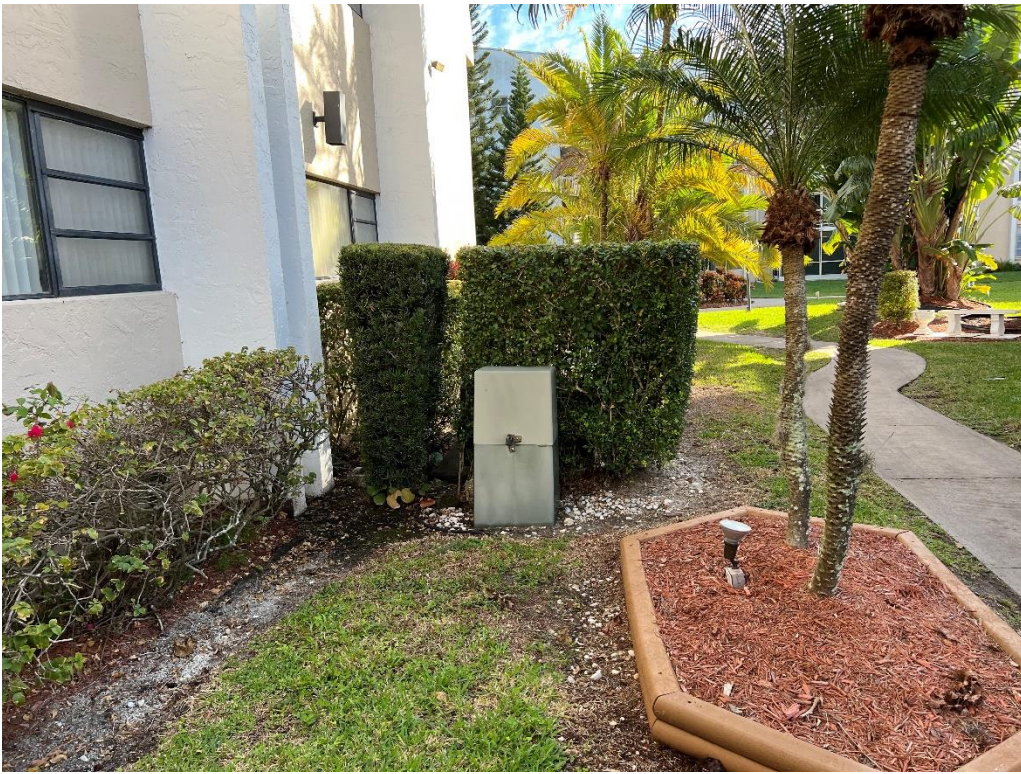
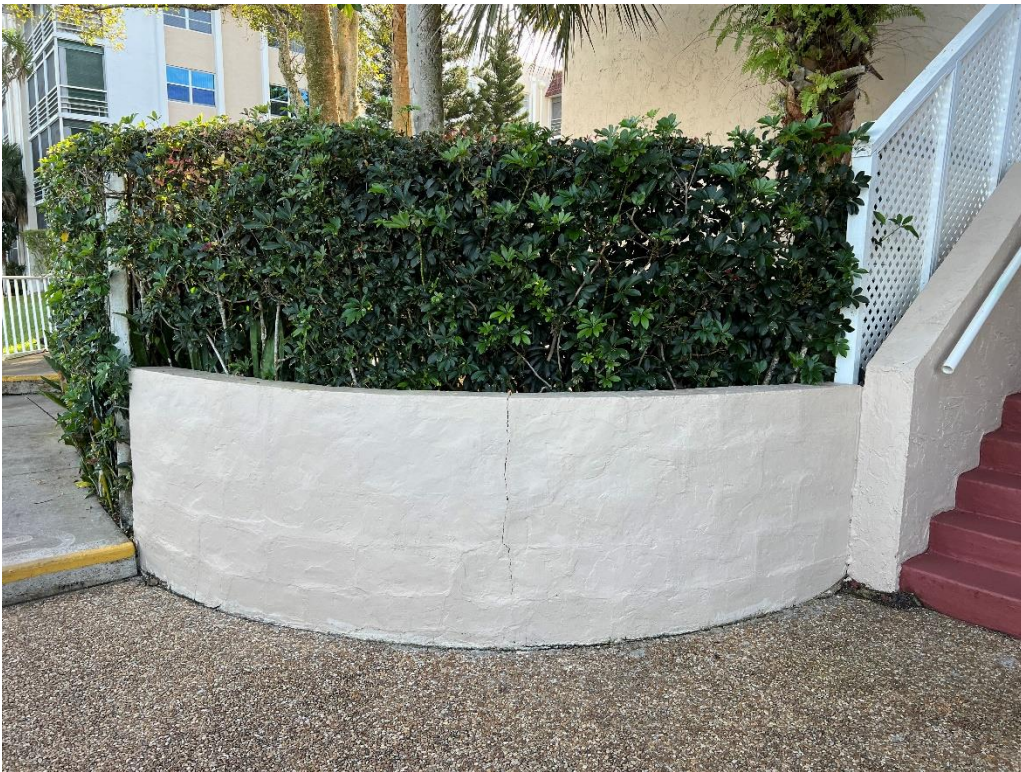
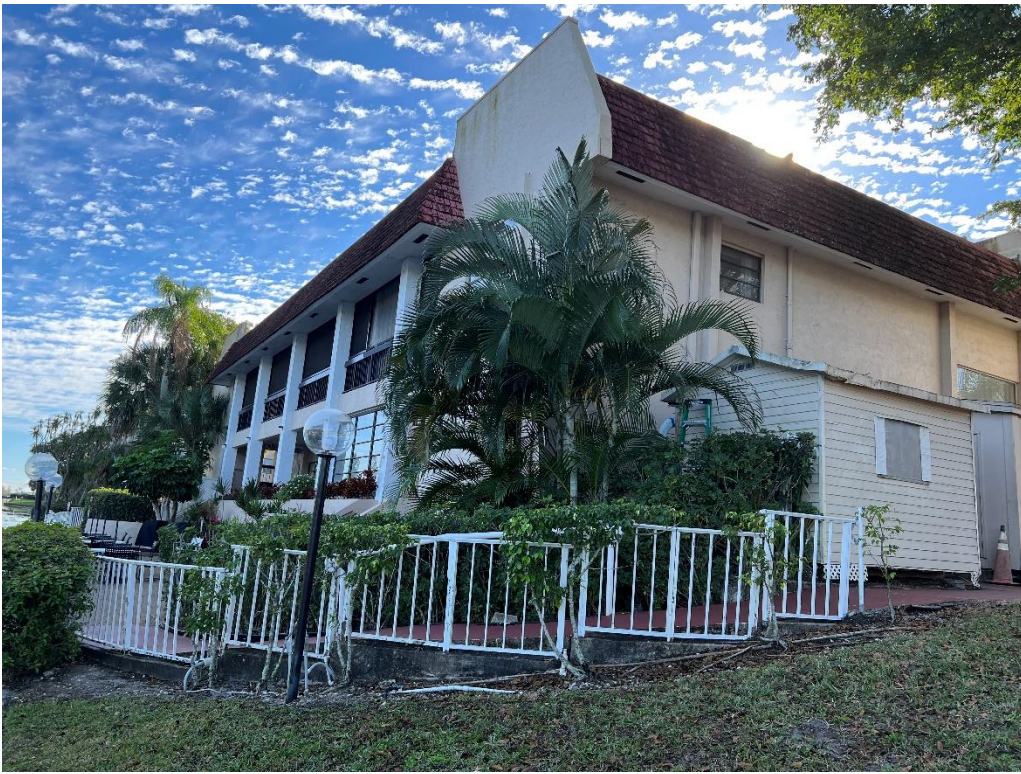
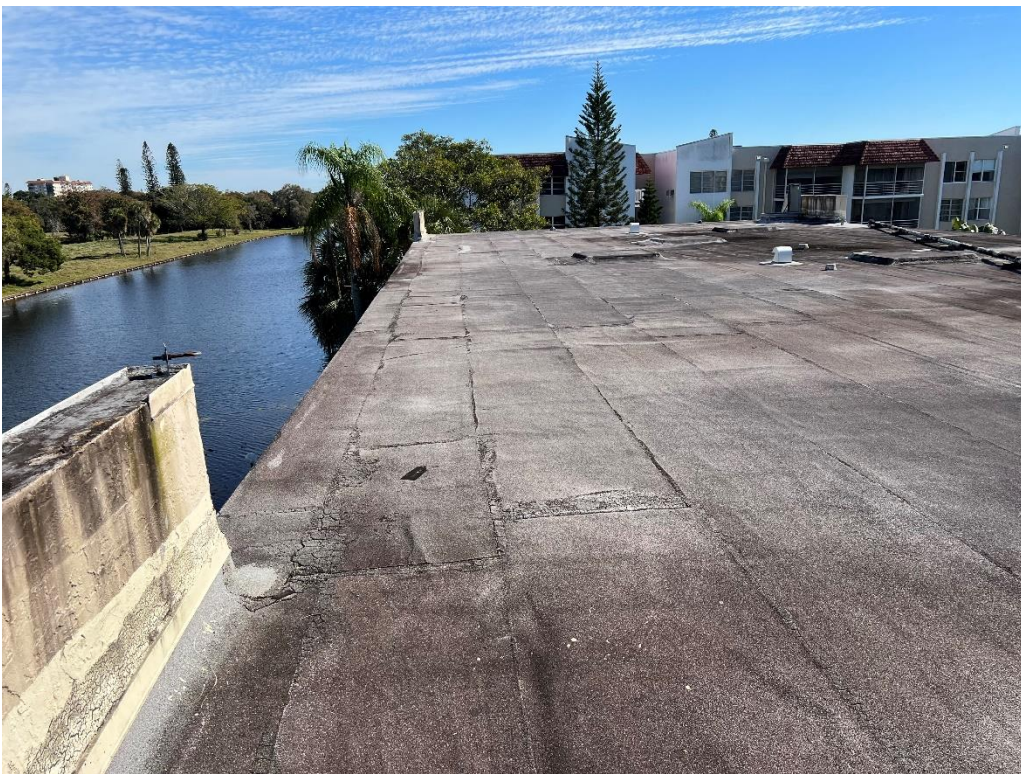
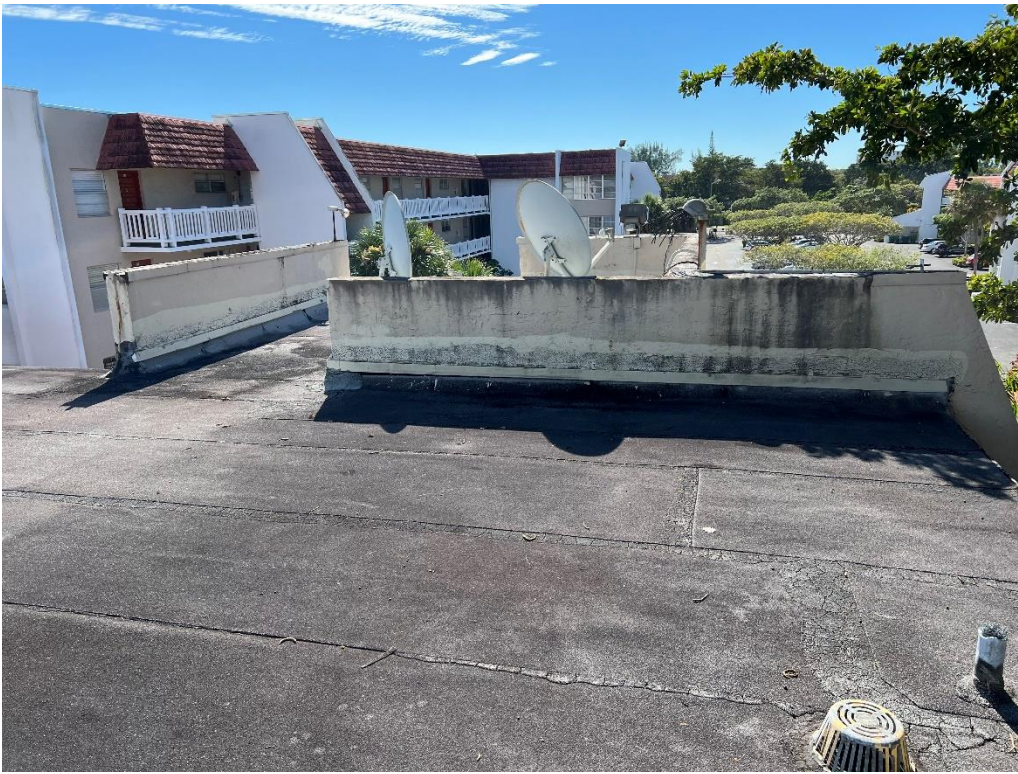
ACE inspected the Club House and found drainage deficiencies around the building and roof. Please refer to photos below and the recommendations section of this report.

Please be advised that poor drainage around the foundation may cause differential settlement causing the exterior walls and the slab to settle and/or crack. Therefore, to prevent differential settlement and cracks in the exterior walls and the slab on grade the building requires drainage improvement to keep excessive water away from the exterior walls, such as roof gutter and downspout, improving surface drainage, redirecting rainwater runoff and splash-back away from the building. All trees, shrubs, planters along the exterior walls should be removed. All equipment should be installed over properly graded ground.

The roof consists of a flat wood deck covered with modified bitumen system with no remaining life. Please be advised both parapet walls and roof are in poor conditions and repair is required.

ACE recommending that the drainage improvement be performed in accordance with plans prepared by an engineer and approved by the Local Building Department.

The ground immediately adjacent to the foundation shall be sloped away from the building at a slope of not less than one unit vertical in 20 units horizontal (5-percent slope) for a minimum distance of 10 feet (3048 mm) measured perpendicular to the face of the wall. If physical obstructions or lot lines prohibit 10 feet (3048 mm) of horizontal distance, a 5-percent slope shall be provided to an approved alternative method of diverting water away from the foundation. Swales used for this purpose shall be sloped a minimum of 2 percent where located within 10 feet (3048 mm) of the building foundation. Impervious surfaces within 10 feet (3048 mm) of the building foundation shall be sloped a minimum of 2 percent away from the building.
