# AKOURI CONSULTING ENGINEERS

RE Summary of repairs and recommendations obtained from the Milestone Phase 1 and 2 for the building located at:

Las Vistas in Inverrary Condominium Association Inc.  
3591 Inverrary Dr Bldg B, Lauderdale, FL 33319

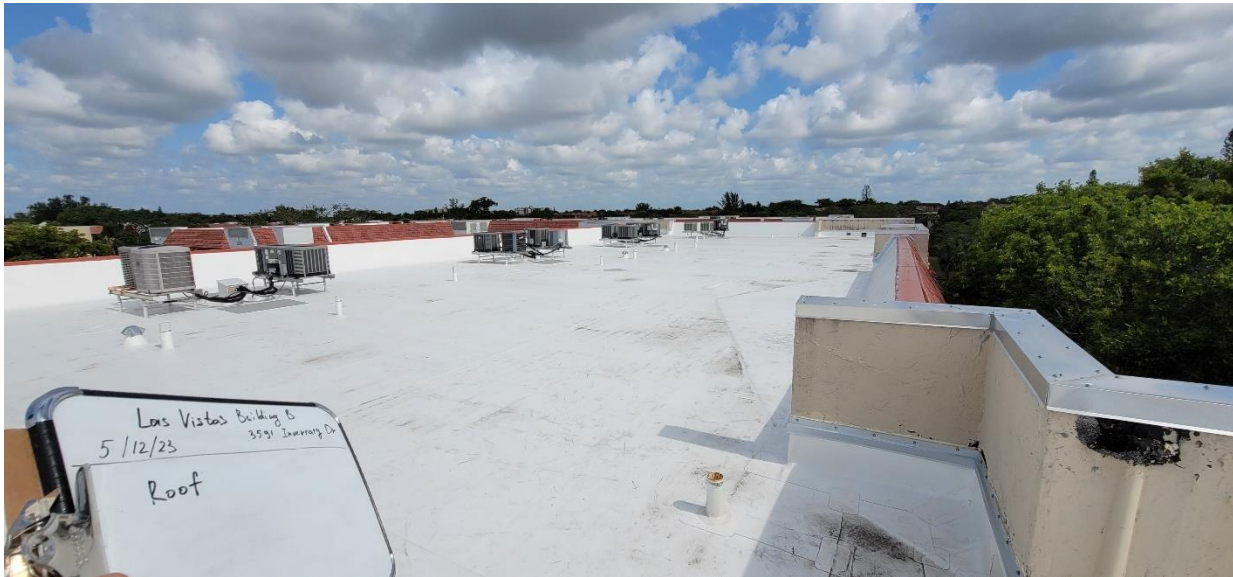
Roof (the re-roofing did not address the repair of the parapet wall to include stucco and paint).

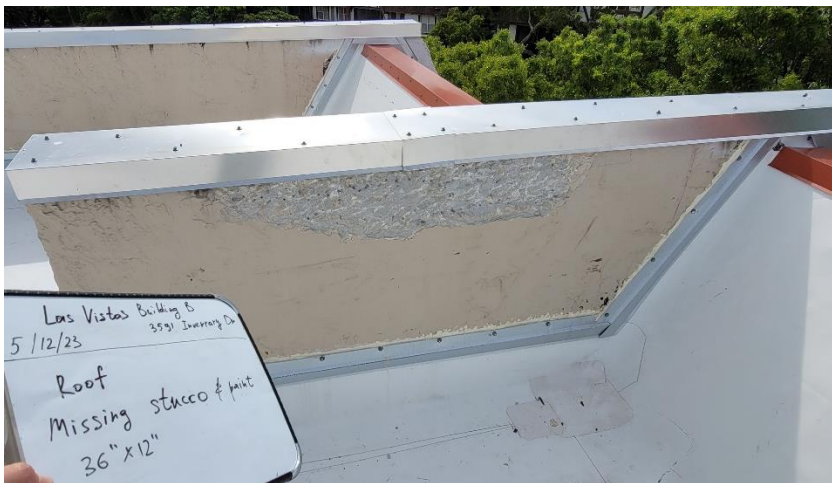
Parapet wall (stucco and paint)

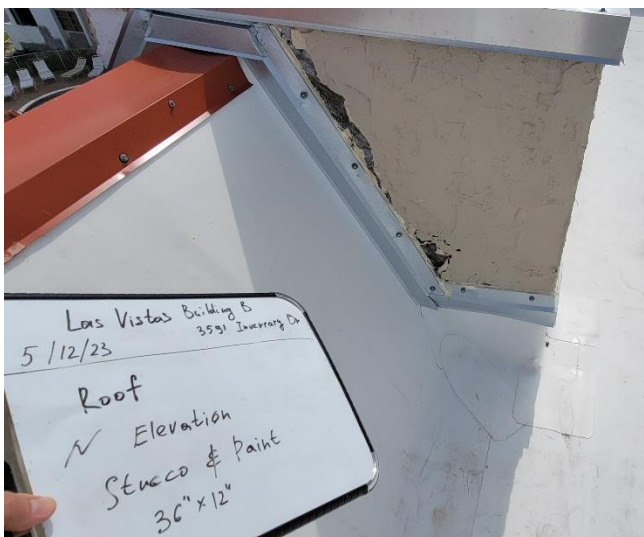
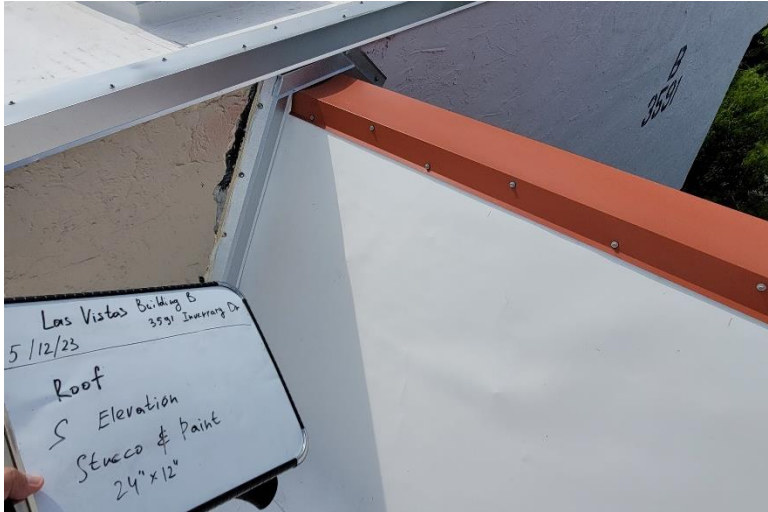
Parapet wall (poor quality flashing)
