# AKOURI CONSULTING ENGINEERS

RE Summary of repairs and recommendations obtained from the Milestone Phase 1 and 2 for the building located at:

Las Vistas in Inverrary Condominium Association Inc.  
3541 Inverrary Dr Bldg G, Lauderdale, FL 33319

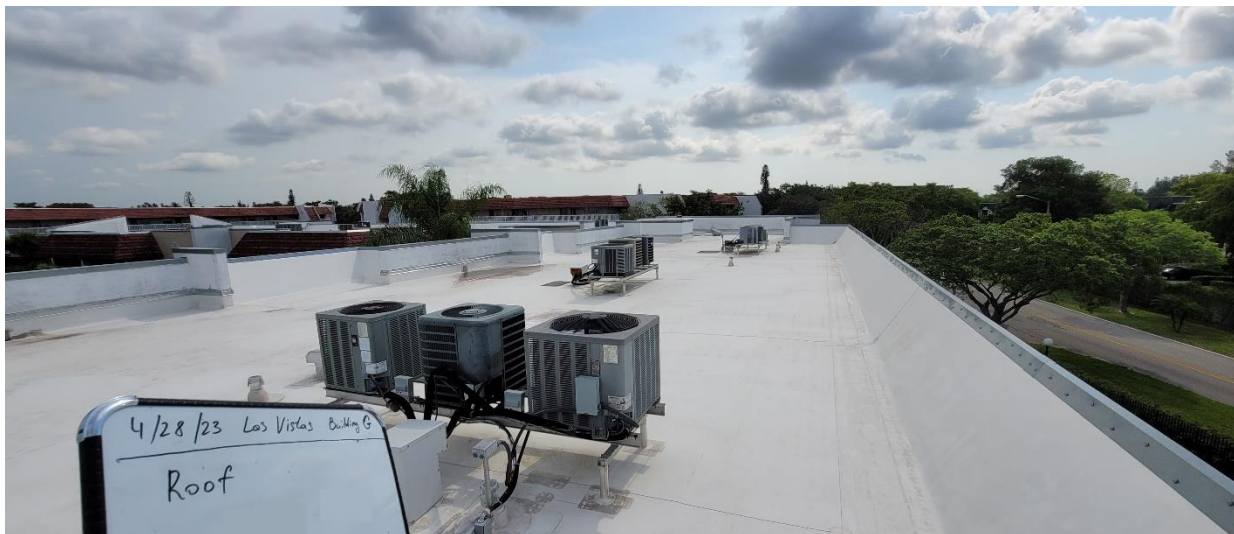
Roof (Single-ply roofing system. Good condition)
