## STRUCTURAL SAFETY INSPECTION REPORT FORM

a. Name on Title: LAS VISTAS IN INVERRARY CONDOMINIUM ASSOCIATION, INC.b. Street Address: 3774 Inverrary Boulevard Bldg P, Lauderhill, FL 33319, Building P.c. Legal Description: LAS VISTAS P-R IN INVERRARY CONDO BLDG P PER CDO BK/PG: 5686/350d. Owner's Name: LAS VISTAS IN INVER CONDO ASSNe. Owner's Mailing Address: 3533 Inverrary Dr, Lauderhill, FL 33319-5921f. Email Address: Contact Number: Dwayne Griffin, Office Manager (954-731-8484), accounting@lasvistascondo.comg. Folio Number of Property on which building is located: 4941 23 DD 0000 (Reference)h. Building Code Occupancy Classification: R-2 FBC 2023, Type III residentiali. Present Use: Condominium Buildingj. General Description: Type of Construction: This is a (3) story concrete building Type of Construction: IIIk. Square Footage: Approximately: 13,500 S.F. Number of Stories: (3)

## Photo Report

Name: Las Vistas in Inverrary Condominium Association Inc.

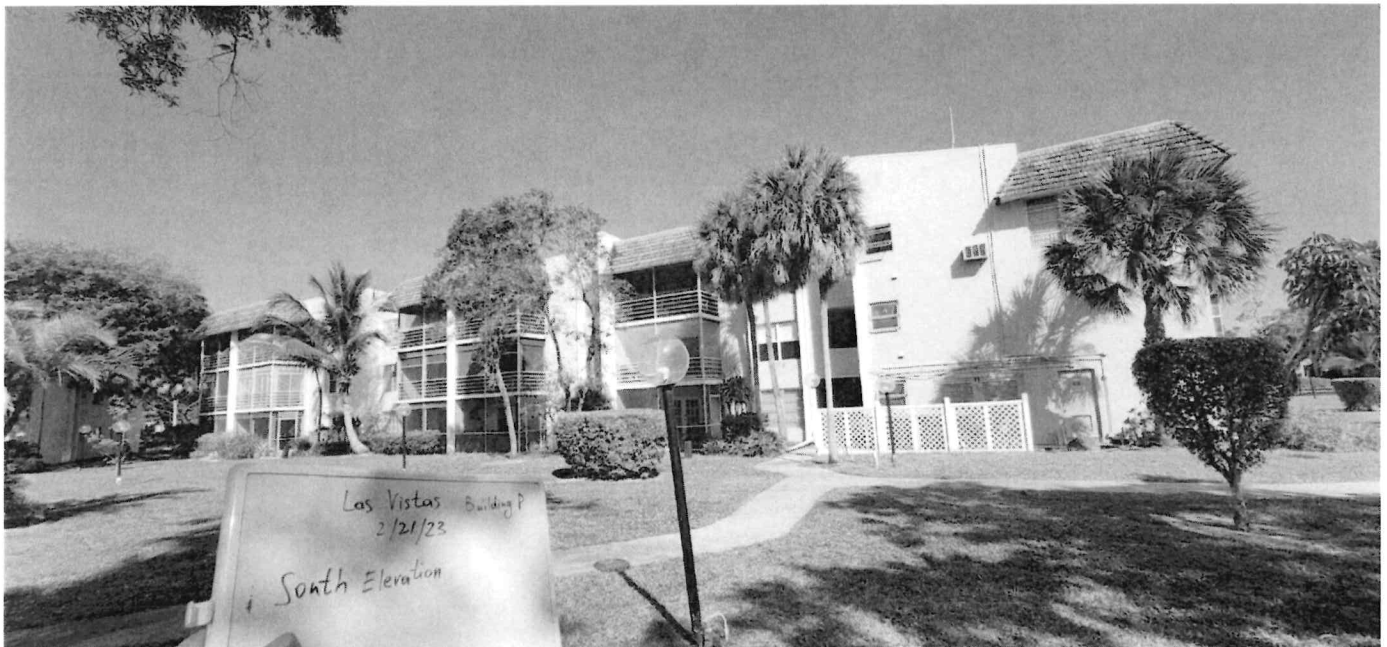
Photo 1: South Side View.

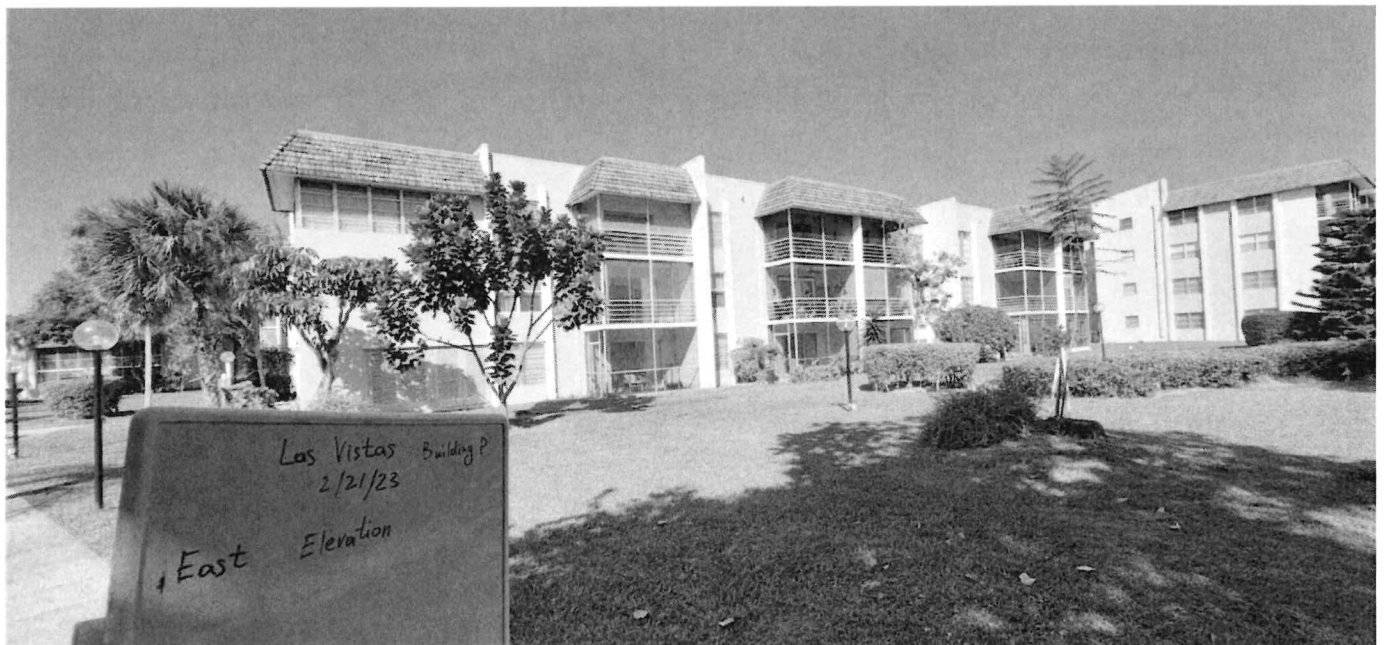
Photo 2: East Side View.

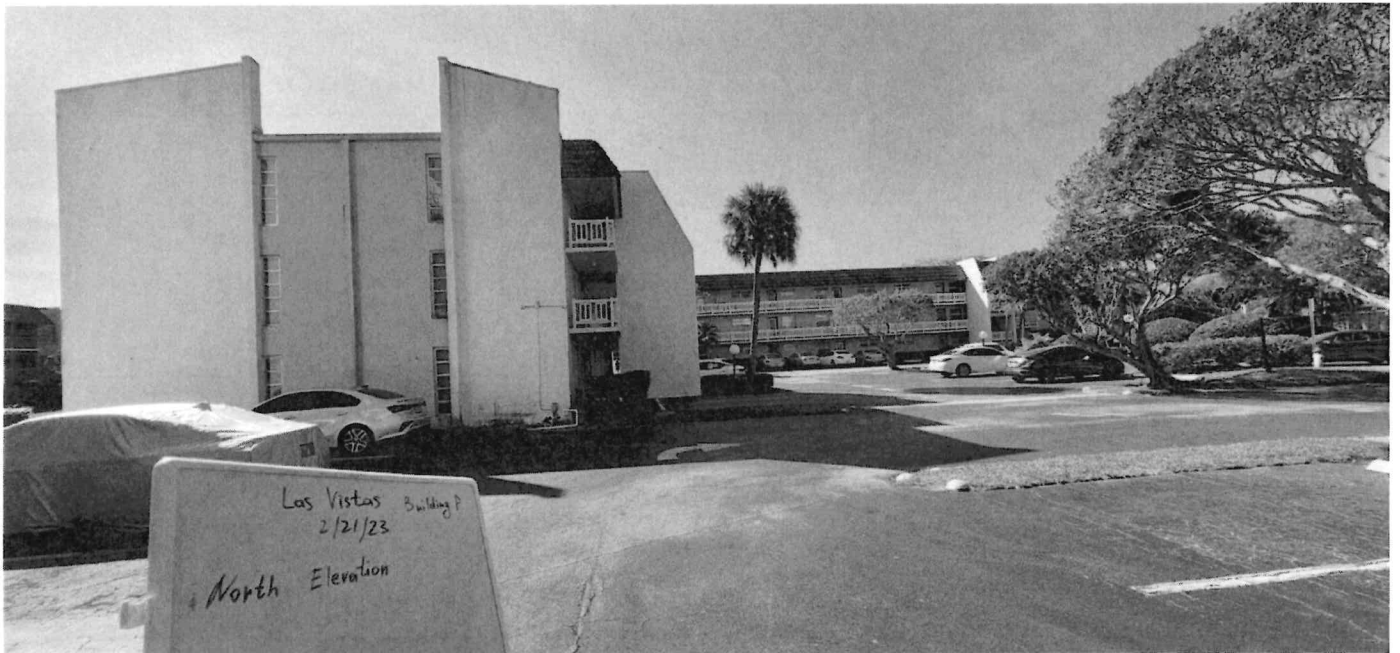
Photo 3: North Side View.

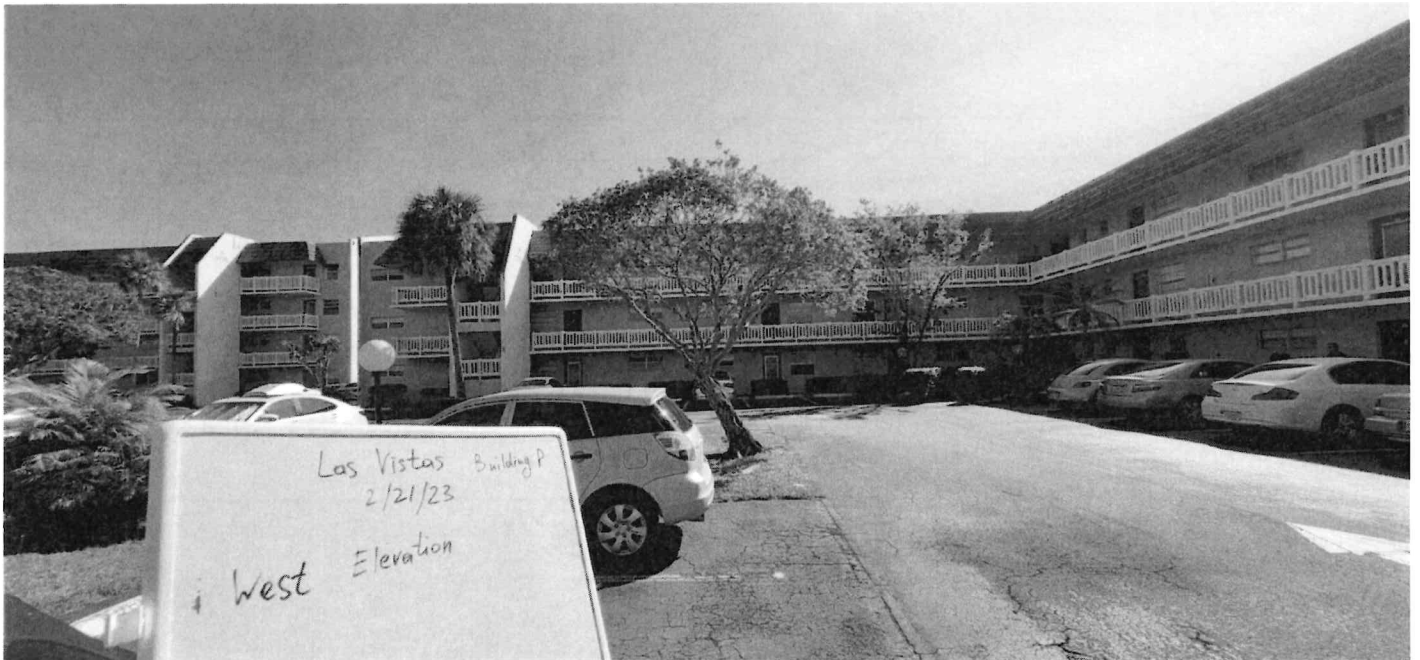
Photo 4: West Side View.

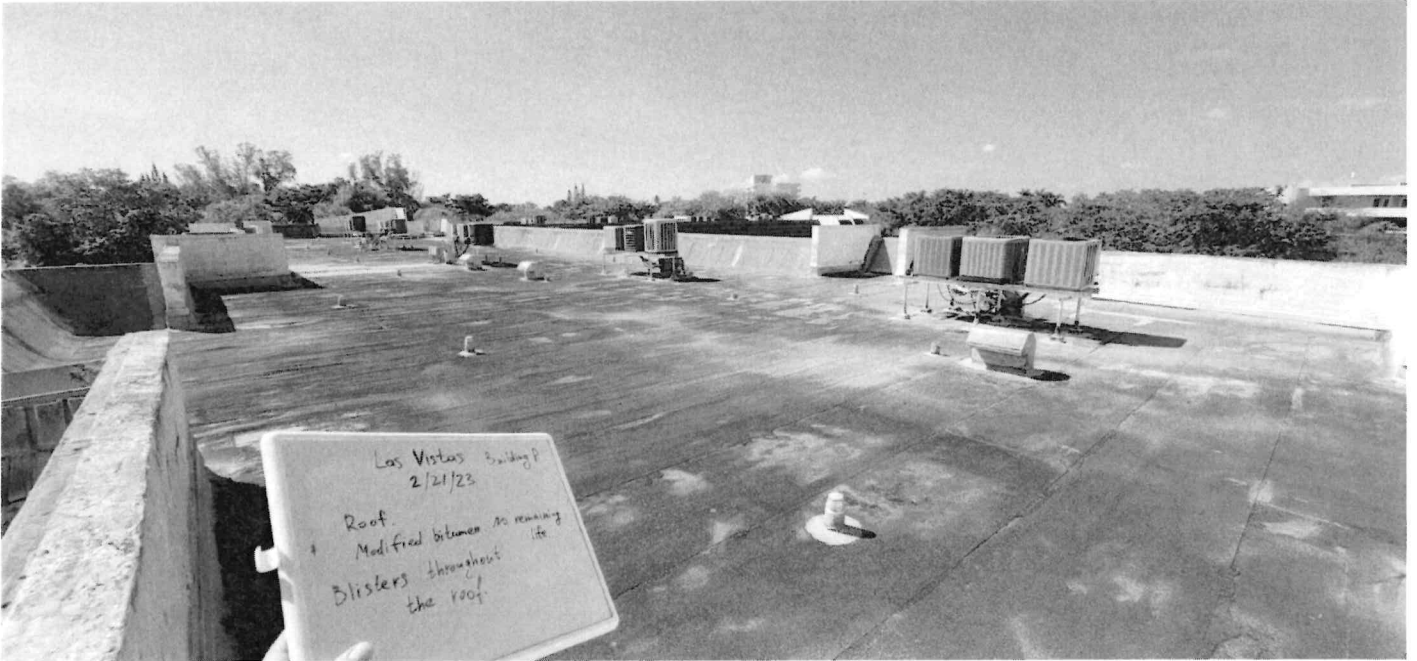
Photo 5: Roof View. Modified bitumen, no remaining life, blisters throughout the roof.

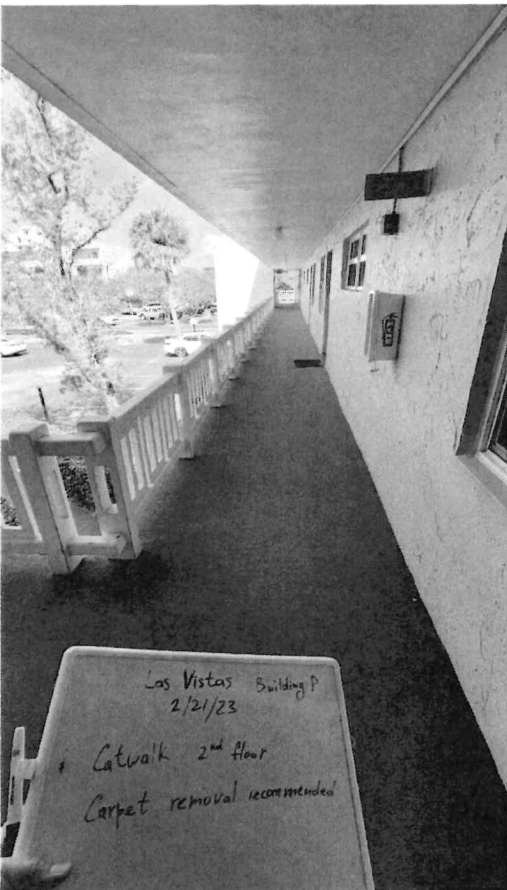
Photo 6: Catwalk second floor- Carpet removal recommended.

The building is structurally safe for its intended use and occupancy, but requires repairs as described in the report. All repairs must be performed in accordance with plans prepared by an engineer and approved by the local building department. The carpet along the catwalks must be removed and concrete spalling repaired.

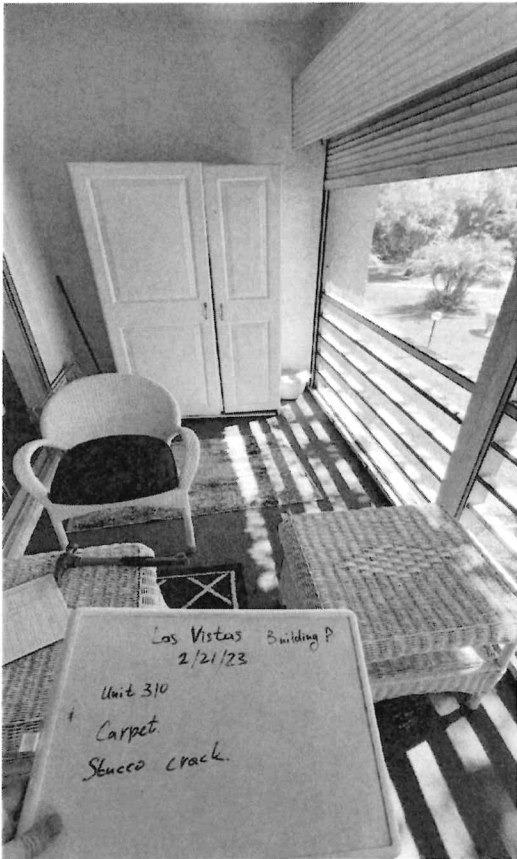
Photo 7: Carpet - stucco crack, unit 310.

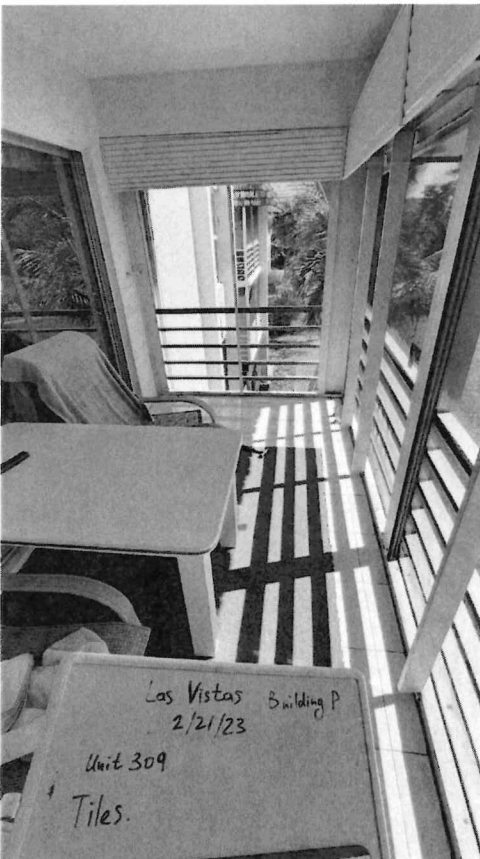
Photo 8: Tiles at unit 309.

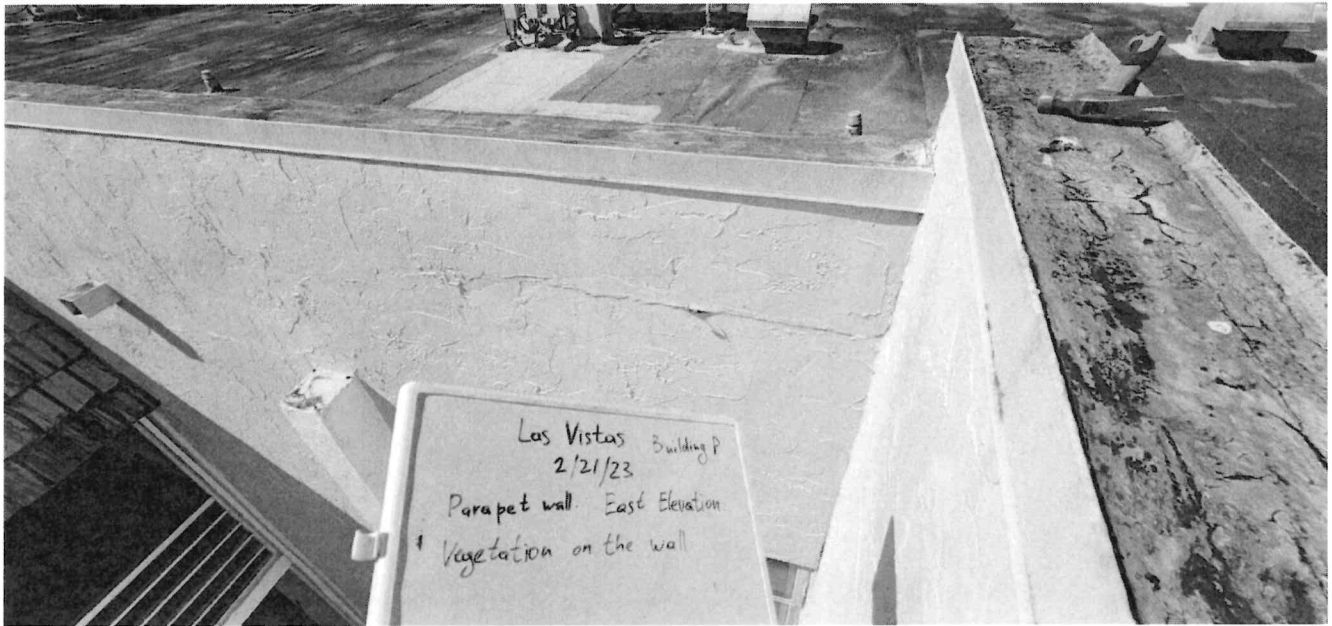
Photo 9: Parapet wall Vegetation on the wall ( East elevation).

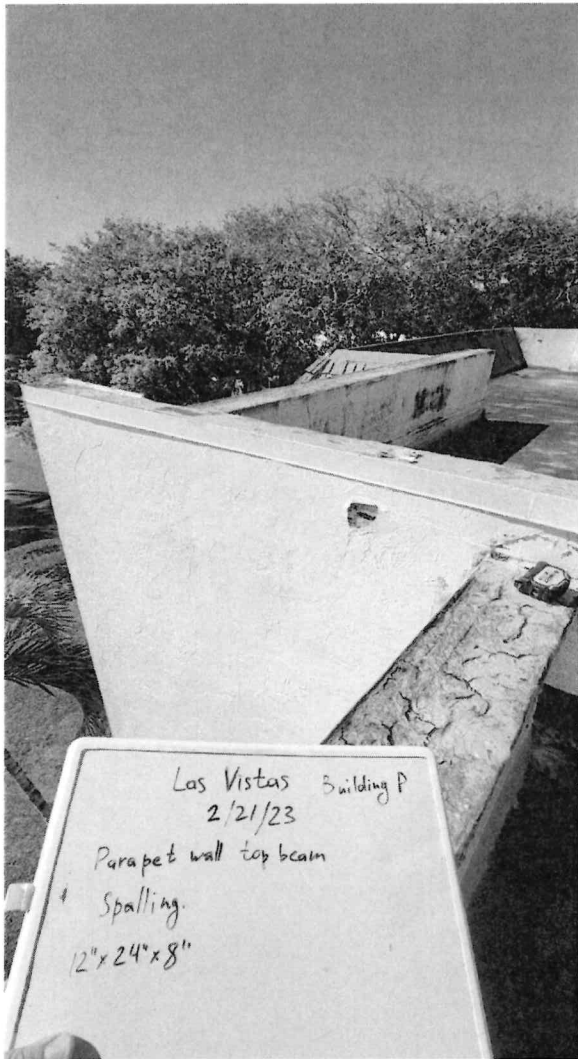
Photo 10: Parapet wall top beam spalling 12"x24"x8"

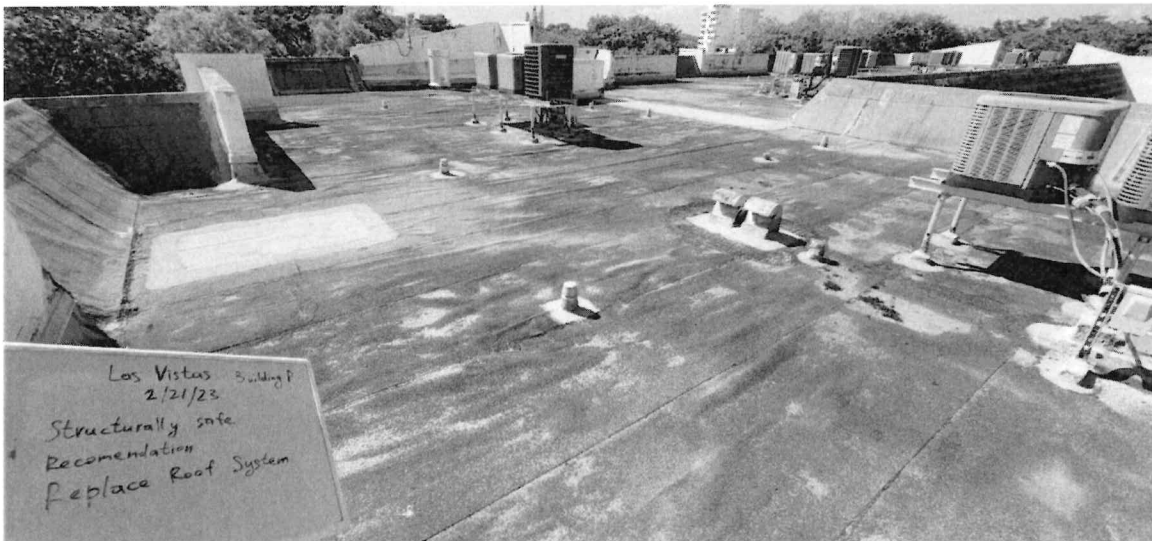
Photo 11: Roof Structurally safe. Recommendation replace roof system.

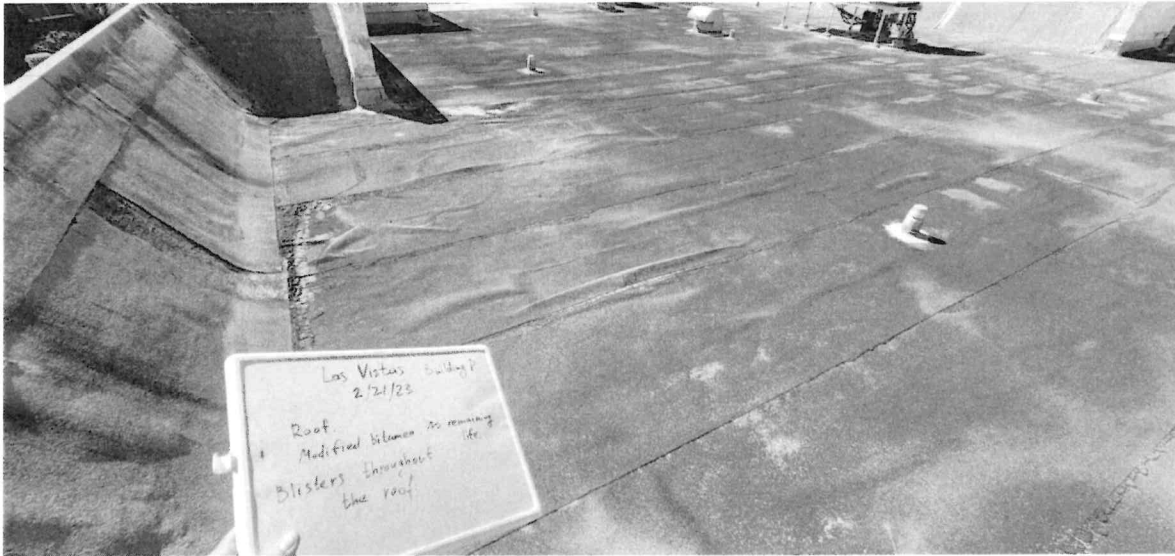
Photo 12: Roof Modified Bitumen no remaining life - Blisters throughout the roof. Roof replacement recommended.

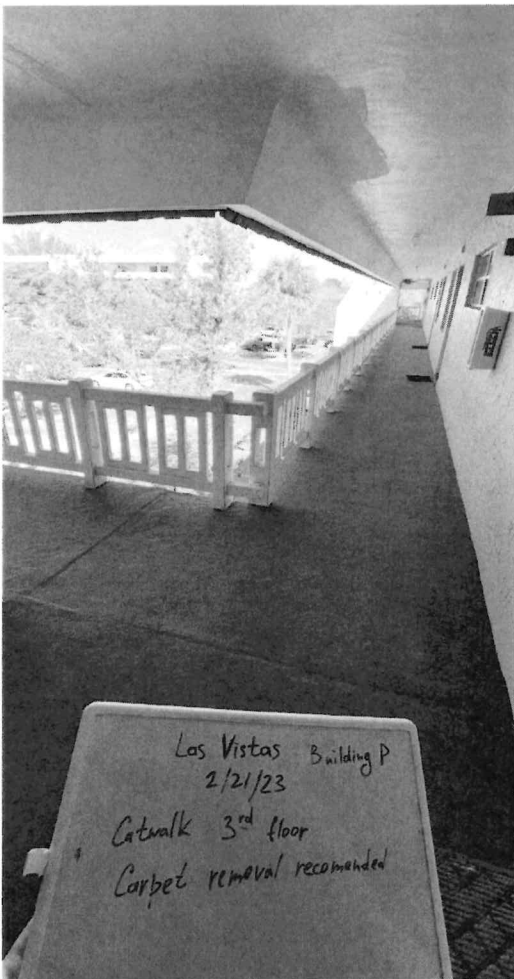
Photo 13: Catwalk carpet removal 3rd floor recommended.

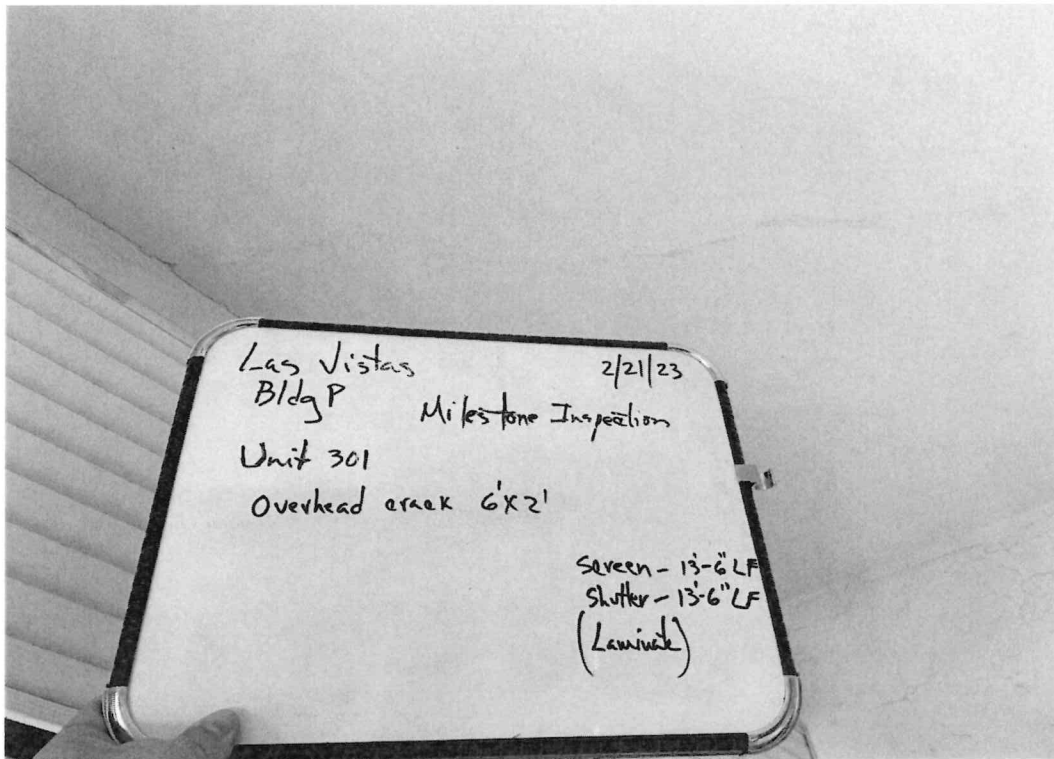
Photo 14: Overhead crack 6'x2', unit 301.

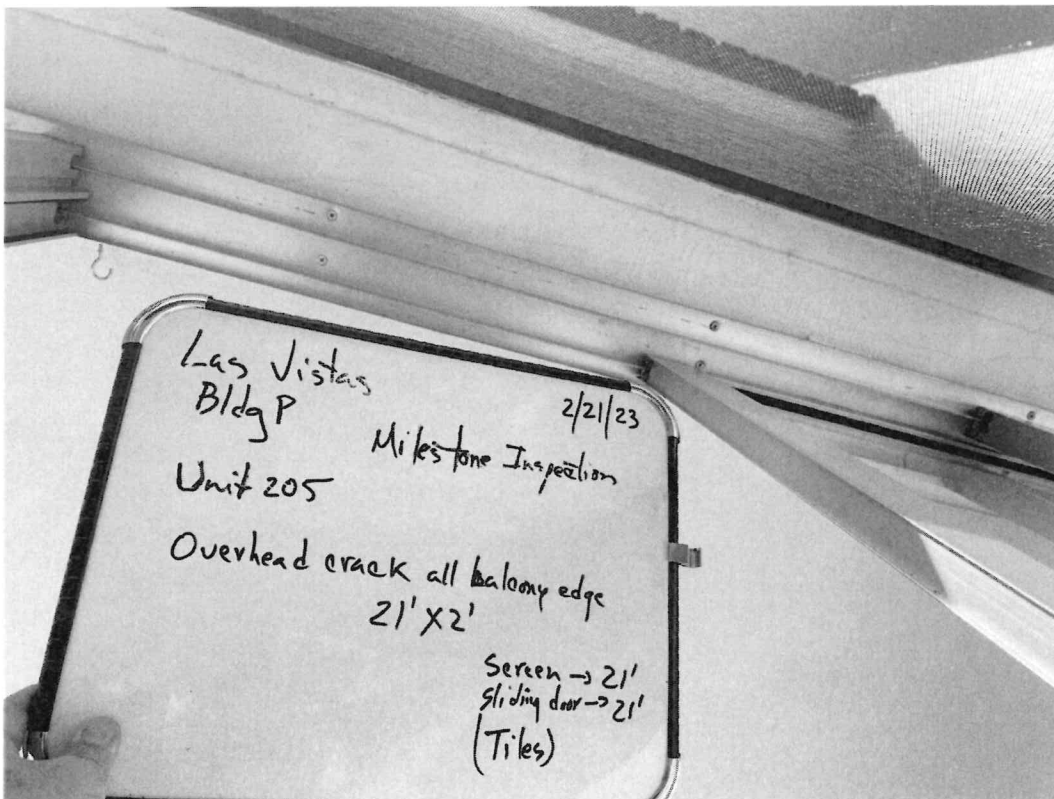
The balconies at the rear of the building are composed of a structural reinforced concrete slab system (6-7) inches in thickness. Concrete spalling of the balcony slabs was observed in multiple locations.

Photo 15: Overhead crack all balcony edge 21'x2', unit 205.

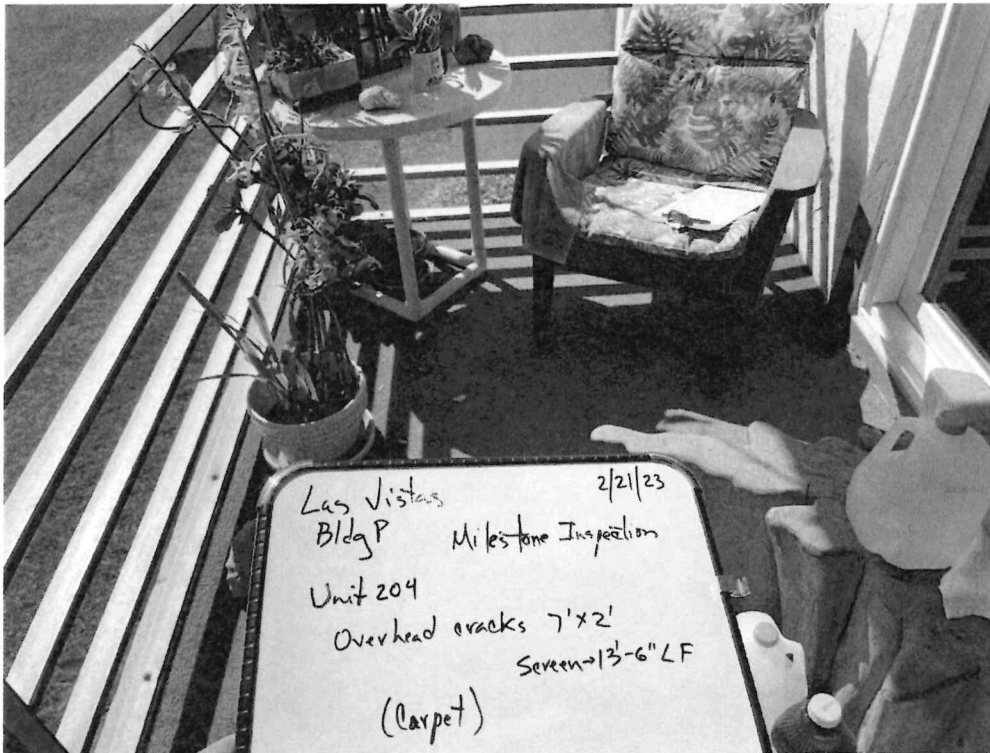
Photo 16: unit 204 Overhead crack 7'x 2', and carpet /screen 13'-6" LF.

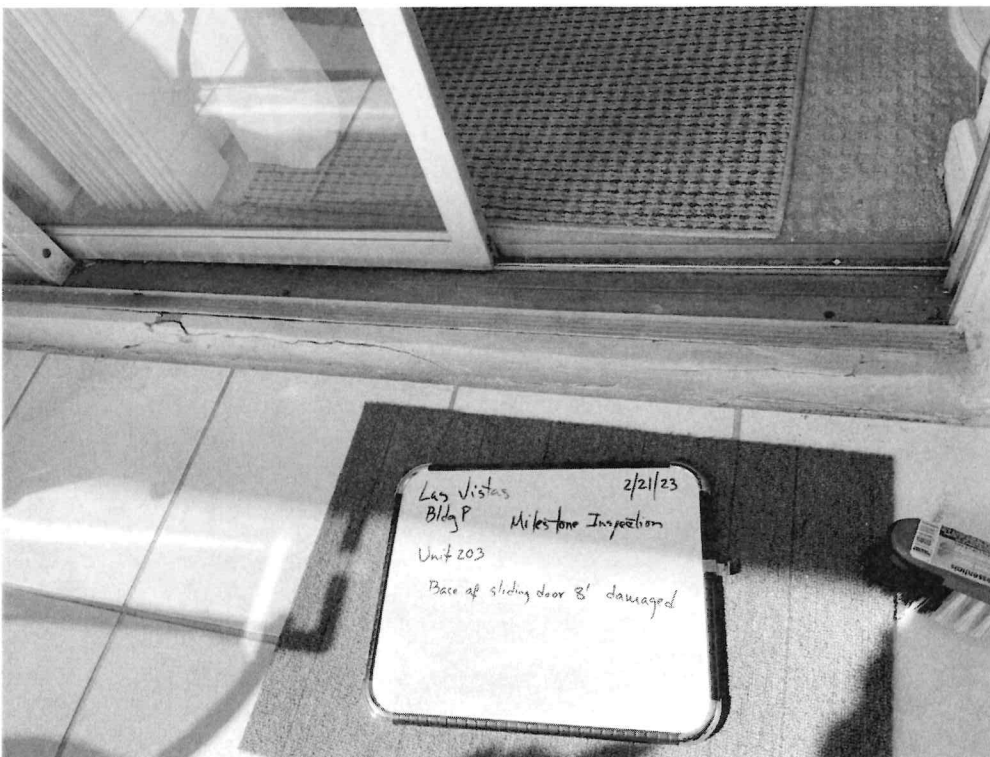
Photo 17: Unit 203 base of sliding door 8' cracks/spalling damage

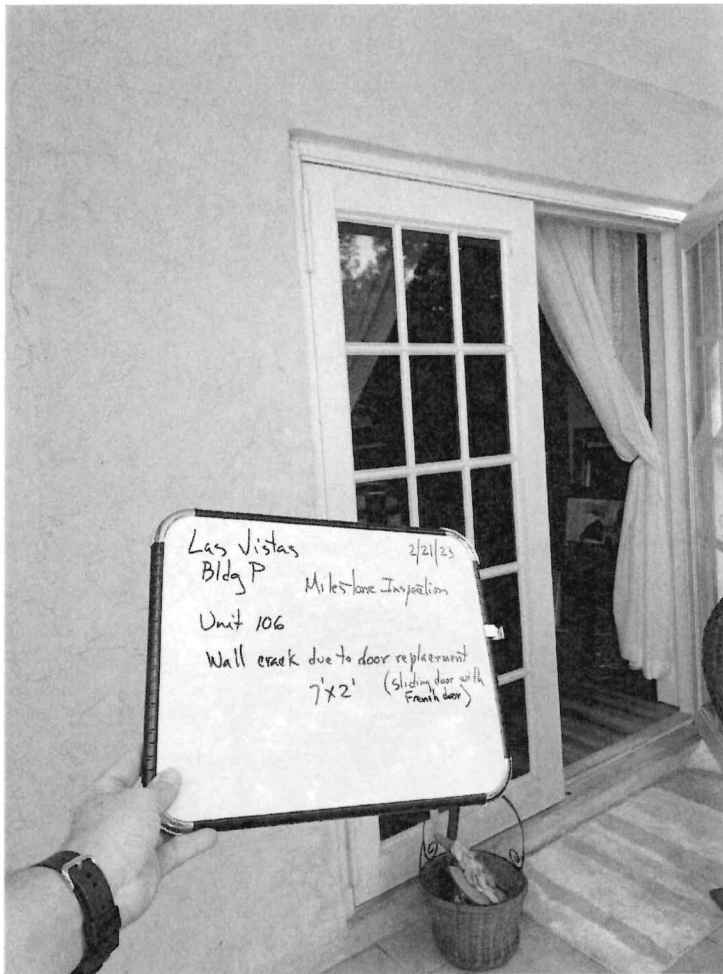
Photo 18: Unit 106; wall crack due to door replacement 7'x2' (sliding door with french door)
