# STRUCTURAL SAFETY INSPECTION REPORT FORM

a. Name on Title: LAS VISTAS IN INVERRARY CONDOMINIUM ASSOCIATION, INC.b. Street Address: 3521 Inverrary Dr Bldg J, Lauderhill, FL 33319. Building J.c. Legal Description: LAS VISTAS J IN INVERRARY CONDO PER CDO BK/PG: 5857/284d. Owner's Name: LAS VISTAS IN INVER CONDO ASSNe. Owner's Mailing Address: 3533 Inverrary Dr, Lauderhill, FL 33319-5921f. Email Address: Contact Number: Dwayne Griffin, Office Manager (954-731-8484), accounting@lasvistascondo.comg. Folio Number of Property on which building is located: 4941 23 CK 0000 (Reference)h. Building Code Occupancy Classification: R-2 FBC 2023, Type III residentiali. Present Use: Condominium Buildingj. General Description: Type of Construction: This is a (4) story concrete building Type of Construction: IIIk. Square Footage: Approximately: 12,500 S.F. approx Number of Stories: (4)

**Photo Report**

Title: Photo Sheet

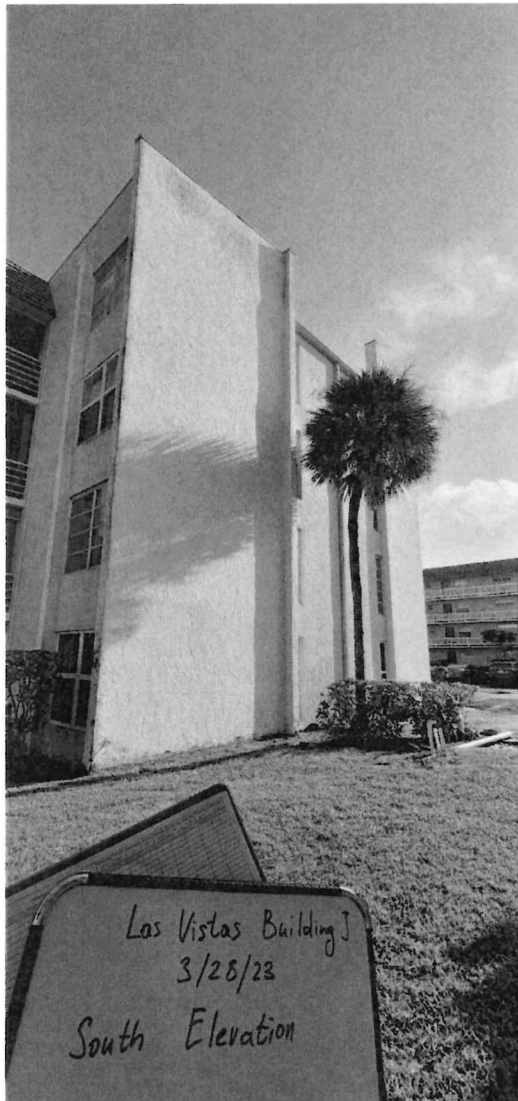
Photo 1: South Side View.

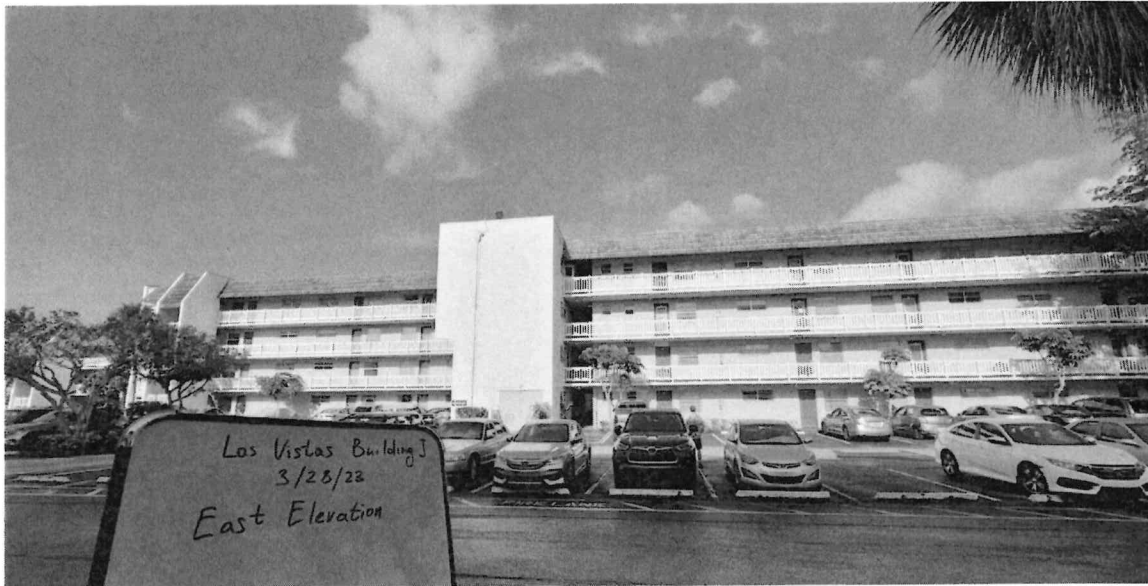
Photo 2: East Side View.

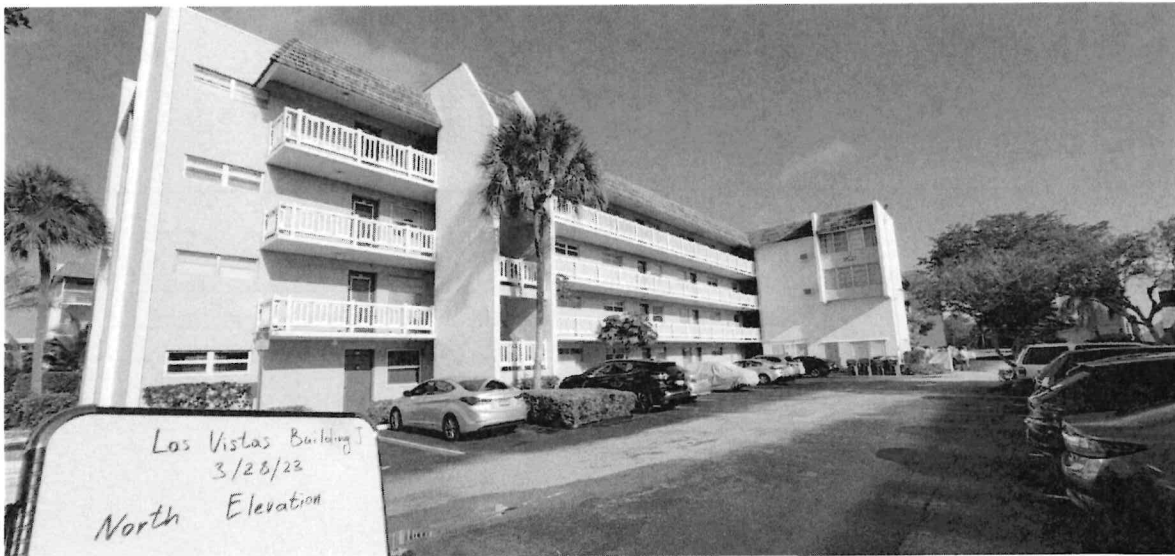
Photo 3: North View.

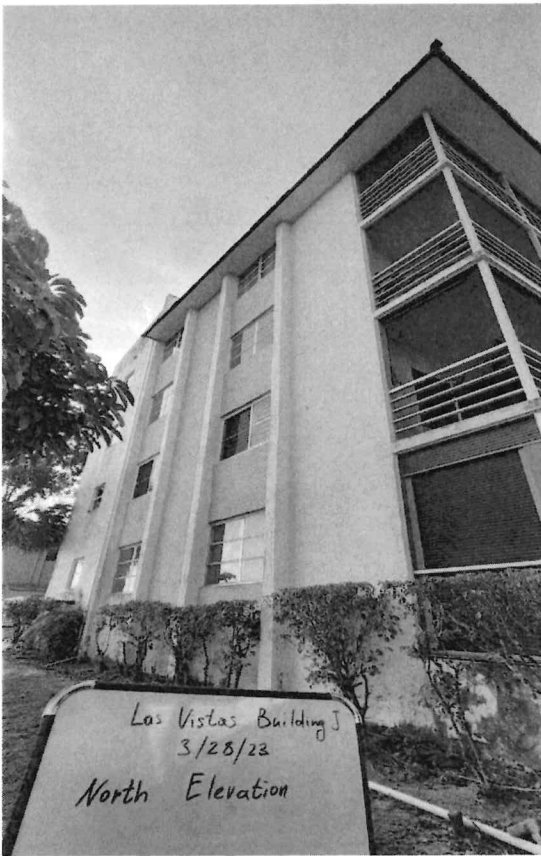
Photo 4: North Side View.

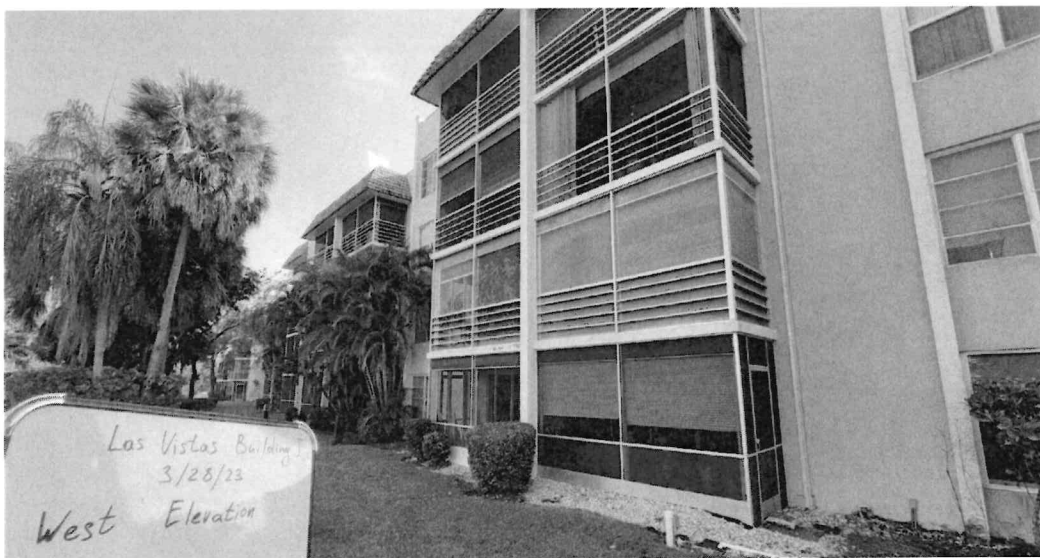
Photo 5: West Side View.

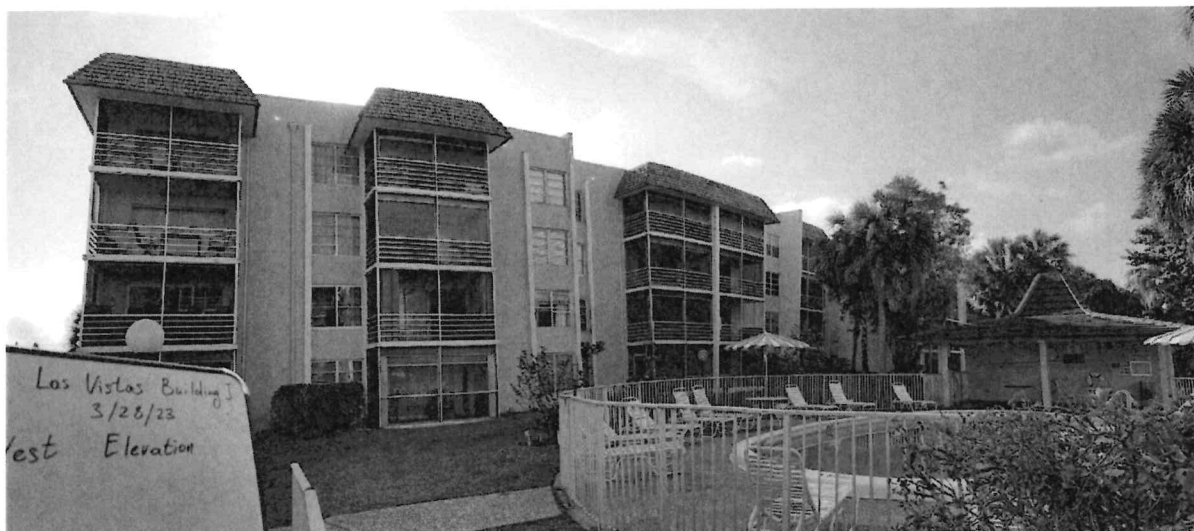
Photo 6: West Side View.

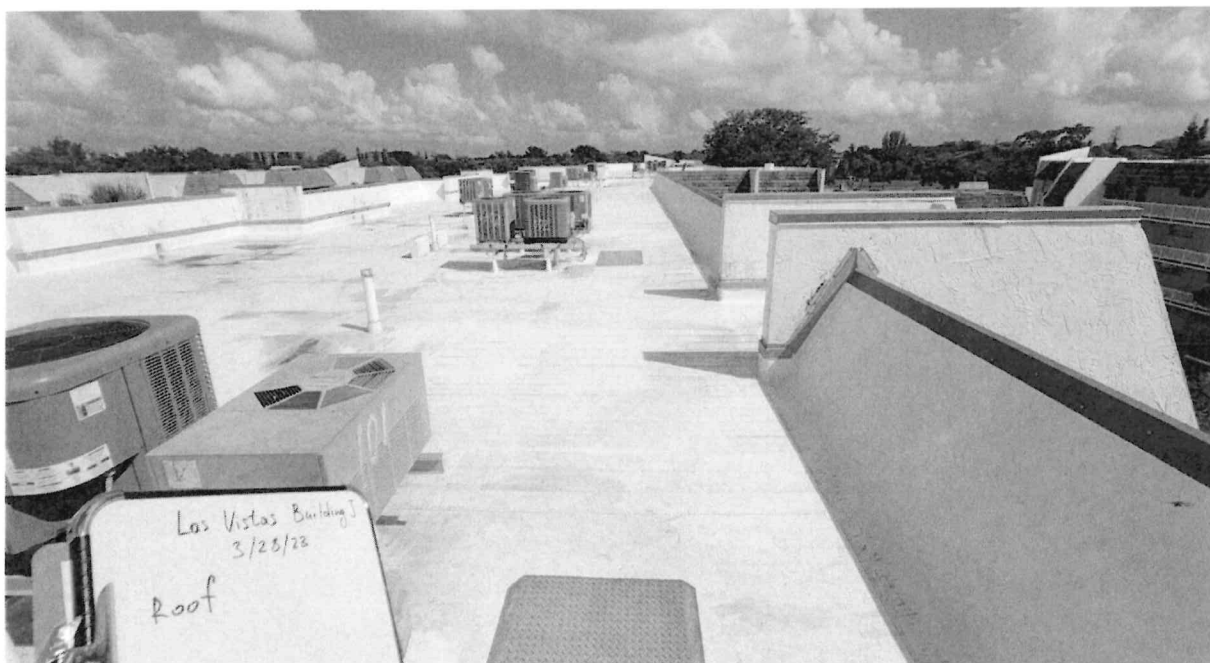
Drains, scuppers were found in fair condition, unless otherwise noted.

Photo 7: Roof View. No overflows observed.

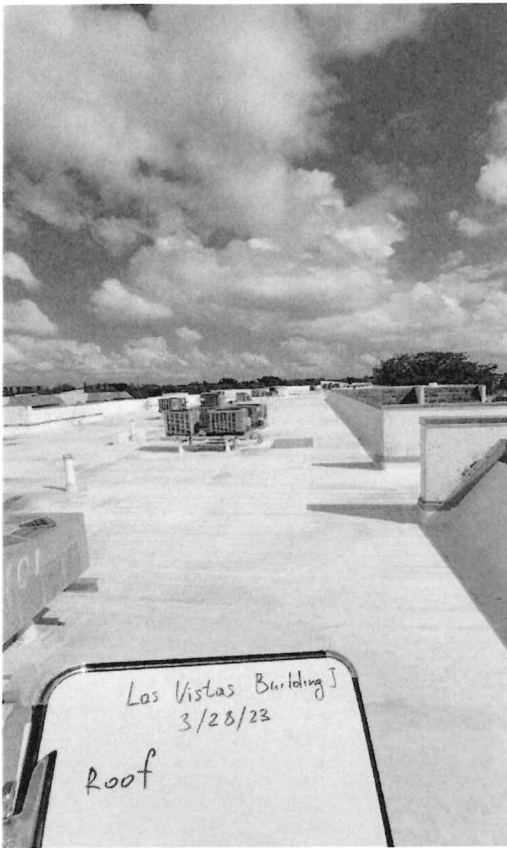
Photo 8: Roof View. No overflows observed.

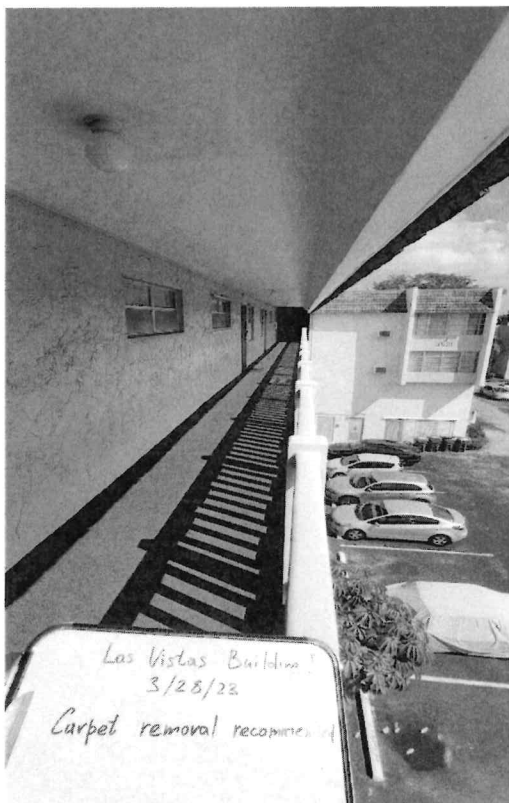
Photo 9: Carpet removal recommended.

The building is structurally safe for its intended use and occupancy, but requires repairs as described in the report. All repairs must be performed in accordance with plans prepared by an engineer and approved by the local building department. The carpet along the catwalks must be removed and concrete spalling repaired.

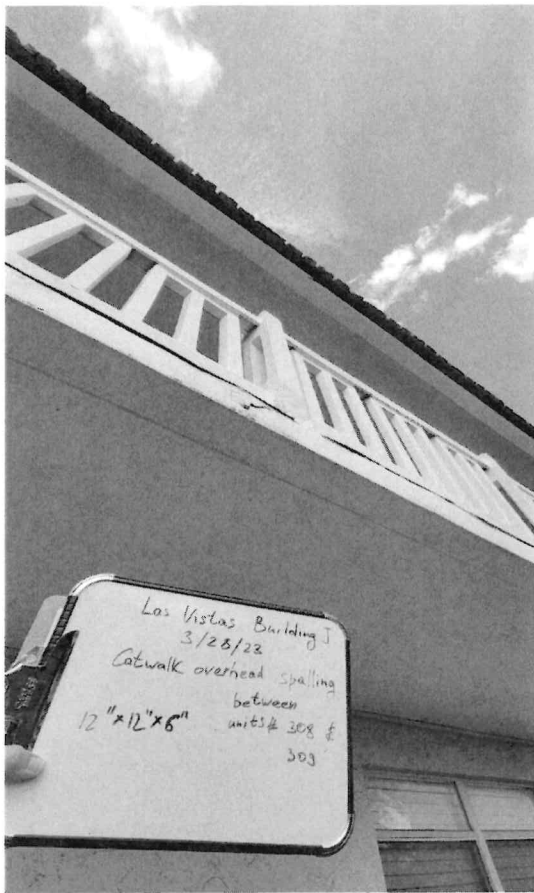
Spalling of the catwalk and balcony slabs was observed in multiple locations.

Photo 10: Catwalk overhead spalling between units 308 & 309 12"x12"x6"

Spalling of the catwalk and balcony slabs was observed in multiple locations. All repairs must be performed in accordance with plans prepared by an engineer and approved by the local building department.

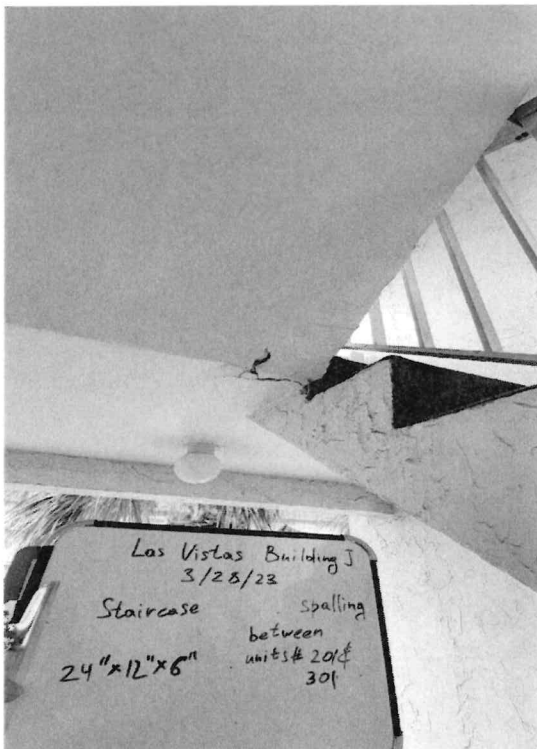
The exterior concrete stairs were observed in fair condition. However, spalled sections were found at multiple locations.

Photo 11: Staircase spalling between units 201 & 301 24"x12"x6"

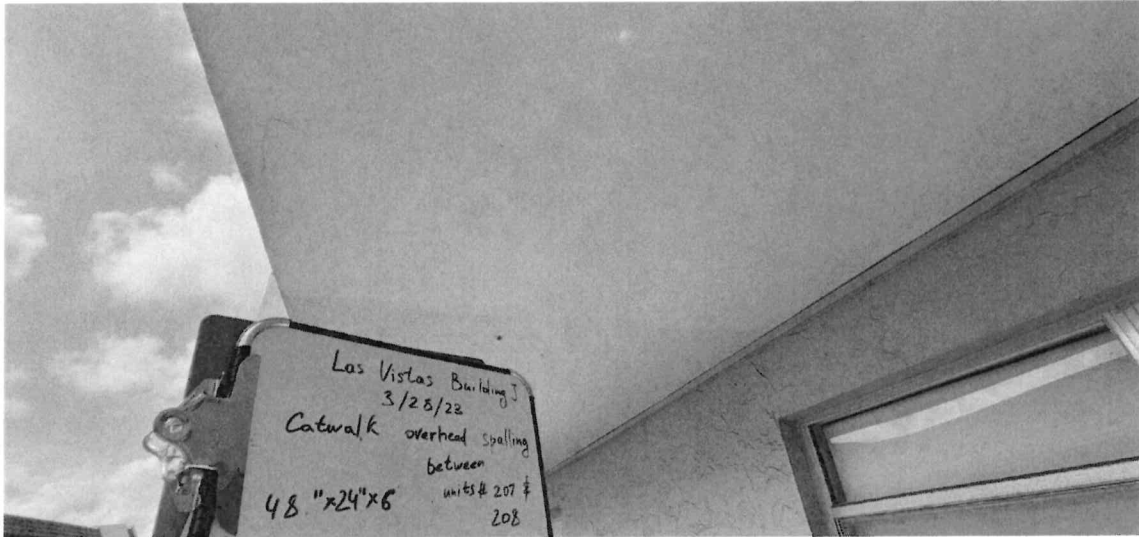
Photo 12: Catwalk overhead spalling between units 207 & 208 48"x24"x6"
