# AKOURI CONSULTING ENGINEERS

RE Summary of repairs and recommendations obtained from the Milestone Phase 1 and 2 for  
the building located at:

Las Vistas in Inverrary Condominium Association Inc.  
3772 Inverrary Boulevard Bldg M, Lauderdale, FL 33319

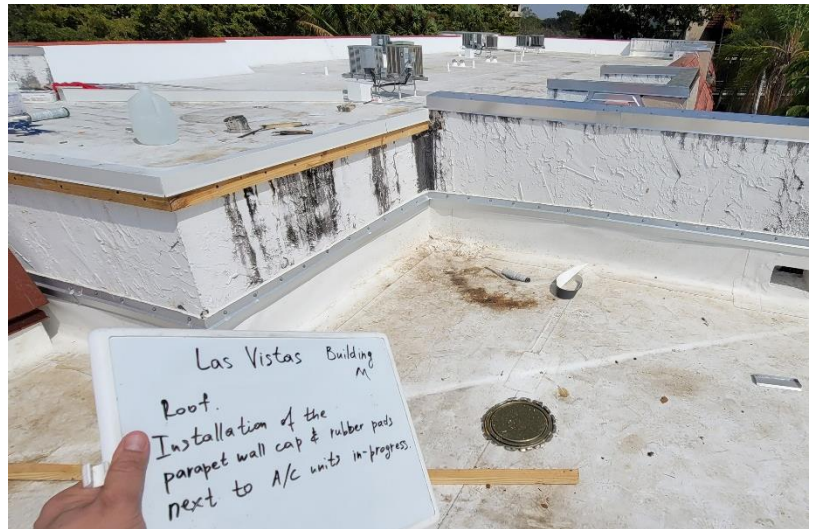
Roof (Single-ply roofing system, parapet walls require repair)

The listed deficiencies below must be corrected in accordance with a concrete restoration bid package prepared by a structural engineer and approved by the Local Building Department.

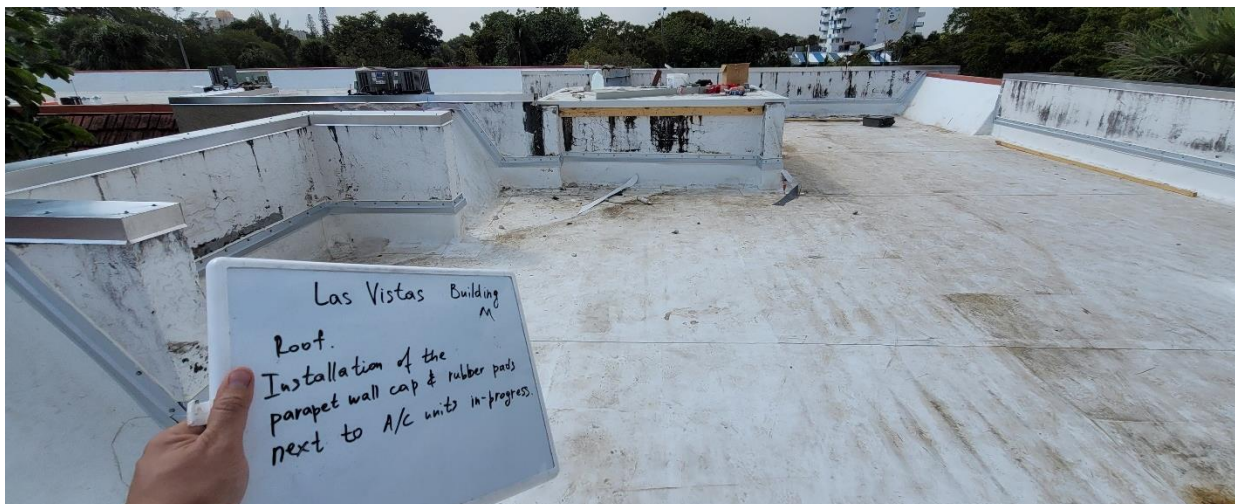
Roof (parapet walls require repair)
