# AKOURI CONSULTING ENGINEERS

RE Summary of repairs and recommendations obtained from the Milestone Phase 1 and 2 for  
the building located at:

Las Vistas in Inverrary Condominium Association Inc.  
3774 Inverrary Blvd Bldg P, Lauderdale, FL 33319

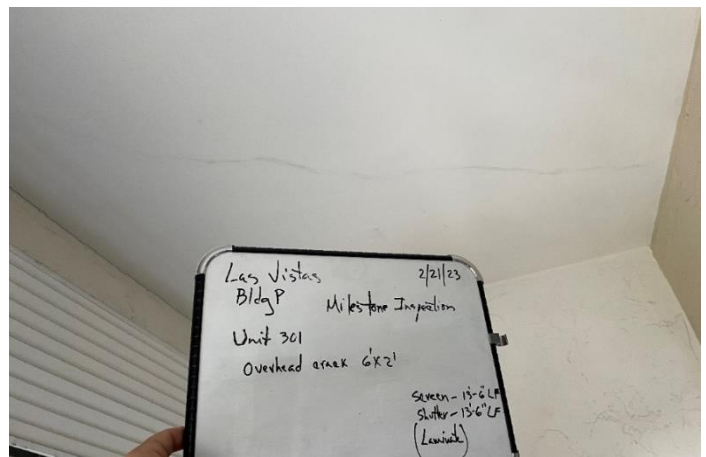
Overhead spalling around expansion joint

The listed deficiencies below must be corrected in accordance with a concrete restoration bid package prepared by a structural engineer and approved by the Local Building Department.

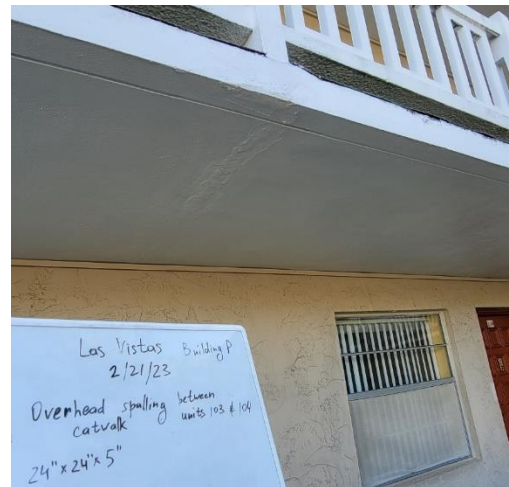
Overhead spalling between Units 103 and 104

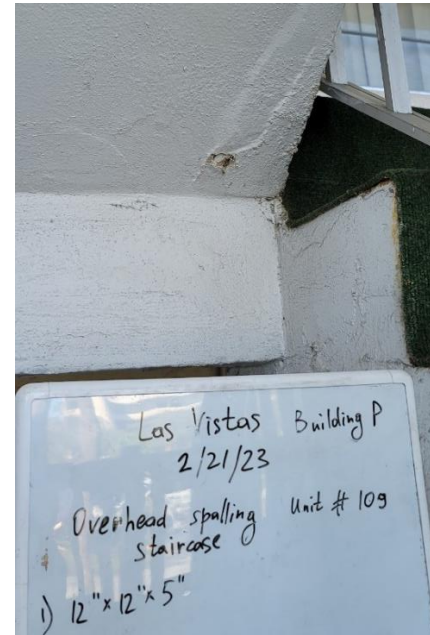
Overhead spalling on staircase in front Unit 109

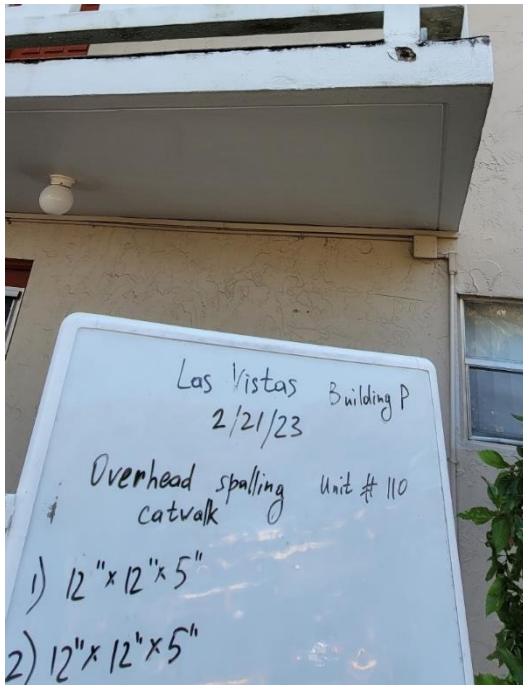
Overhead spalling in front Unit 110

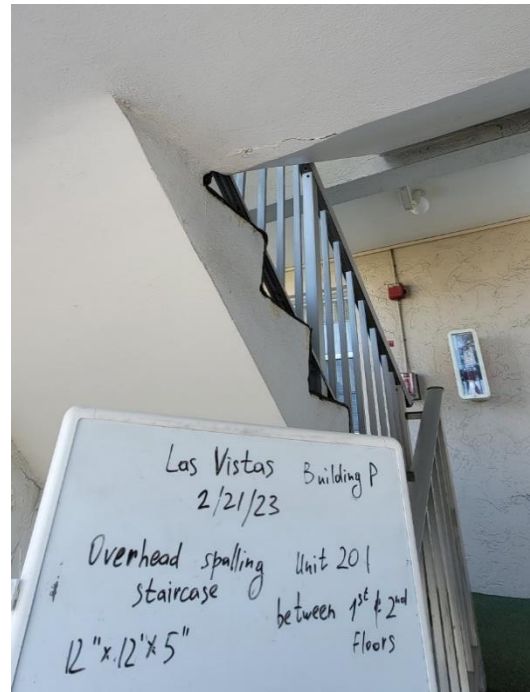
Overhead spalling on staircase between 1<sup>st</sup> and 2<sup>nd</sup> floor (Unit 201)

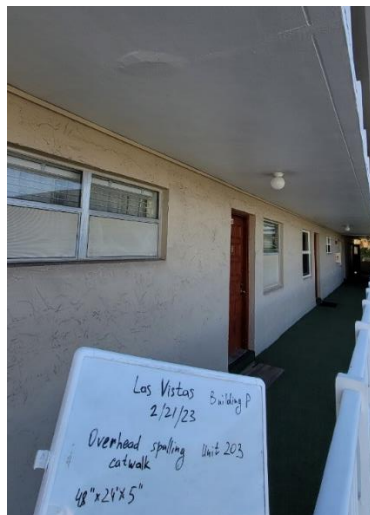
Overhead spalling on catwalk in front Unit 203

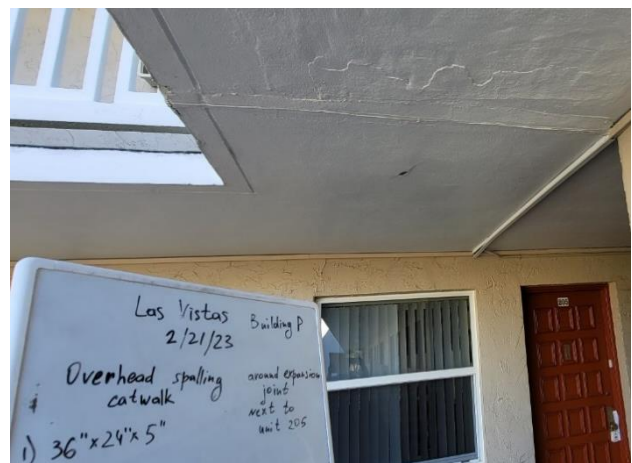
Overhead spalling around expansion joint next to Unit 205

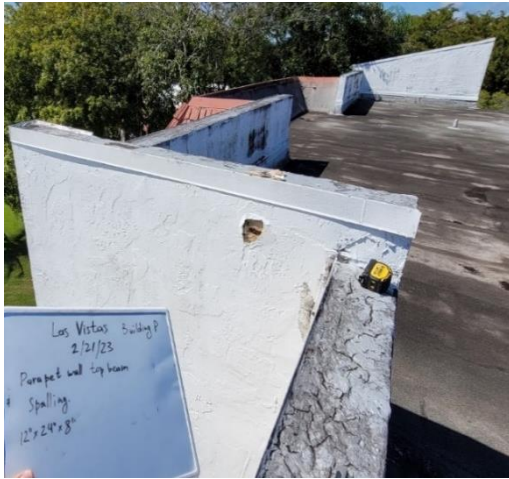
Roof: Parapet with spalling and vegetation

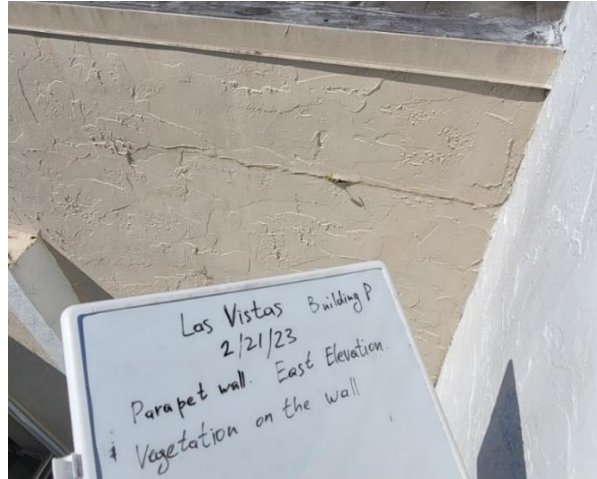
Roof: Parapet with spalling and vegetation

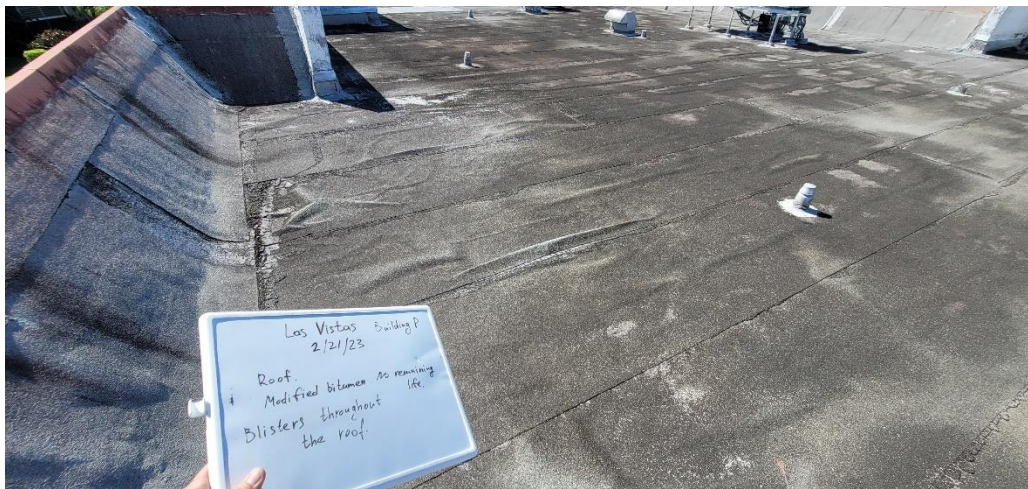
Roof: Blisters throughout the roof. The roof system must be replaced.
