# STRUCTURAL SAFETY INSPECTION REPORT FORM

a. Name on Title: LAS VISTAS IN INVERRARY CONDOMINIUM ASSOCIATION, INC.

b. Street Address: 3776 Inverrary Boulevard Bldg R, Lauderhill, FL 33319.

## Photo Report

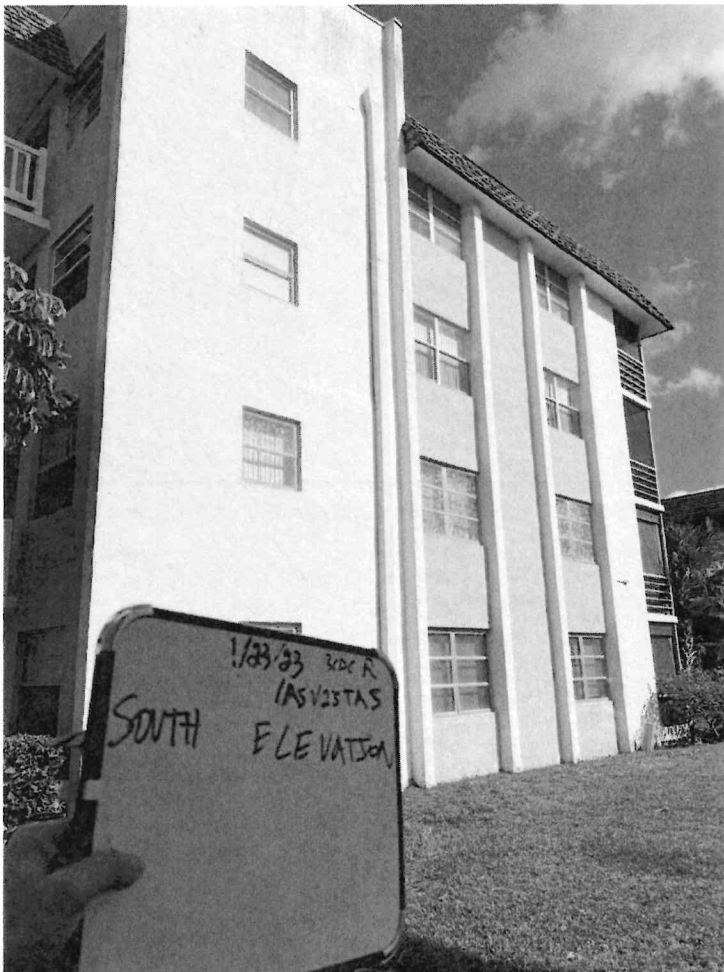
Photo 1: South Side View.

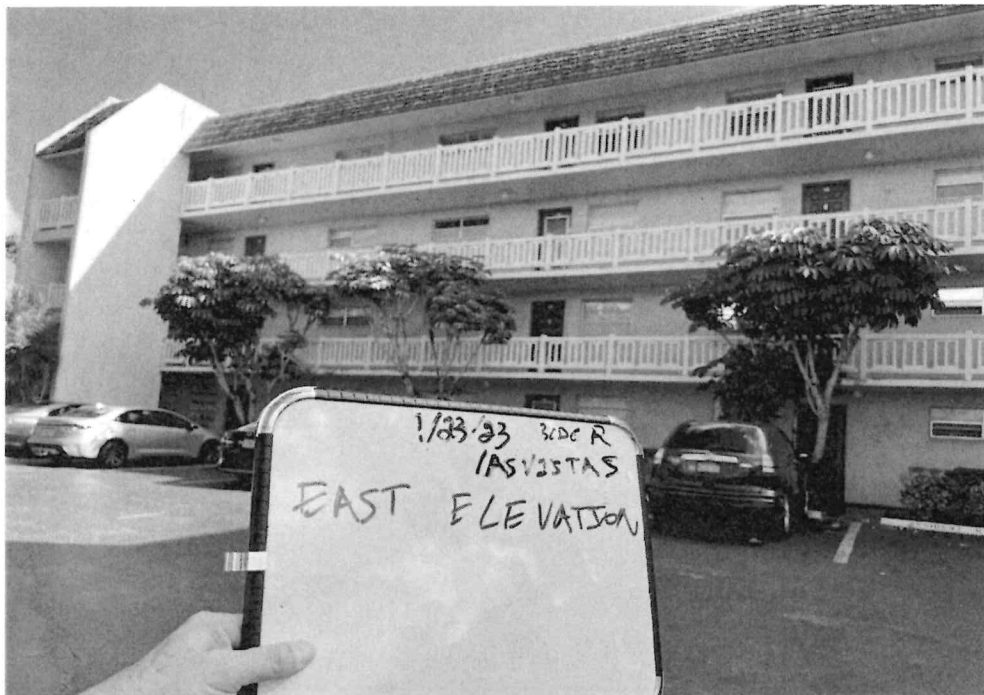
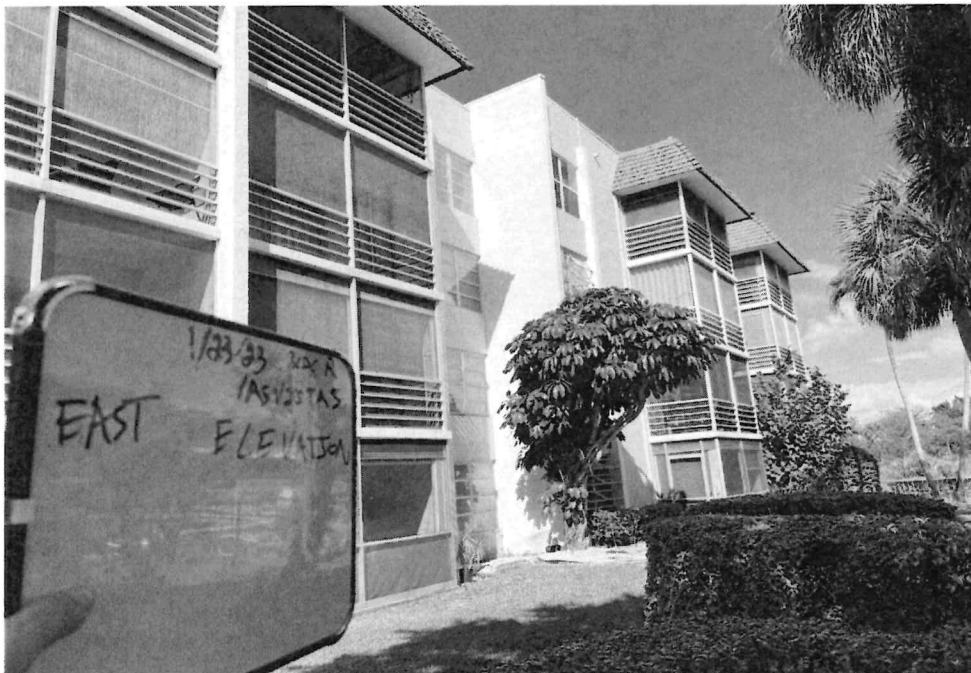
Photo 2&3: East Side view

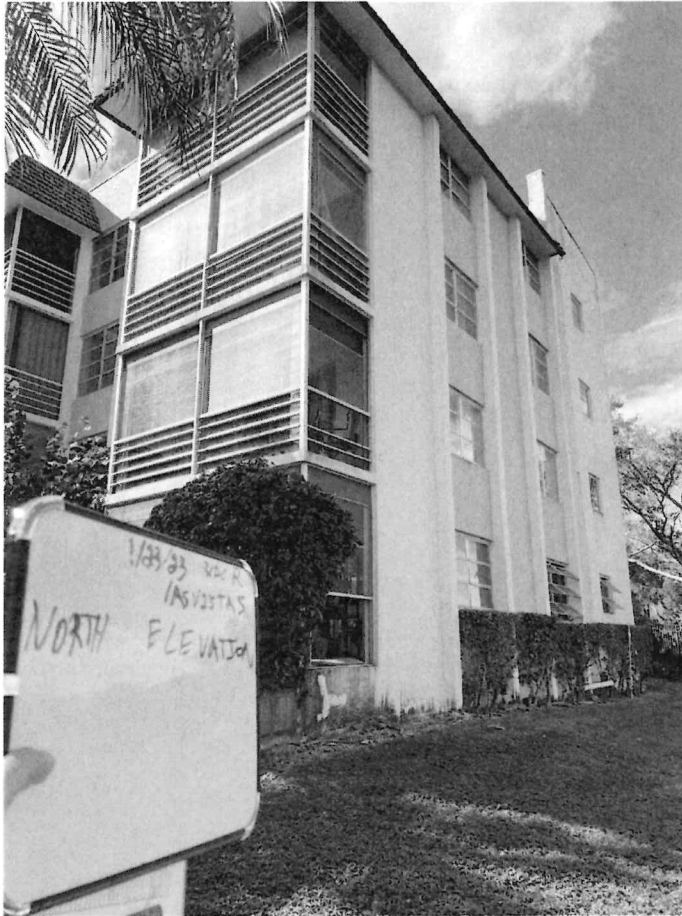
Photo 4: North side view

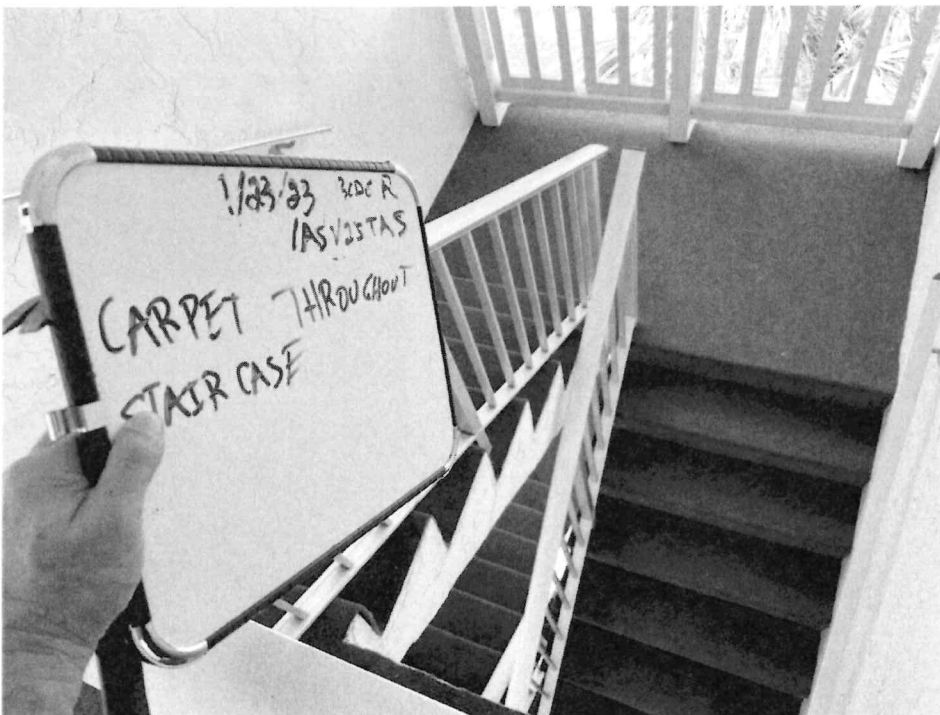
Photo 5: carpet Staircase throughout, recommended removal of carpet.

The building is structurally safe for its intended use and occupancy, but requires repairs as described in the report. All repairs must be performed in accordance with plans prepared by an engineer and approved by the local building department. The carpet along the catwalks must be removed and concrete spalling repaired.

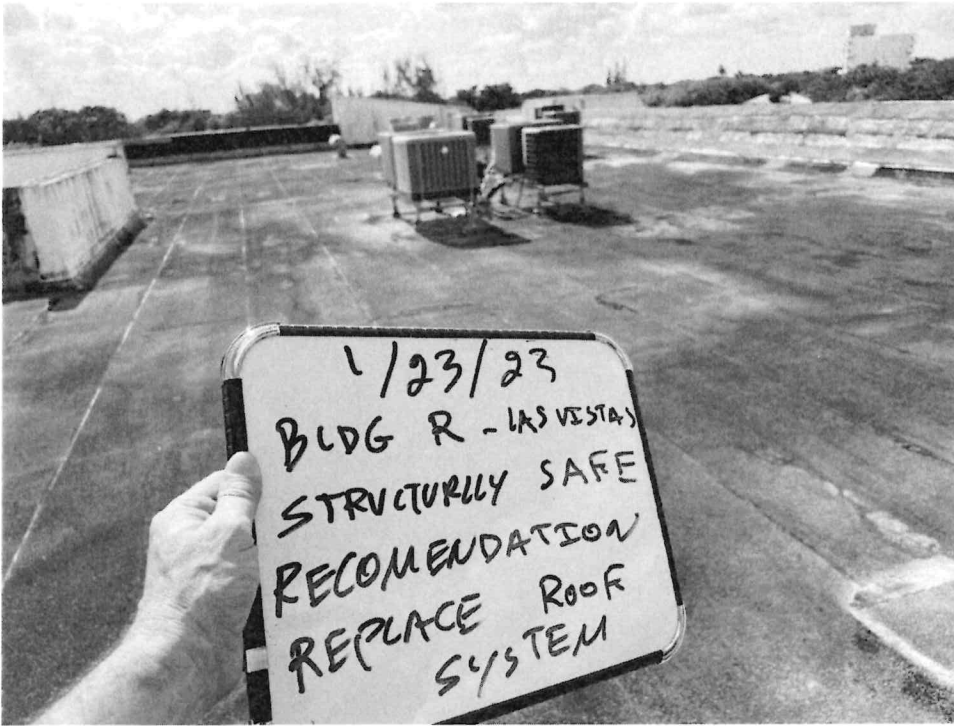
Flat single ply roof system over the concrete deck was observed to be in fair condition.

Photo 6: Roof Structurally safe recommendation replace roof system.

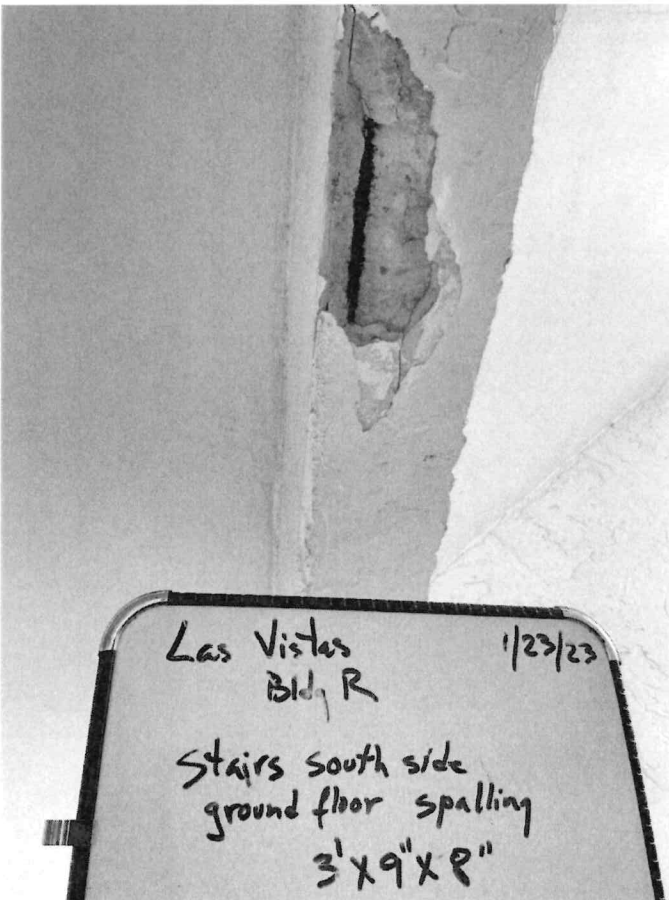
The exterior concrete stairs were observed in fair condition. However, spalled sections were found at multiple locations.

Photo 7: Stairs South side ground floor beam spalling 3'x9"x8", notice rusted exposed bar.

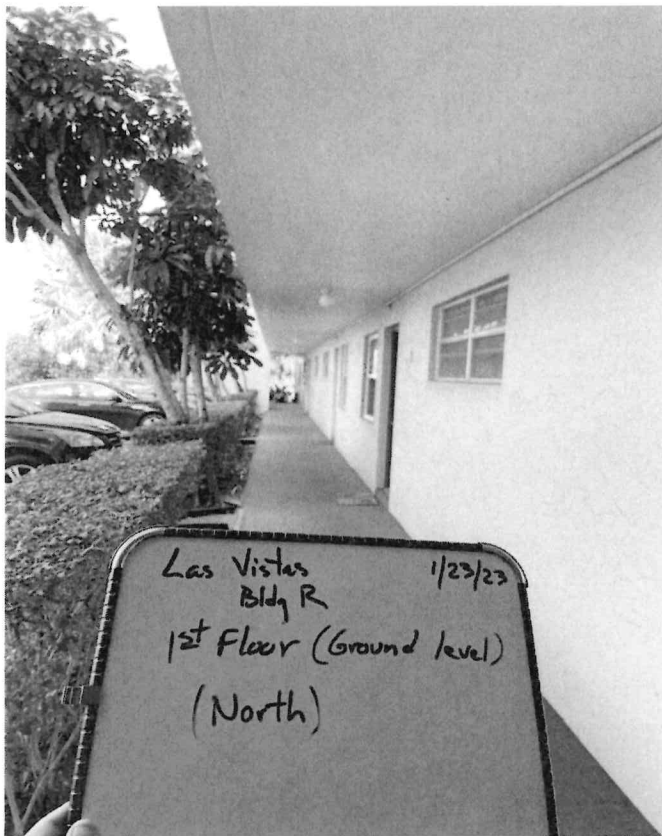
Photo 8: North Side View, ground level..

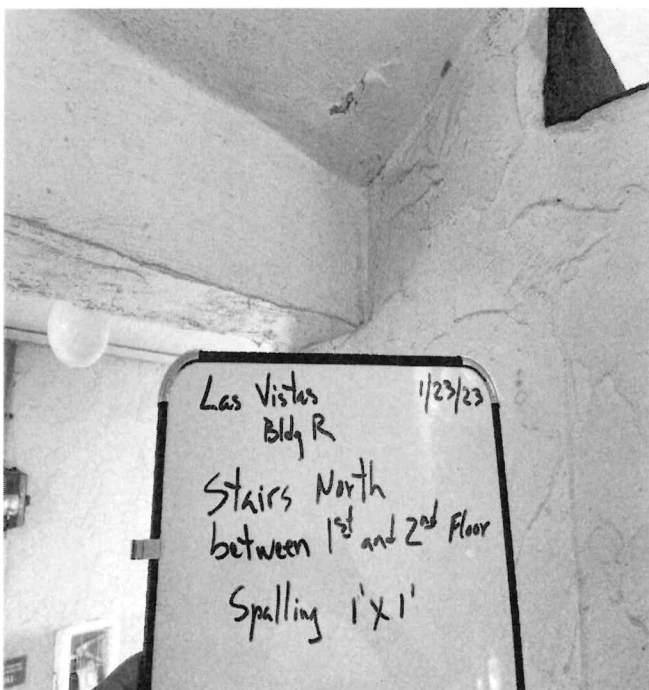
Photo 9: Stairs North between 1st and 2nd floor spalling 1'x1'.

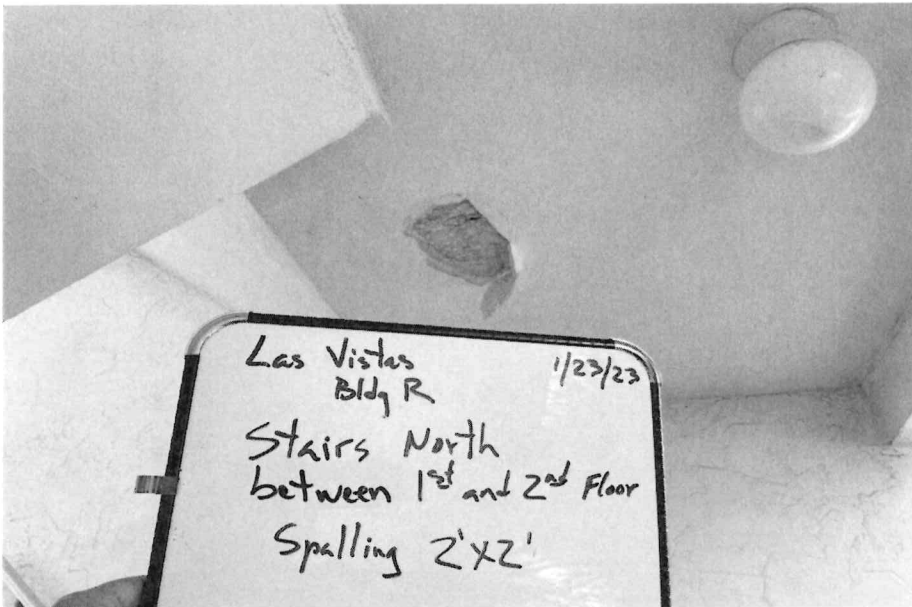
Photo 10: North Stairs overhead ceiling slab spalling between 1st and 2nd floor 2'x2'

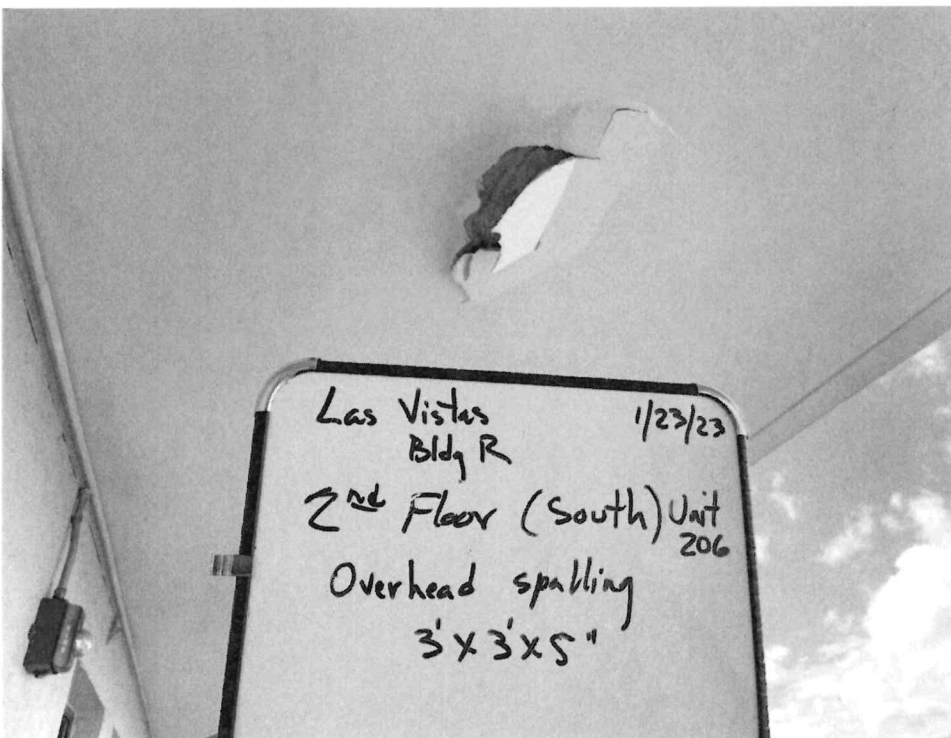
Photo 11: Overhead ceiling slab spalling 2nd floor (south) 3'x3'x5\".

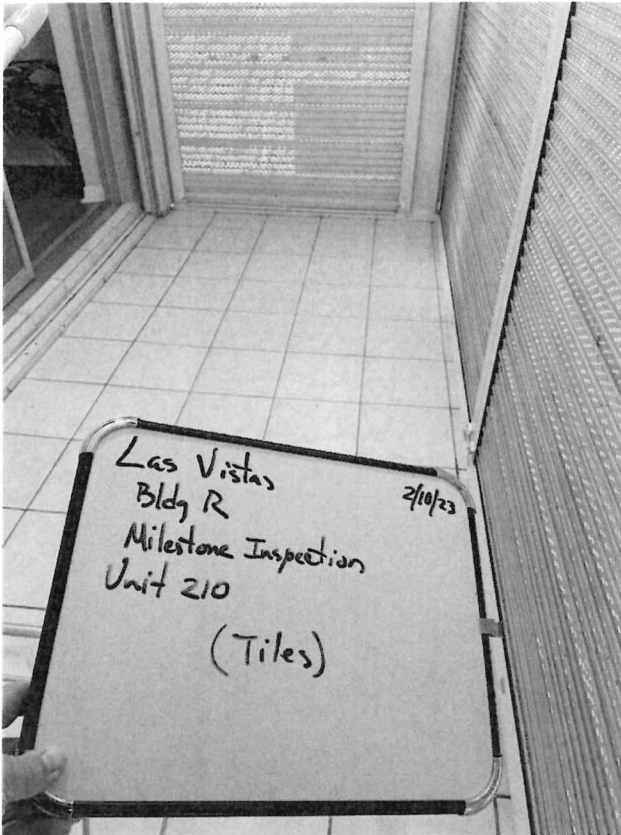
Photo12: Tiles at unit 210 balcony.

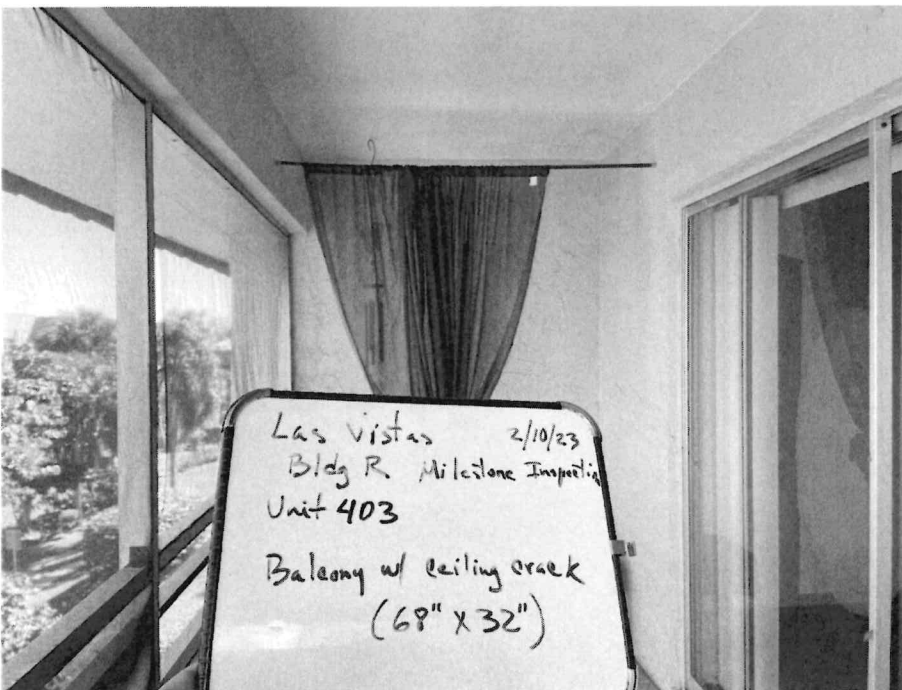
Photo 13: Balcony w/ ceiling crack 68"x32", unit 403.

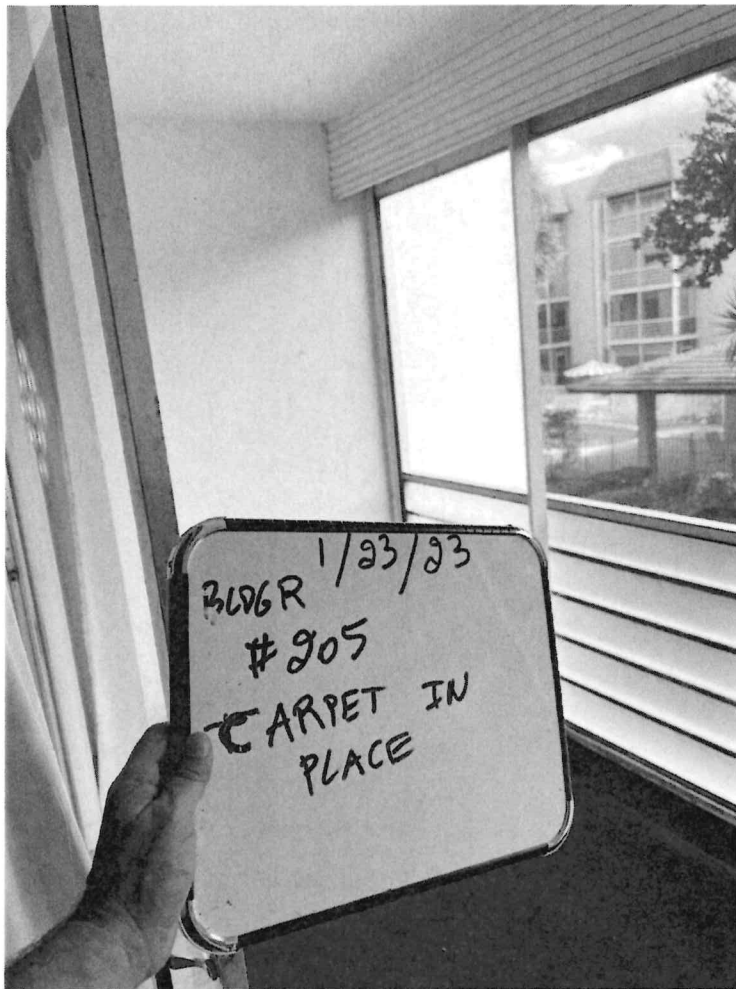
Photo 14: Carpet in place unit # 205.

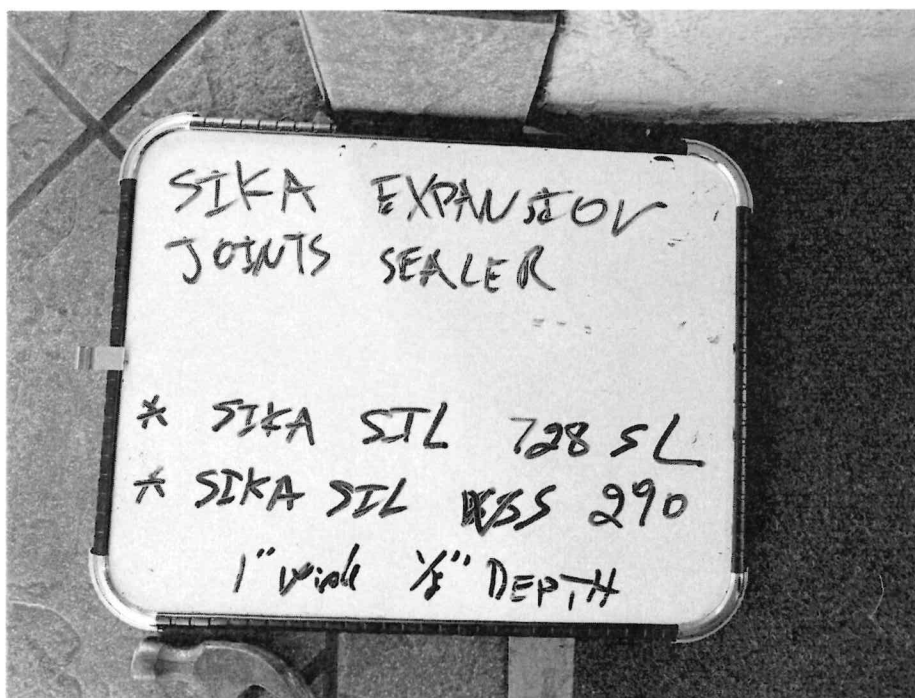
Photo 15: SIKA Expansion joints sealer.(1"W x1/8" depth).

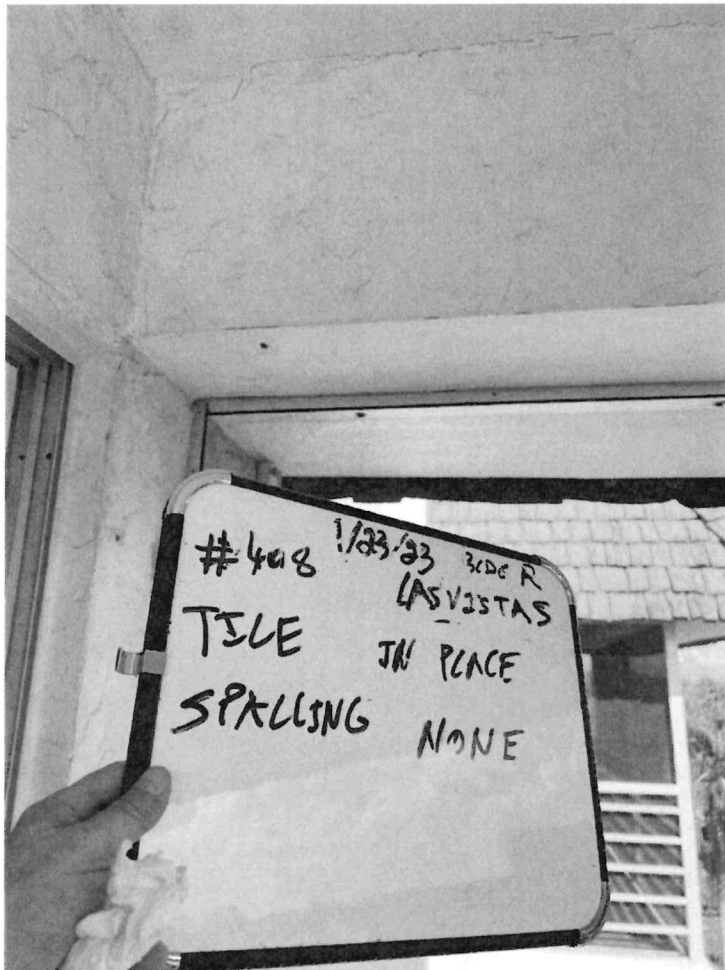
Photo 16: Tile in place spalling, unit 408.

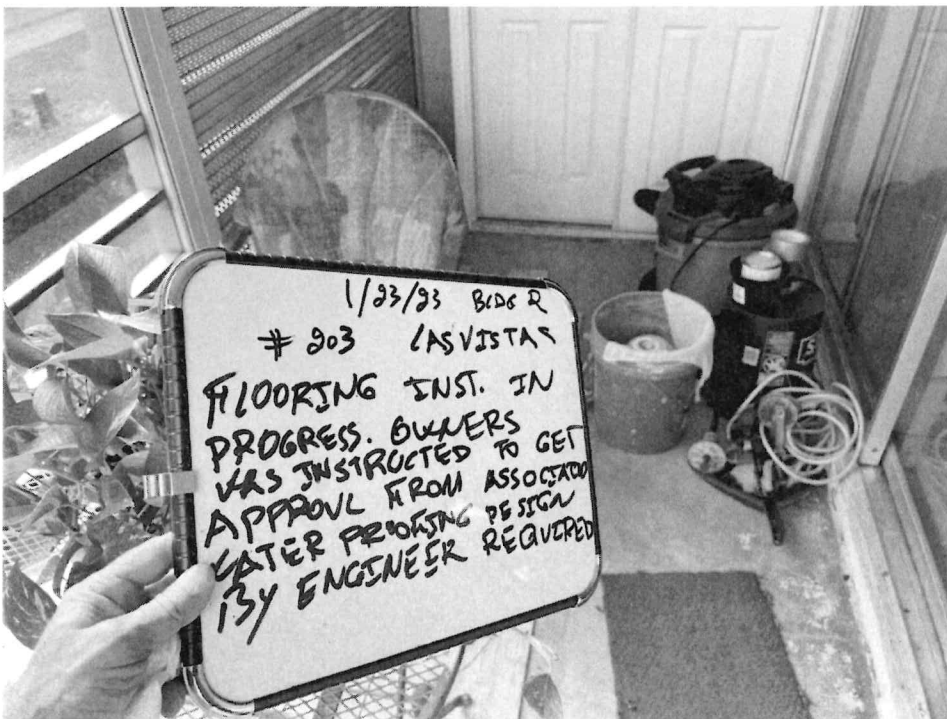
Photo 17: Flooring Installation In progress.

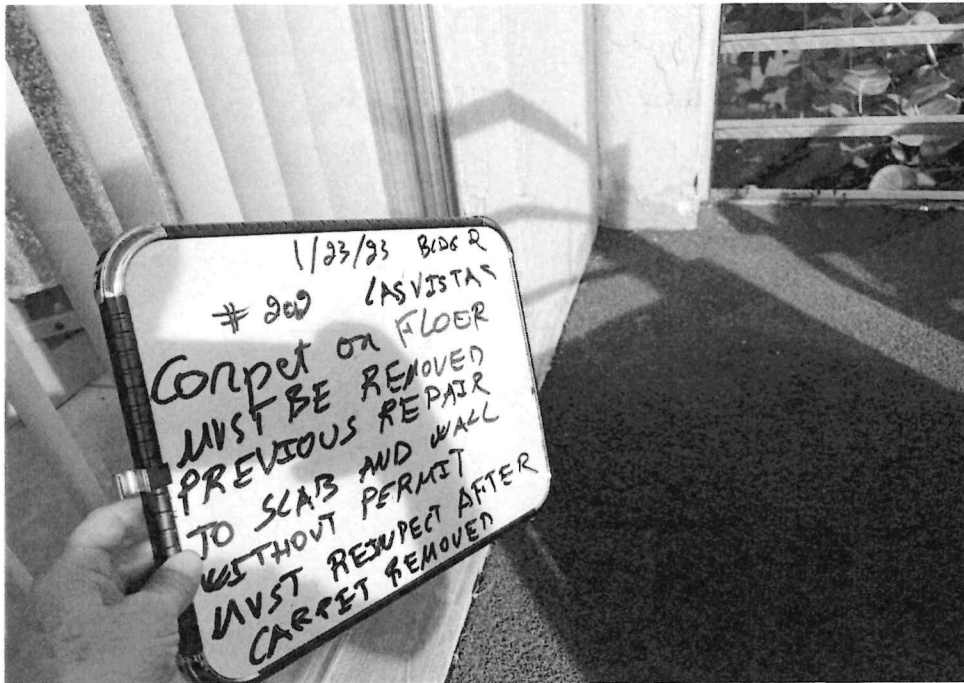
Photo 18: unit 202 Carpet must be removed- previous repair to slab and wall without permit.

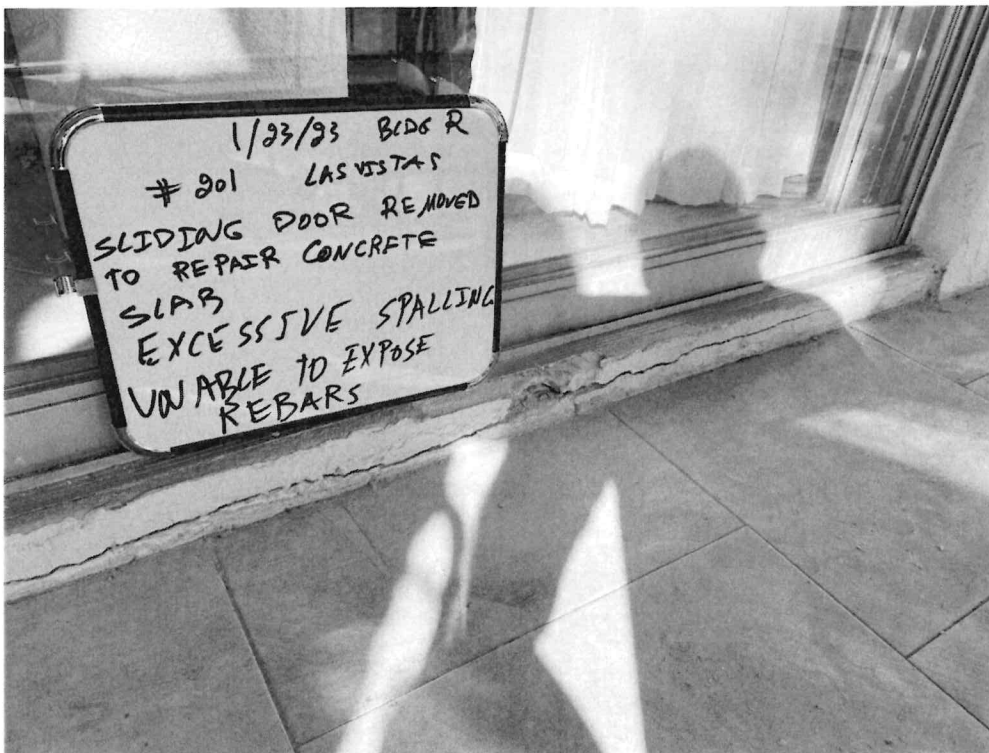
Photo 19: unit 201 sliding door removed to repair concrete slab - excessive spalling,  
Unable to expose rebars for further investigation.

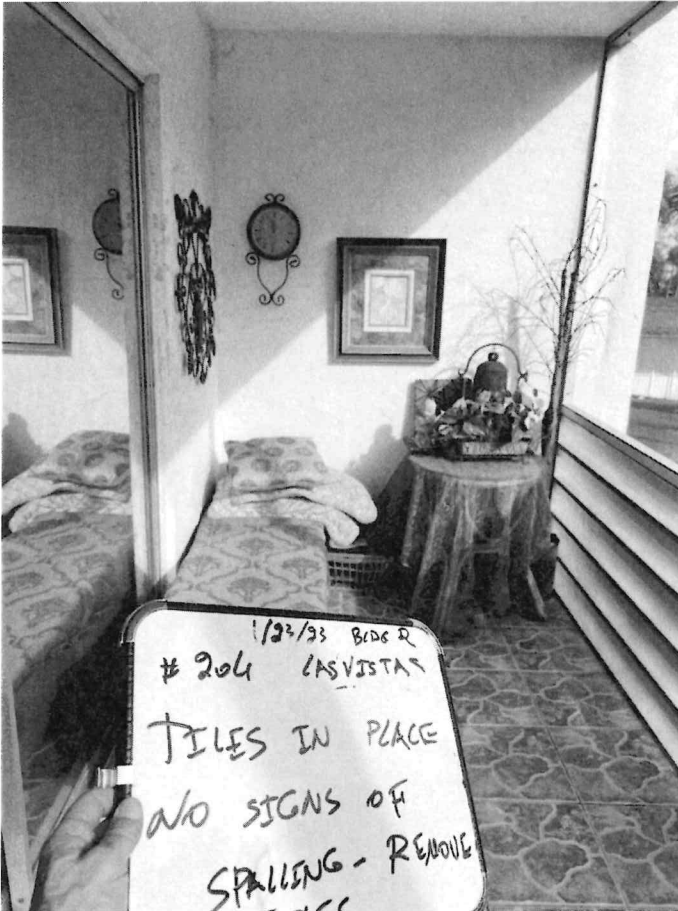
Photo 20: tiles in place no sign of spalling unit 204.

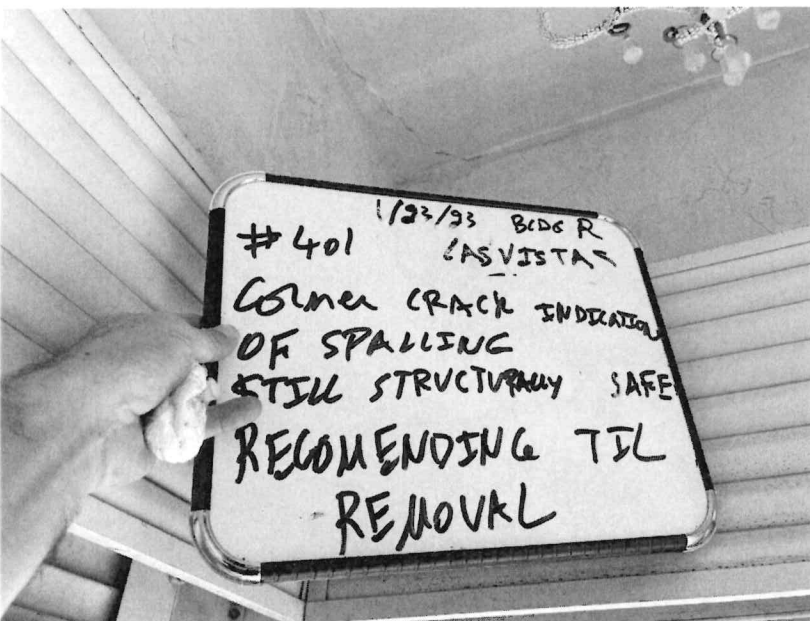
Photo 21: Column crack Indication of spalling sill structurally unknown - PE. recommended further investigation and tile removal, unit 401.

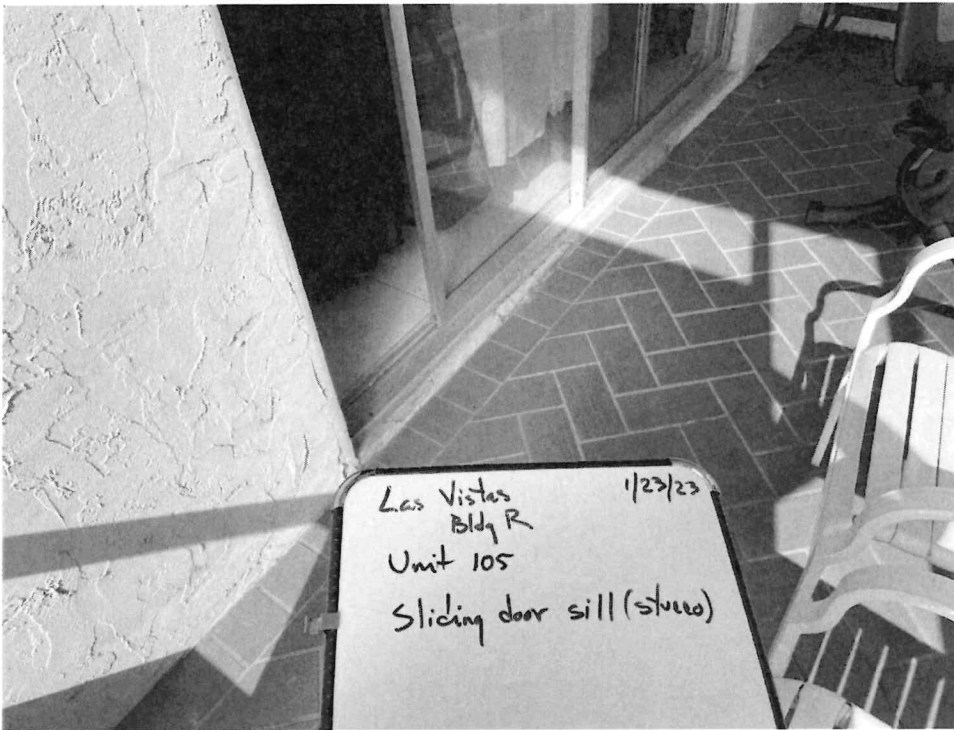
Photo 22: Unit 105 sliding door sill ( stucco).

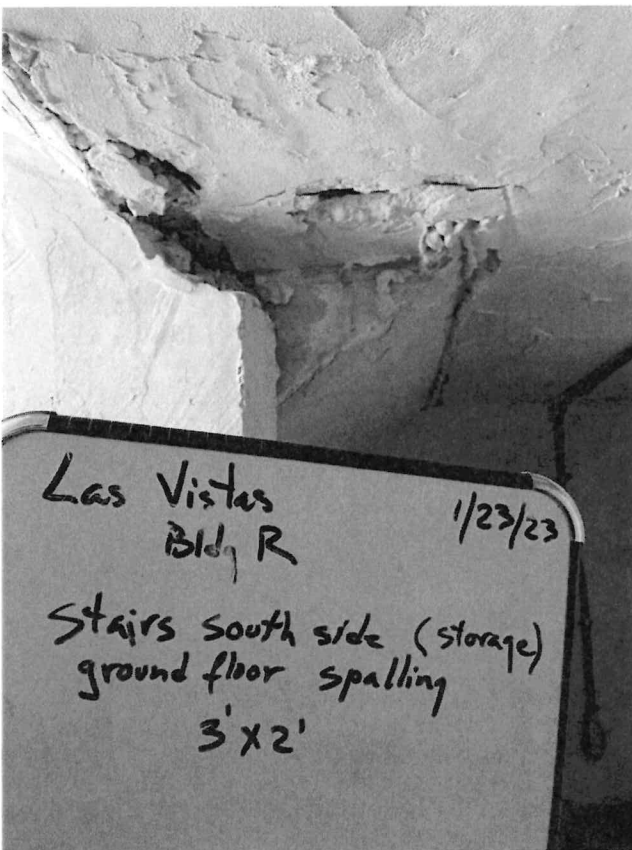
Photo 23: Stairs south side (storage room) ground floor spalling 3'x2'

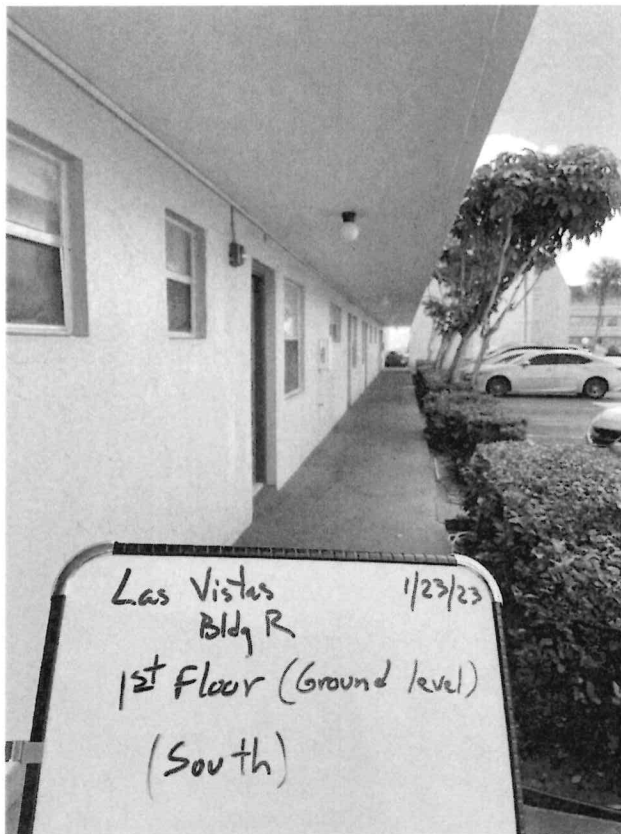
Photo 24: 1st floor ( Ground level ) south.

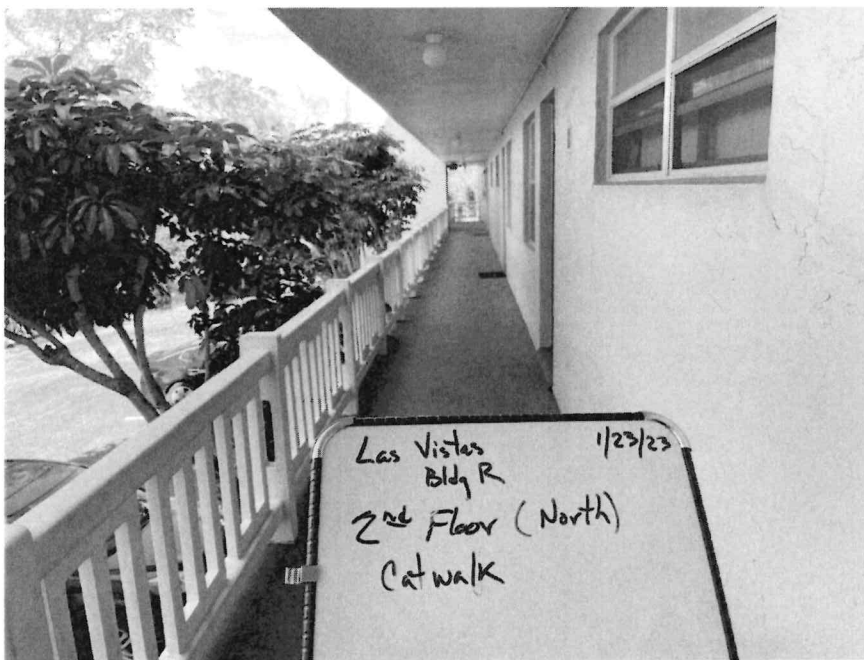
Photo 25: 2nd floor (North) Catwalk, green carpet recommended to be removed.

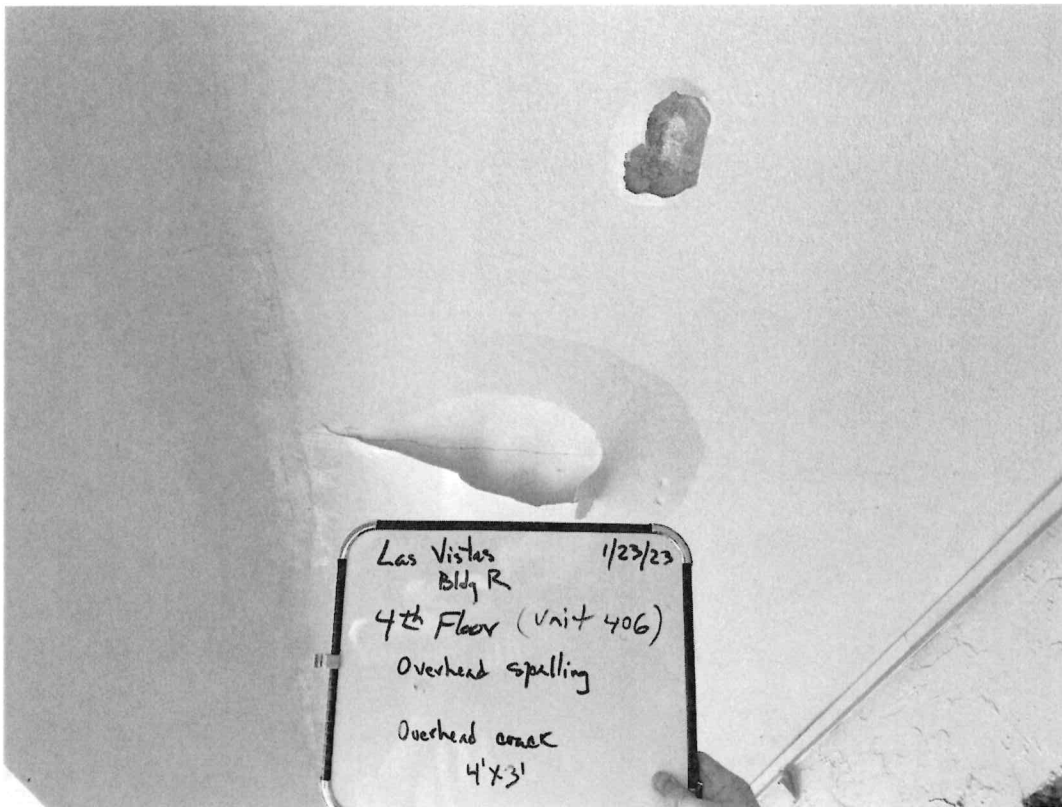
Photo 26: 4th floor, unit 406, overhead concrete spalling 4'x3'.

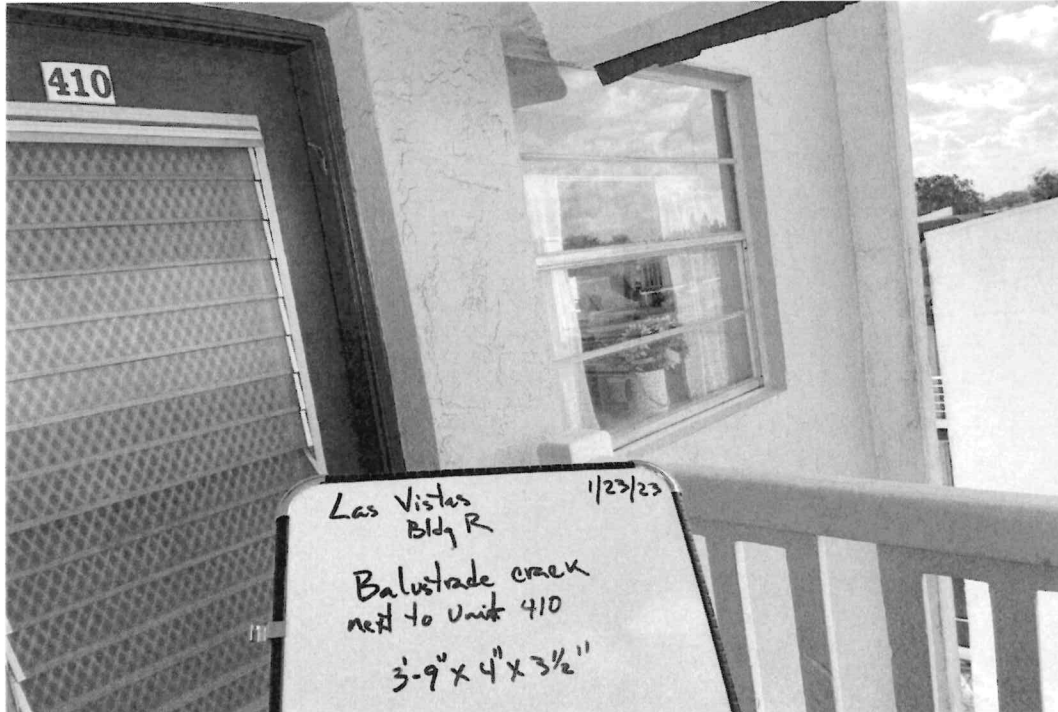
Photo 27: Balustrade crack next to unit 410, 3'-9"x4"x3 1/2".

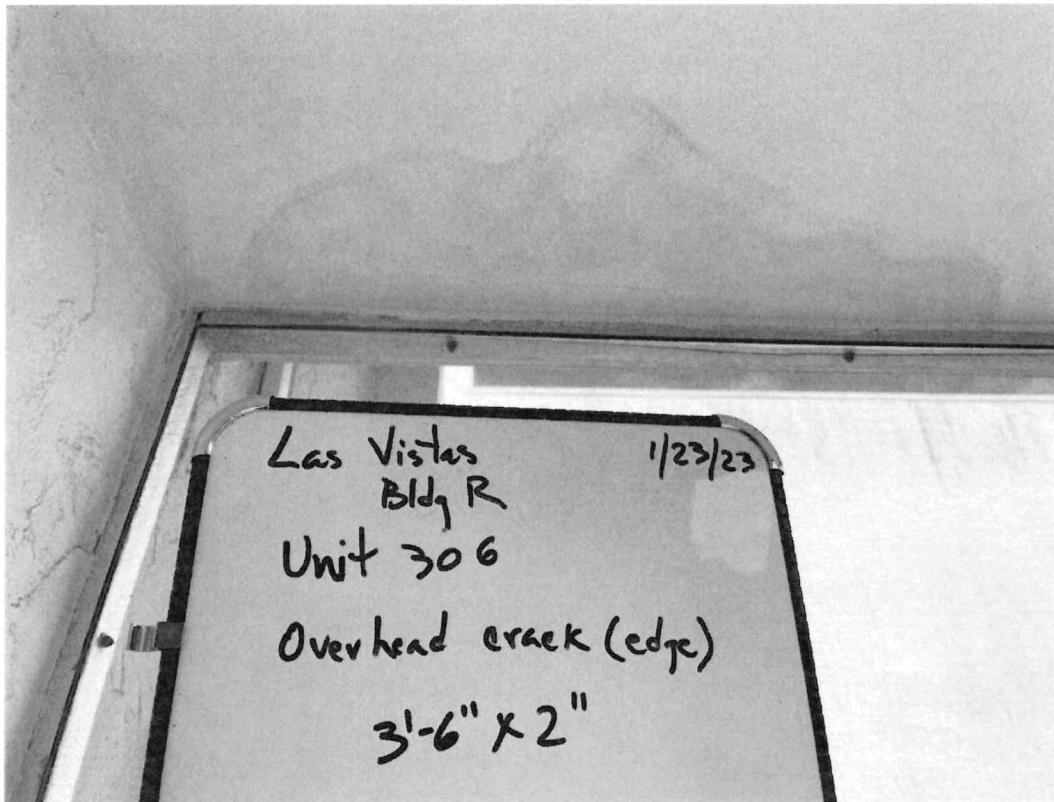
Photo 28: Overhead crack (edge) unit 306, 3'-6"x2".

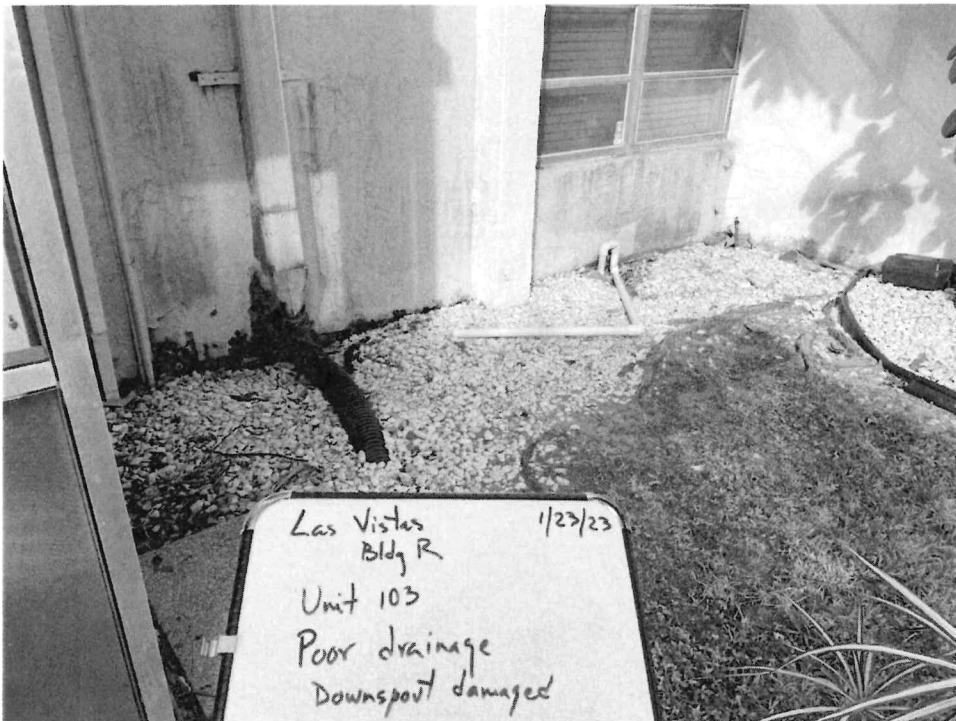
Photo 29: Poor drainage downspout damaged unit 103, need to be replaced.

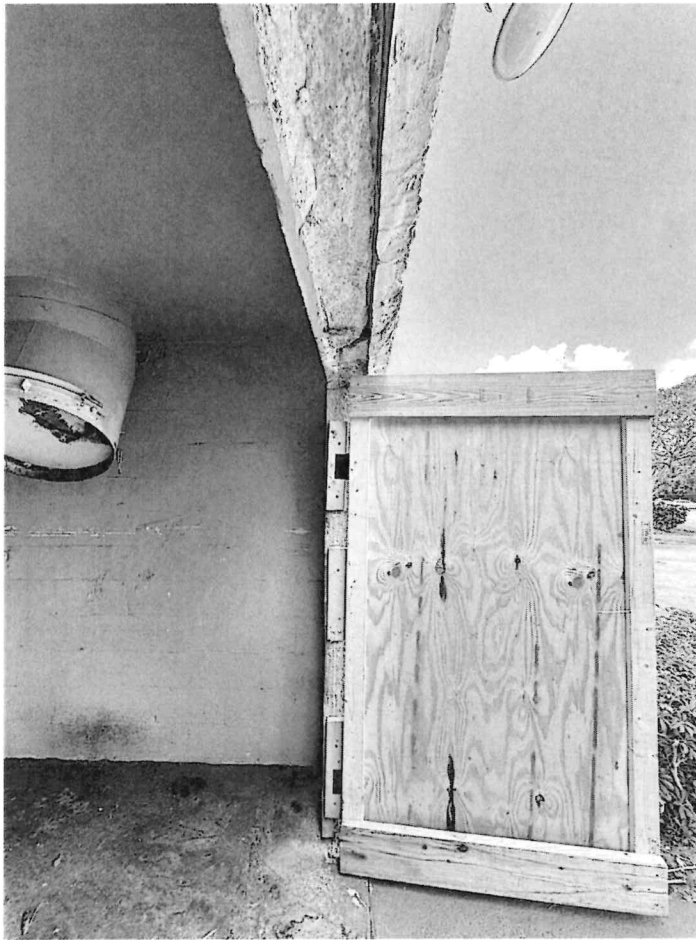
Photo 30: Make shift Polywood & 2x6 wood framed Garbage/Trash room door; (replace) with approved metal 2-Hr fire door as per code.
