**ELECTRICAL SAFETY INSPECTION REPORT FORM**

**1. DESCRIPTION OF STRUCTURE**a. Name on Title: Las Vistas in Inverrary Condominium Association Inc. (Reference)b. Street Address: 3581 Inverrary Dr., Lauderhill, FL 33319 (Building C)c. Legal Description: LAS VISTAS C IN INVERRARY CONDO UNIT 101 PER CDO BK/PG: 5956/141 (reference)d. Owner's Name: Las Vistas in Inverrary Condominium Association Inc. (Reference)e. Owner's Mailing Address: 3533 Inverrary Drive Lauderhill, FL 33319 (Reference)f. Email Address: accounting@lasvistascondo.com Contact Number: (954) 731-8484g. Folio Number of Property on which Building is Located: 4941 23 CC 0010 (reference)h. Building Code Occupancy Classification: Ri. Present Use: Condominiumj. General Description: Four story concrete building Type of Construction: IIIk. Square Footage: Apprx. 43,976 S.F. Number of Stories: 4

Name of title: Las Vistas in Inverrary Condominium Association Inc. (Reference)  
Address: 3581 INVERRARY DRIVE, LAUDERHILL FL 33319 (BLDG C)  
Folio #: 4941 23 CC 0010 (Reference)  
Legal Description: LAS VISTAS C IN INVERRARY CONDO UNIT 101 PER CDO BK/PG: 5956/141 (reference)  
Reference: Photos required for the 25/30-year recertific

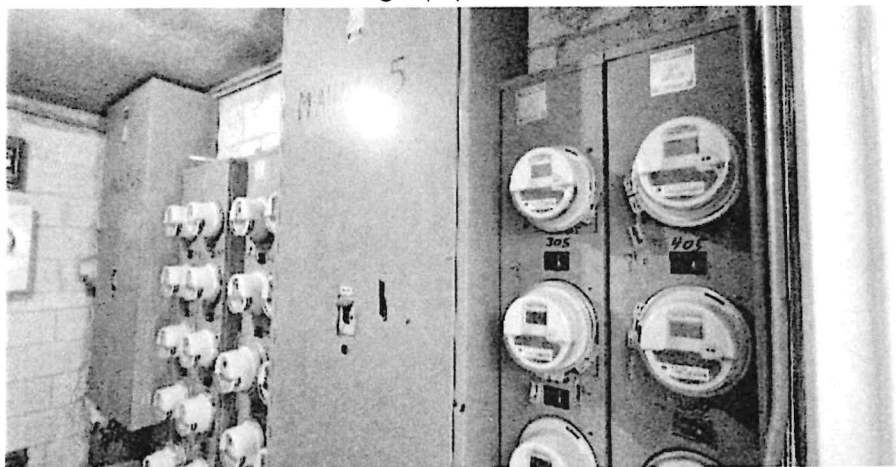
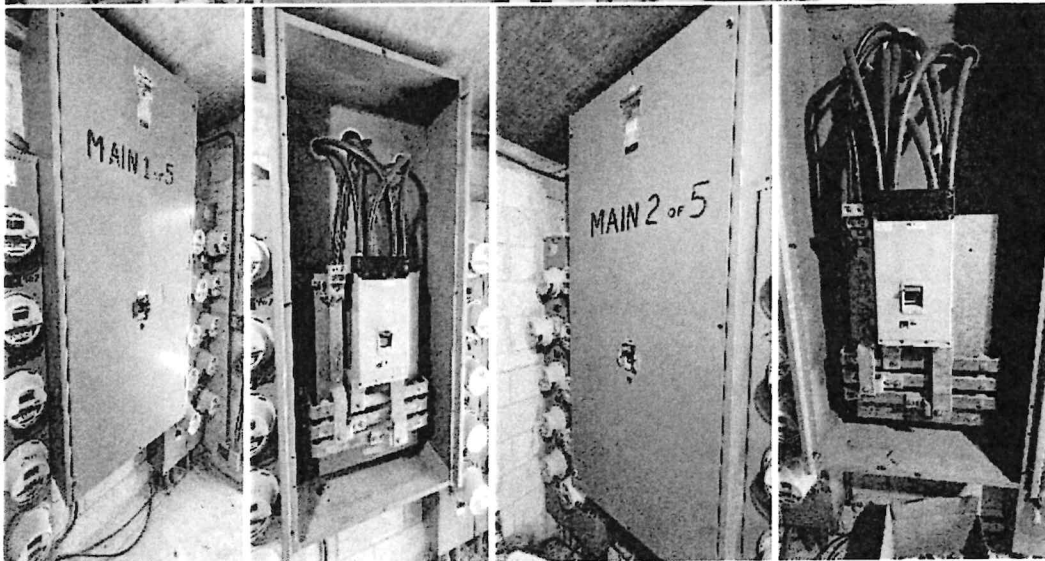
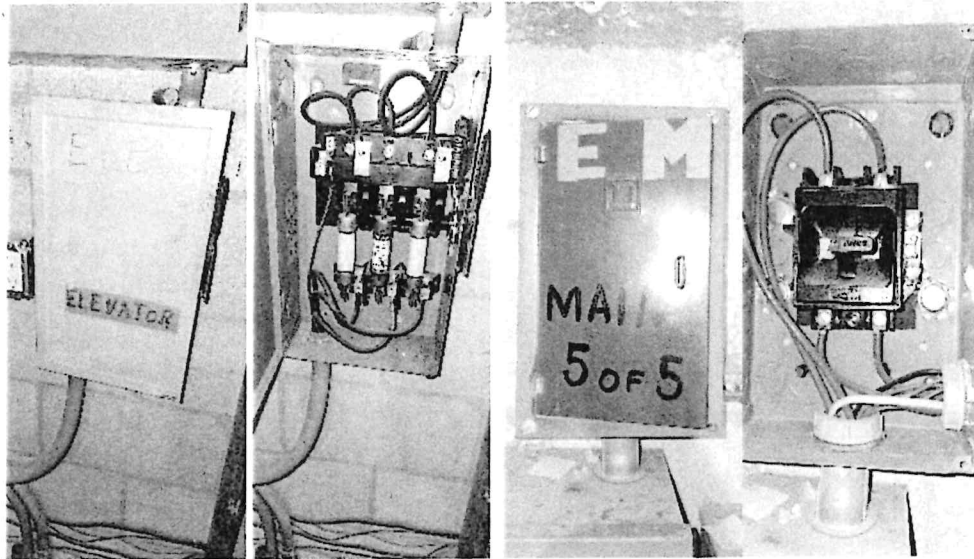
Main disconnects and metering equipment.

There are five (5) main disconnects.
