## STRUCTURAL SAFETY INSPECTION REPORT FORM

a. Name on Title: LAS VISTAS IN INVERRARY CONDOMINIUM ASSOCIATION, INC.b. Street Address: 3581 Inverrary Dr Lauderhill, FL, 33319c. Legal Description: LAS VISTAS C IN INVERRARY CONDO UNIT 101 PER CDO BK/PG: 5956/141d. Owner's Name: LAS VISTAS IN INVER CONDO ASSNe. Owner's Mailing Address: 3581 Inverrary Dr., Lauderhill, FL 33319. Building C.f. Email Address: Contact Number: Dwayne Griffin, Office Manager (954-731-8484), accounting@lasvistascondo.comg. Folio Number of Property on which building is located: 4941 23 CC 0010 (Reference)h. Building Code Occupancy Classification: R FBC 2023 , Type III residentiali. Present Use: Condominium Buildingj. General Description: Type of Construction: This is a (4) story concrete building Type of Construction: IIIk. Square Footage: Approximately: 14,948 SF Number of Stories: (4)

## Photo Report

Property Address: 3581 Inverrary Dr., Lauderdale, FL 33319. Building C.

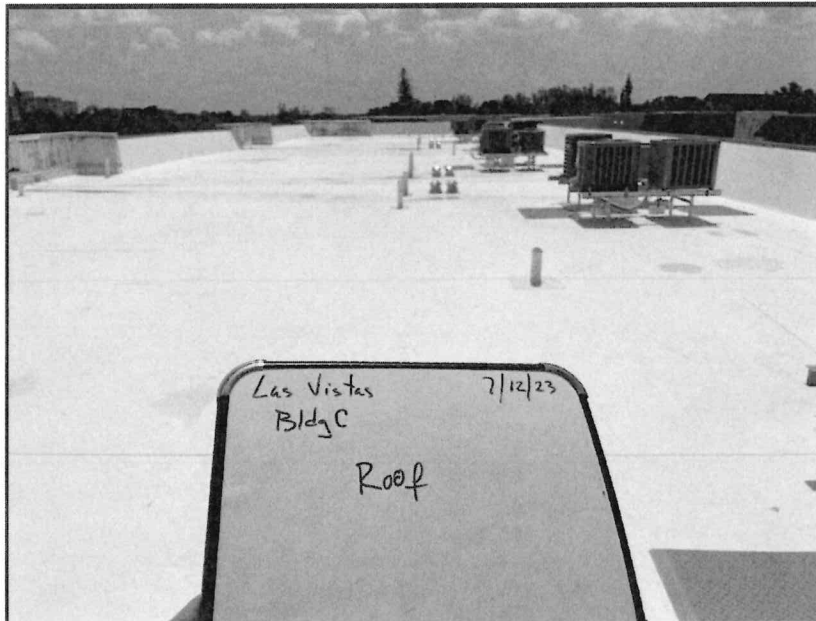
Photo 5: Roof View.

Flat single ply roof system over the concrete deck was observed to be in good condition.

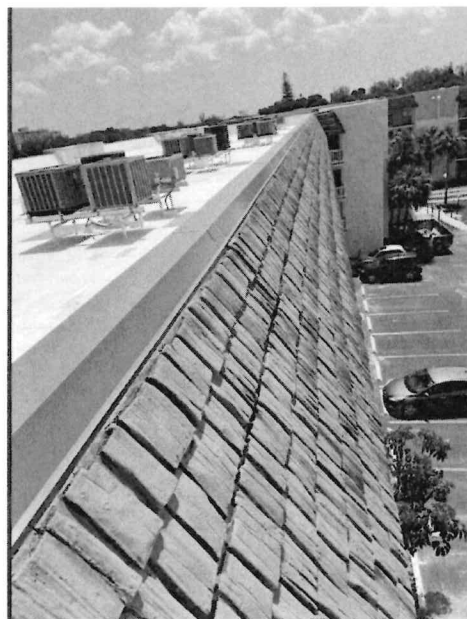
Airconditioning equipment were found on supports and observed to be in good condition.

The concrete tile roof along the mansard roof was observed generally in fair condition. Although there was no access To confirm the underlying structural system, No visible deficiencies were noted during the inspection.

Photo 6: Mansard Roof and AC Units
