## STRUCTURAL SAFETY INSPECTION REPORT FORM

**1. DESCRIPTION OF STRUCTURE**a. Name on Title: LAS VISTAS IN INVERRARY CONDOMINIUM ASSOCIATION, INC.b. Street Address: 3501 Inverrary Boulevard Bldg L, Lauderhill, FL 33319, Building L.c. Legal Description: LAS VISTAS L IN INVERRARY CONDO PER CDO BK/PG: 5956/351d. Owner's Name: LAS VISTAS IN INVER CONDO ASSNe. Owner's Mailing Address: 3533 Inverrary Dr, Lauderhill, FL 33319-5921f. Email Address: Contact Number: Dwayne Griffin, Office Manager (954-731-8484), accounting@lasvistascondo.comg. Folio Number of Property on which building is located: 4941 23 DA 0000 (Reference)h. Building Code Occupancy Classification: R-2 FBC 2023, Type III residentiali. Present Use: Condominium Buildingj. General Description: Type of Construction: This is a (2) story concrete building Type of Construction: IIIk. Square Footage: Approximately: 12,200 S.F. Number of Stories: (2)

## Photo Report

Property Address: 3501 Inverrary Boulevard, Lauderhill, FL 33319. **Building L**

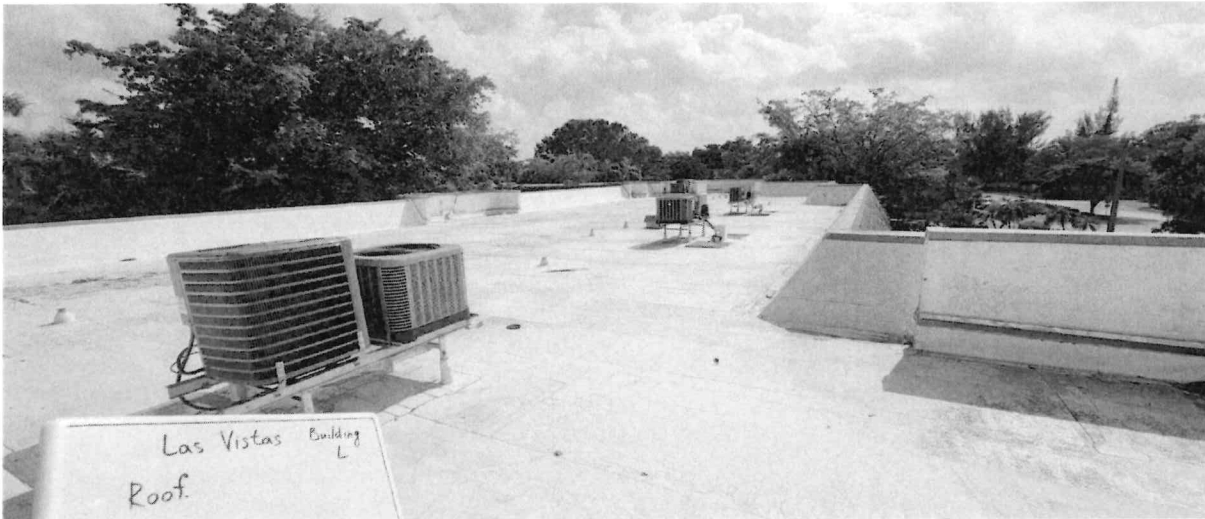
Photo 5: Roof View. No overflows observed.

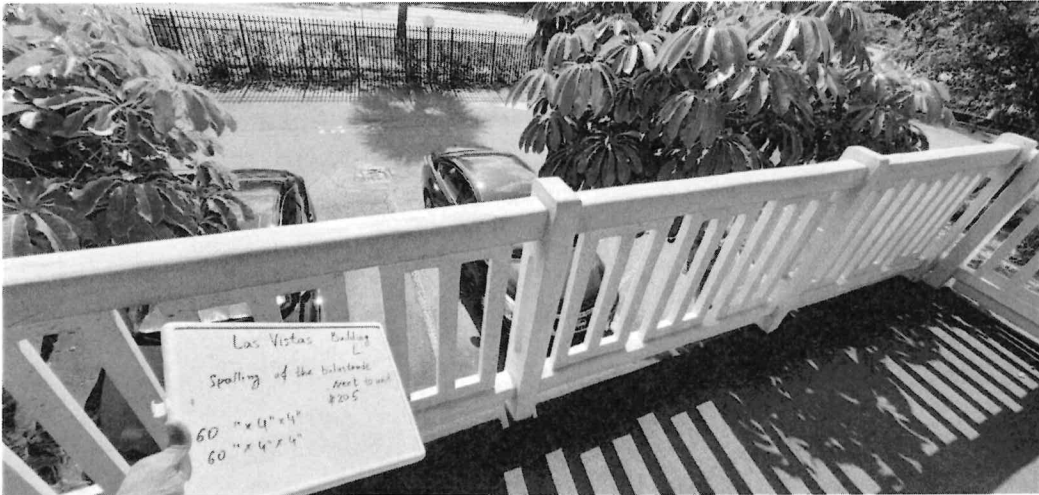
Photo 7: Spalling of the balustrade next to unit #205.(60"x4"x4").

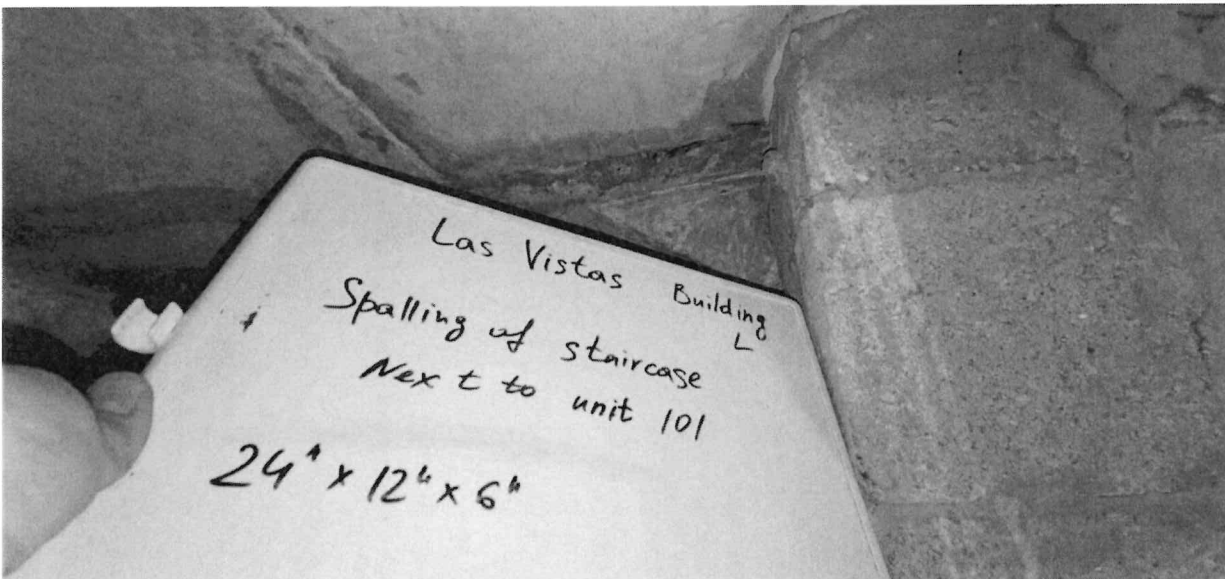
The exterior concrete stairs were observed in fair condition. However, spalled sections were found at multiple locations.

Photo 8: Spalling of concrete staircase next to unit 10; 24"x12"x6"

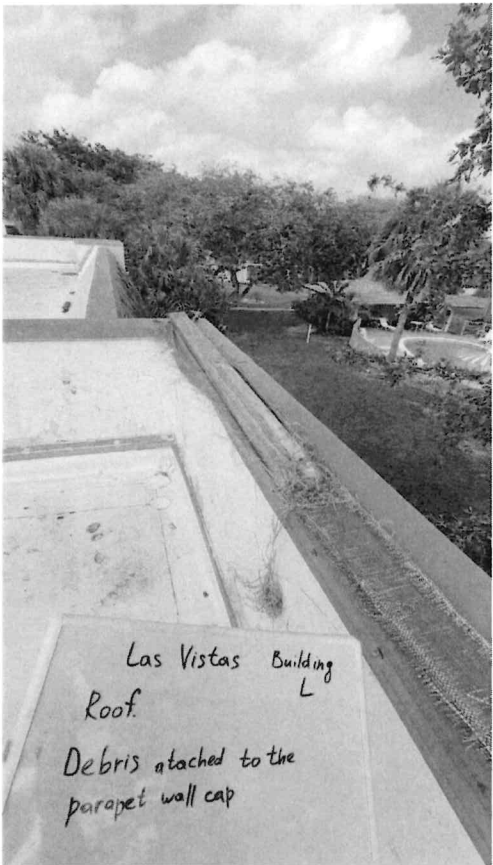
Photo 9: Roof Debris attached to the parapet wall cap.

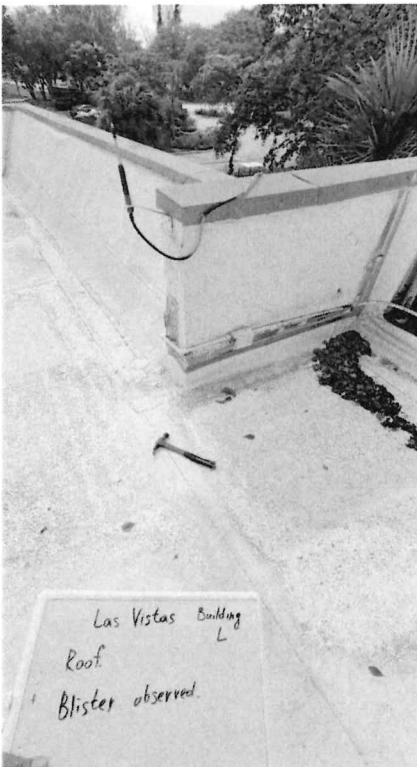
Photo 10: Roof - Blister Observed

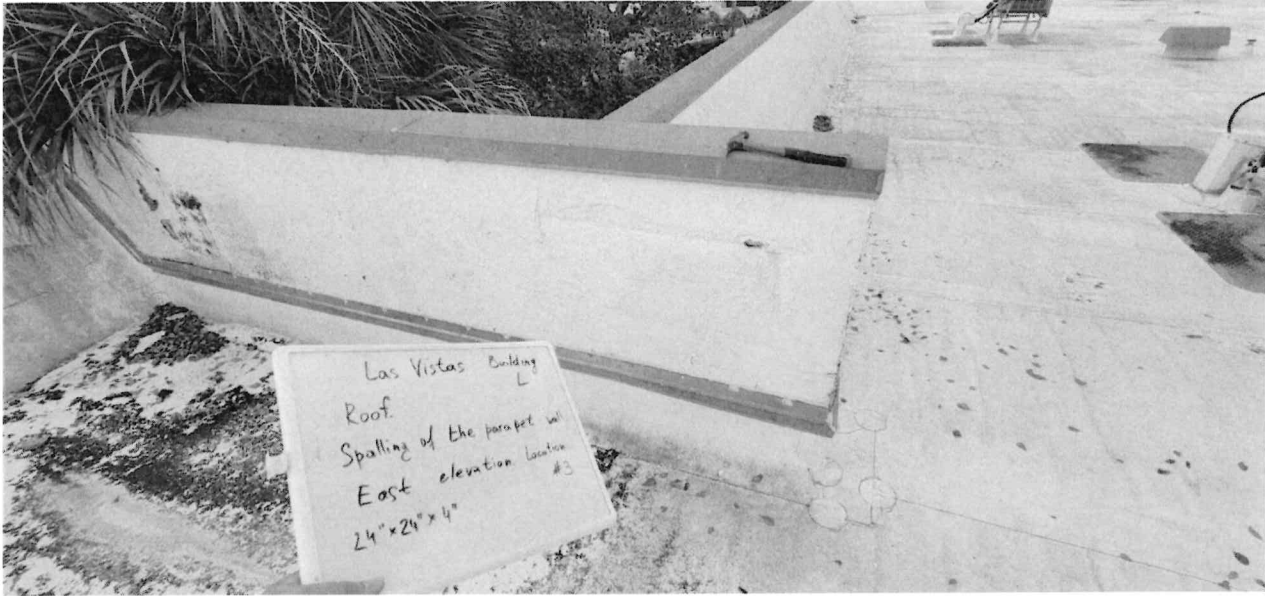
Photo 11: Roof Spalling of the parapet wall east elevation location #3; 24"x24"x4"
